## Client

**Jon Doe**  
**123 Your Street**  
**Your Town, NY 13440**  
**HIN™: 134403026**  
**Email:**  
**Inspection Date:** 09-12-2015

Welcome and thank you for choosing Superior Quality Home Inspections.  
 This report is designed to be as thorough as possible, but also clear and concise.  
 If you have any questions please call us at (315)-794-1565.

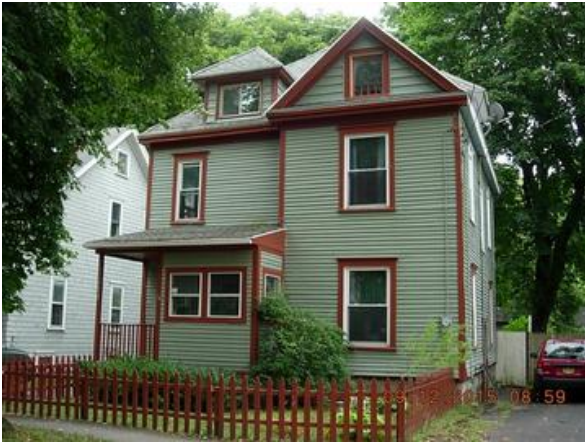
No gutter downspouts and extensions noted. This can cause accumulation of water next to the foundation which can lead to a wet basement. Recommend adding gutter downspouts with extensions.

No Downspouts

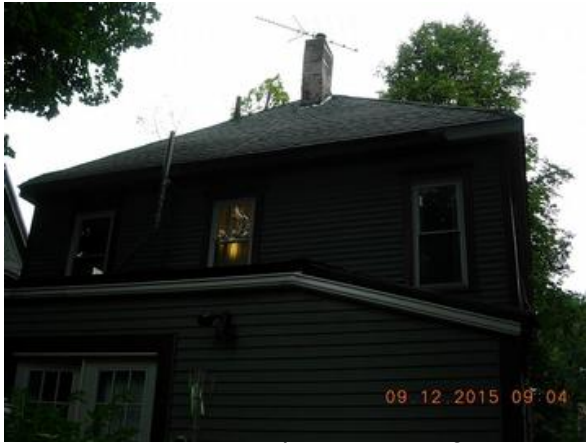
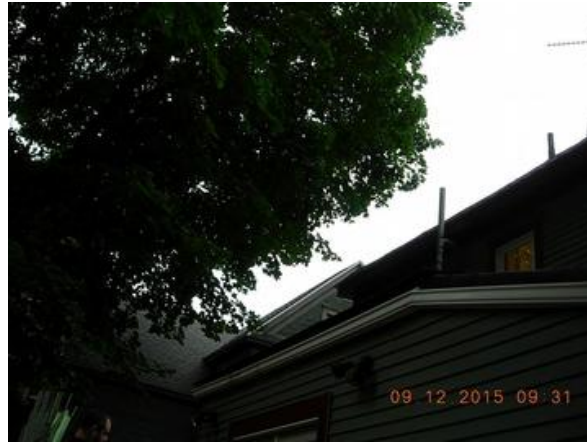
Trees are overhanging roof and are within 10 feet of roof vertically. Recommend pruning trees so they're at least 10 feet above roof, or don't overhang the roof.

Trees Overhanging Roof

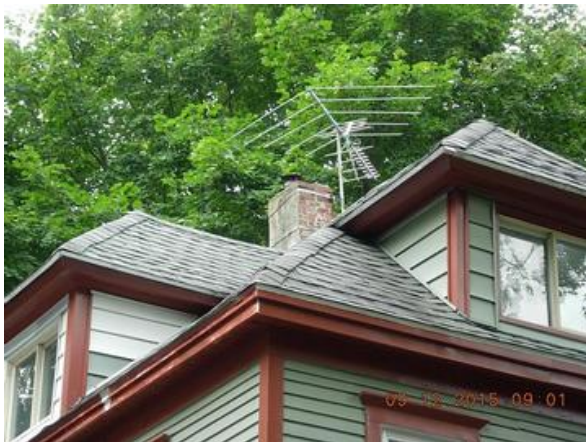
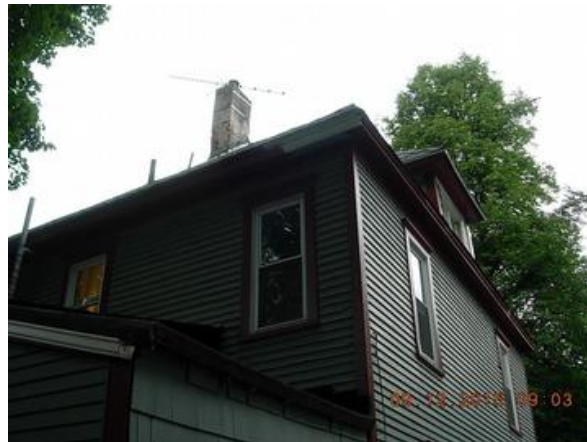
Chimney is severely deteriorated. This allows water to infiltrate the brick and mortar, causing further damage to chimney. Recommend qualified contractor repair as necessary.

Chimney Deterioration

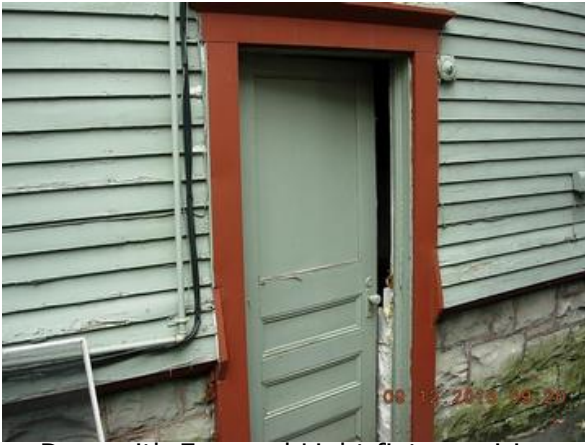
Open light fixture on the outside the home has live wires exposed to the elements. This is a fire/safety hazard. Recommend a qualified electrician repair as necessary.

Door with Exposed Light fixture wiring

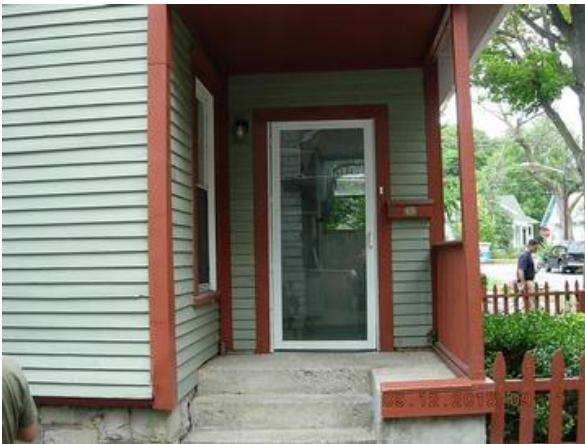
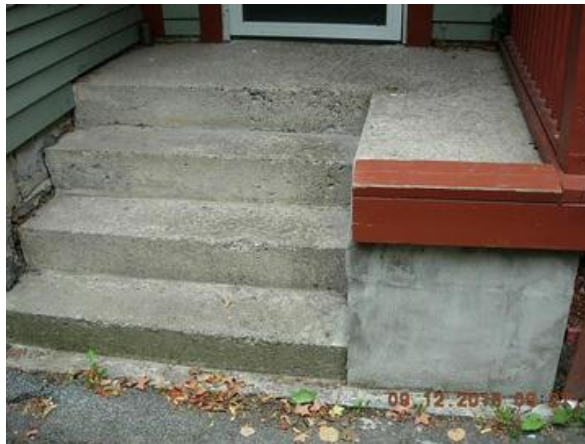
Main entry porch on the front of the home is missing a hand railing. This could be a safety hazard when using the steps in this area. Recommend a qualified contractor repair as necessary.

Hand Rail Missing

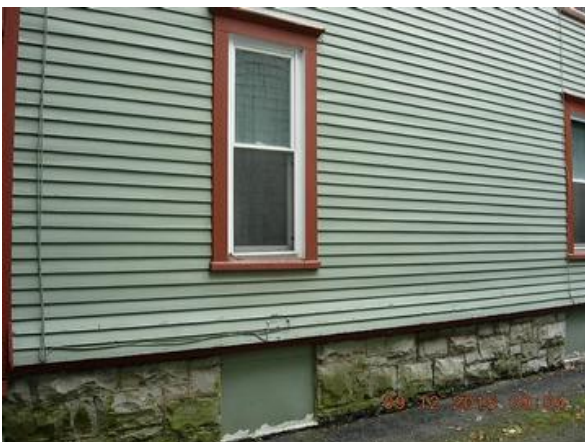
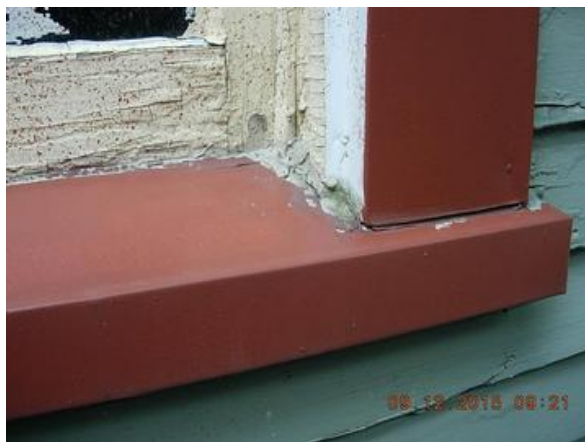
Window trim needs caulking around numerous windows. This can allow water infiltration around the windows and inside the walls. Recommend a contractor repair as necessary.

Caulking deteriorated

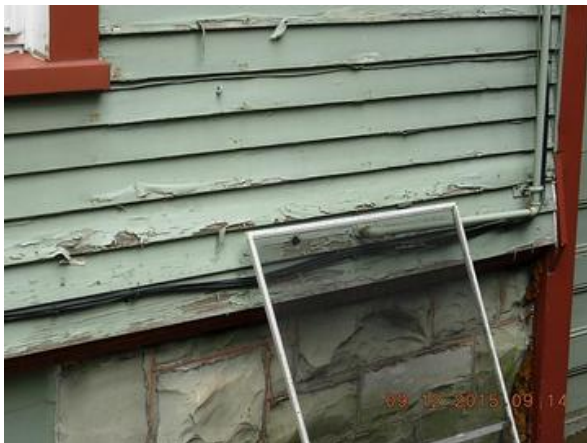
09/12/2015 Wood siding is damaged and/or deteriorated in multiple areas. A qualified contractor should evaluate and repair as necessary to prevent water intrusion.

Deteriorated Siding

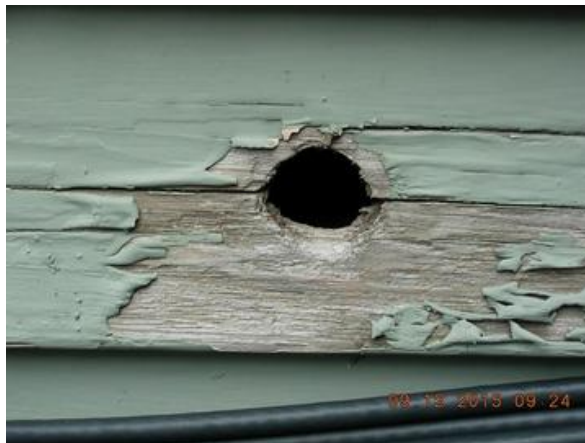
Hole in Siding

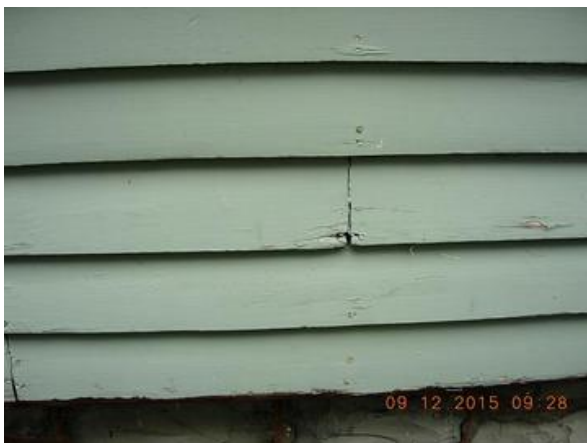
Siding Deterioration

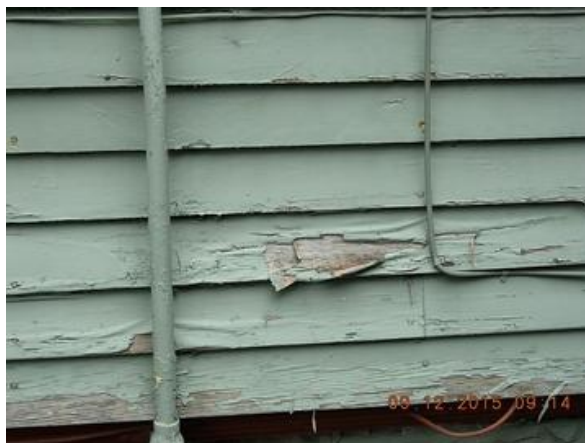
Deteriorated Siding

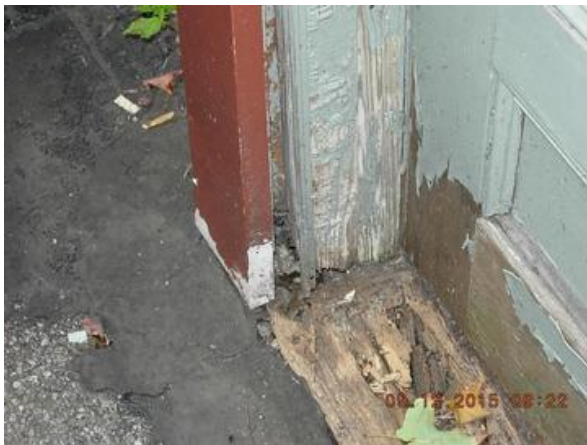
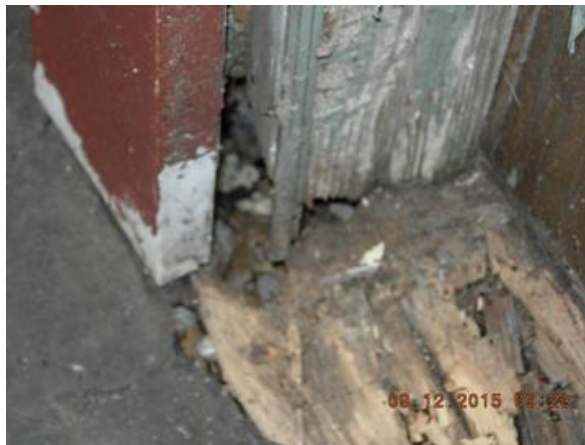
09/12/2015 Wooden door and its threshold on the side of the home is deteriorated and have extensive areas of rot. This could allow water intrusion into the home. Recommend contractor repair as necessary.

Deteriorated Door and Threshold

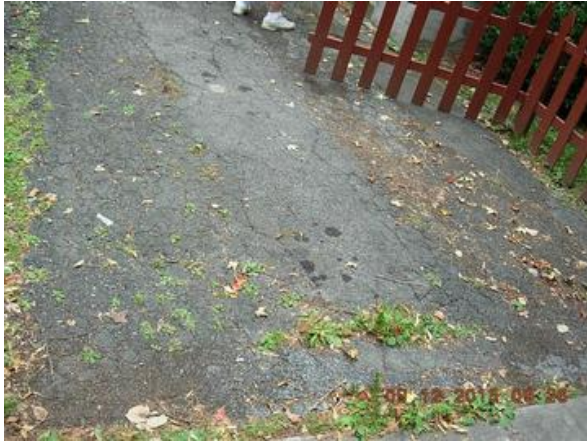
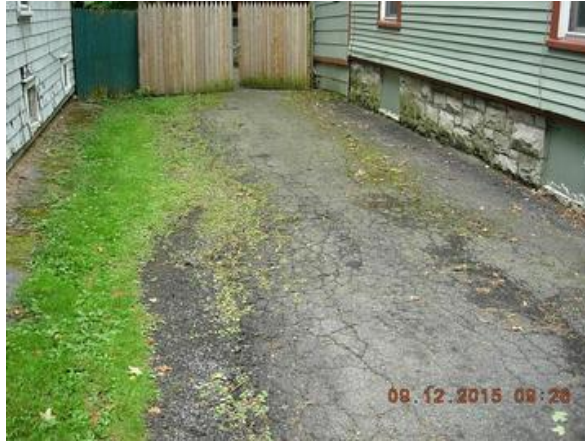
The homes driveway is beyond the end of its useful life and is severely deteriorated along the majority of the length of the home. Recommend a contractor repair as necessary.

Driveway Deterioration

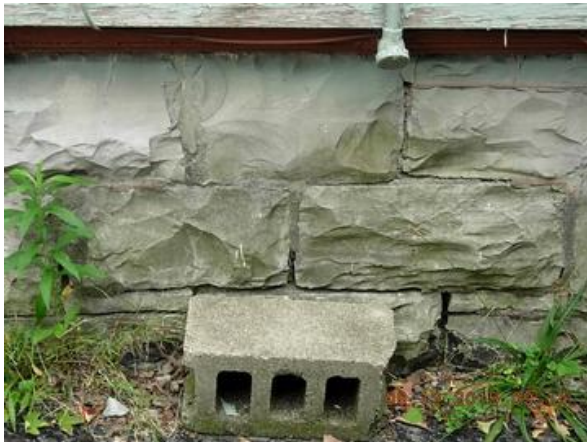
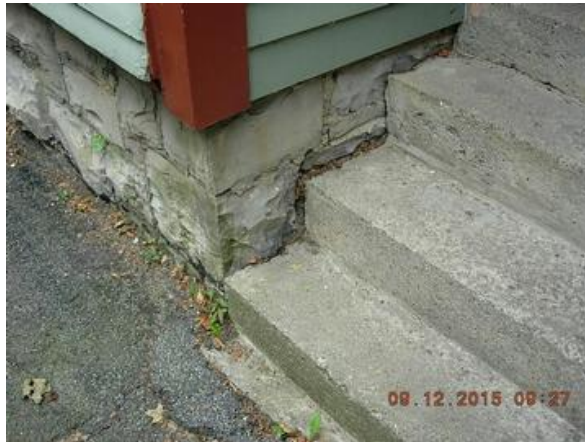
Noted cracks in foundation in the area where the foundation wall meets the driveway. This can allow water infiltration which will lead to further damage. Recommend qualified contractor repair as necessary.

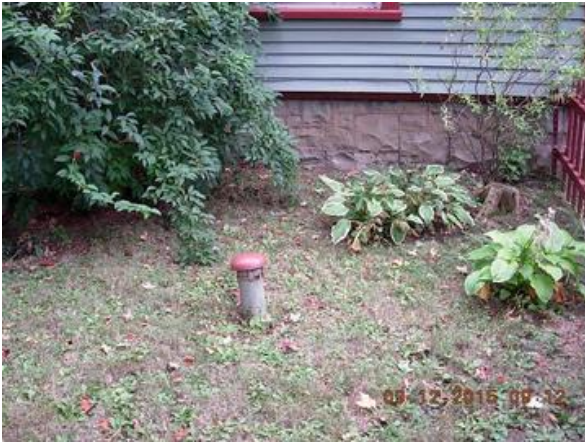
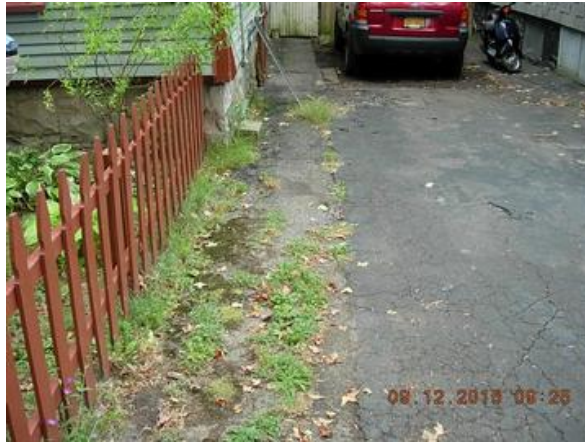
Perimeter grading slopes towards building in areas. Recommend grading soil so it slopes down and away from the building to direct rainwater away from foundation.

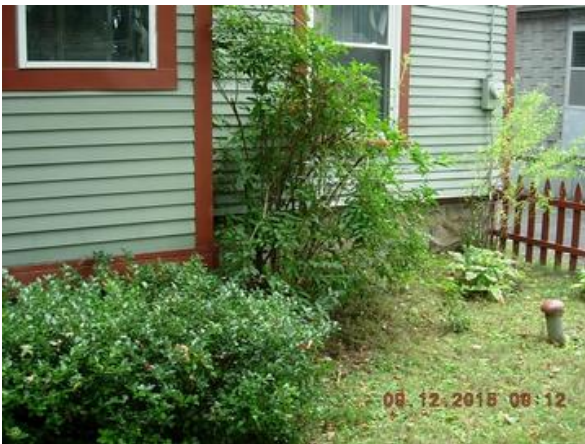
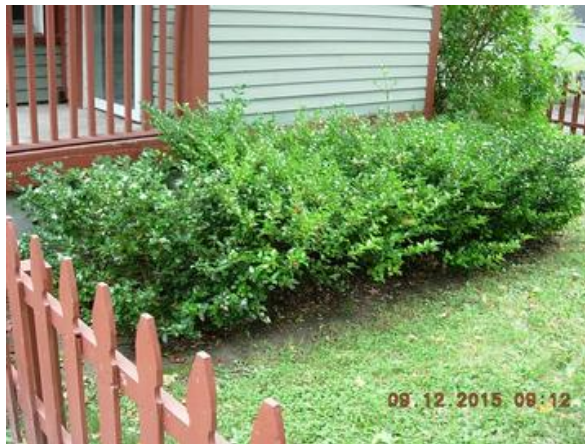
09/12/2015 Shrubs are in contact with siding in the front of the home. Recommend pruning or moving shrubs so there's at least a one foot gap between shrubs and siding.

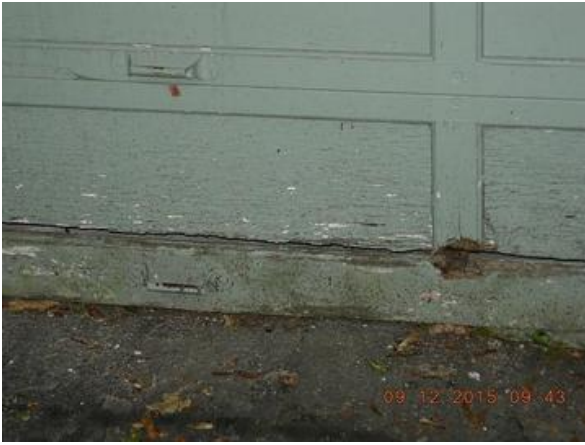
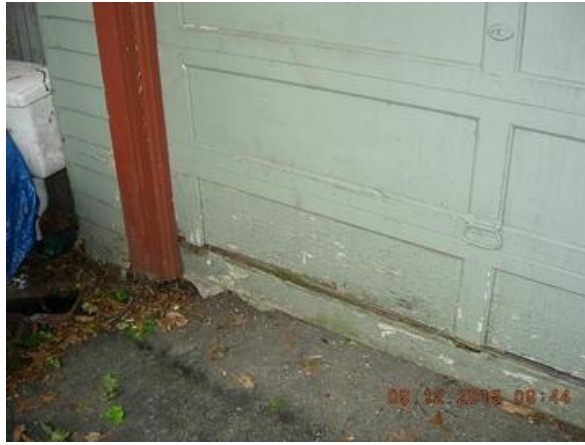
09/12/2015 Garage door is beyond its useful life. Door panels are deteriorated and rotting. Recommend qualified contractor repair as necessary.

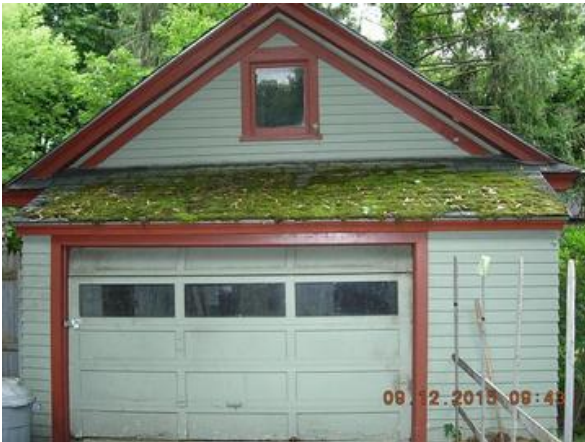
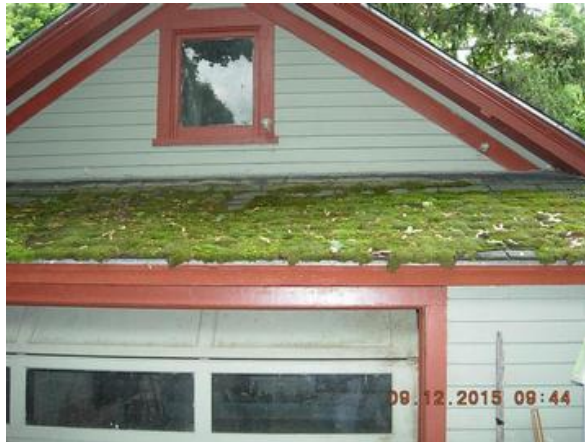
09/12/2015 Heavy areas of moss growth on the garage roof. This could allow water to leak through the roof into the garage. Recommend a qualified contractor repair as necessary.

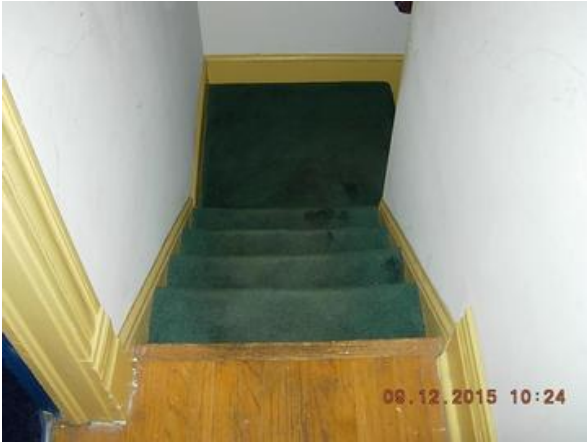
09/13/2015 No railing noted on the stairs to the second floor. This is a safety hazard and should be addressed. Recommend a contractor repair as necessary.

Stairs without Railing

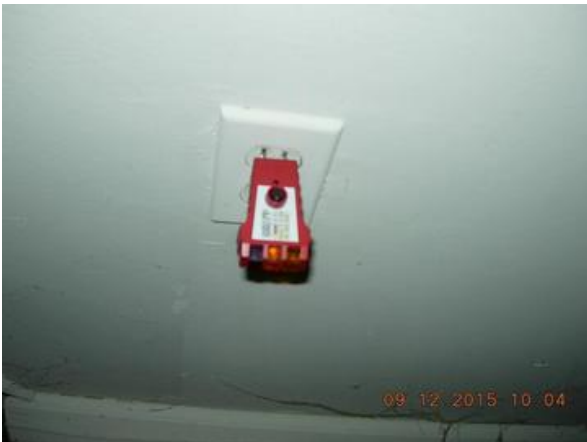
09/13/2015 One or more open ground outlets. Recommend having a licensed electrician either replace these outlets with 2-pronged outlets, or establish a proper ground wire.

Open Ground Outlet

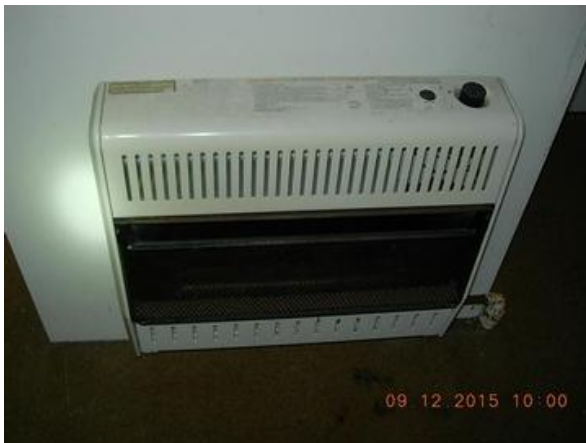
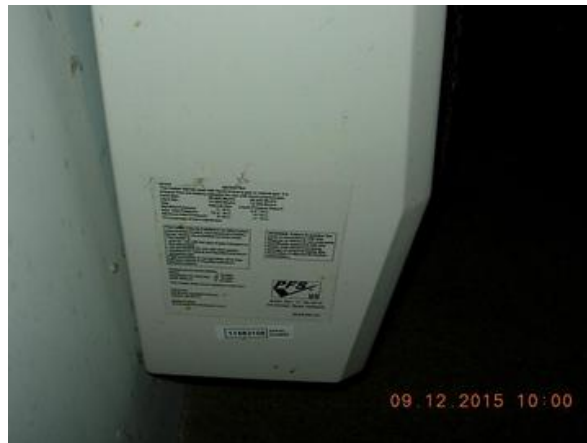
Third floor gas space heater did not fire on the day of inspection. Recommend a contractor repair as necessary.

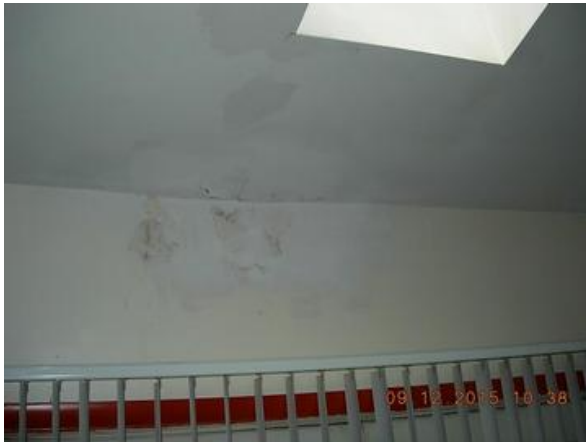
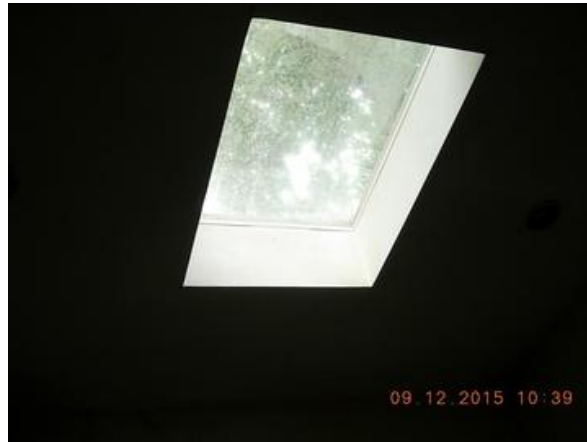
09/13/2015 Skylight in back room shows signs of water intrusion as evidenced by staining in the area around it. Recommend a qualified contractor repair as necessary.

Moisture stains around skylight

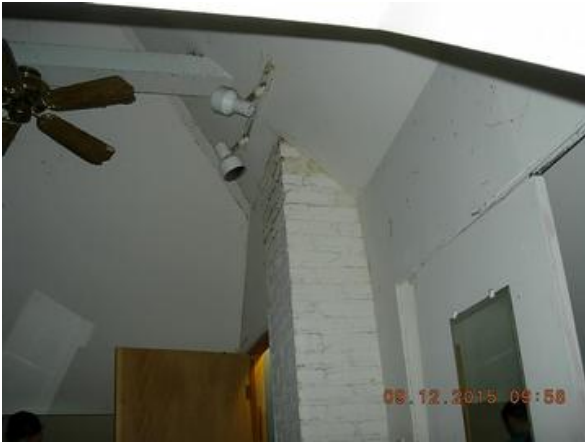
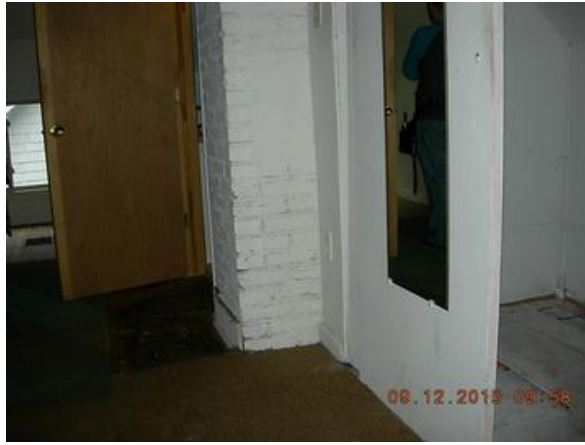
09/13/2015 Bathroom door did not operate properly. Recommend a contractor repair as necessary.

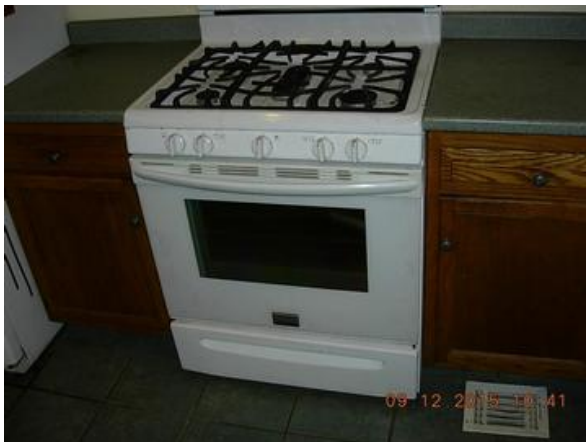
09/13/2015 Areas of the counter top and island were loose and unsecured. Recommend contractor repair as necessary.

Loose/unsecured counter tops

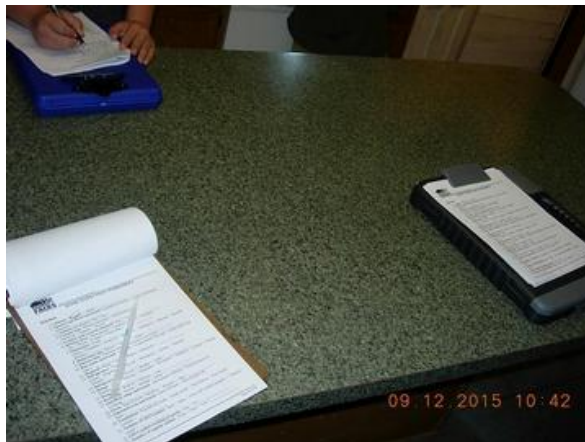
Island area is loose

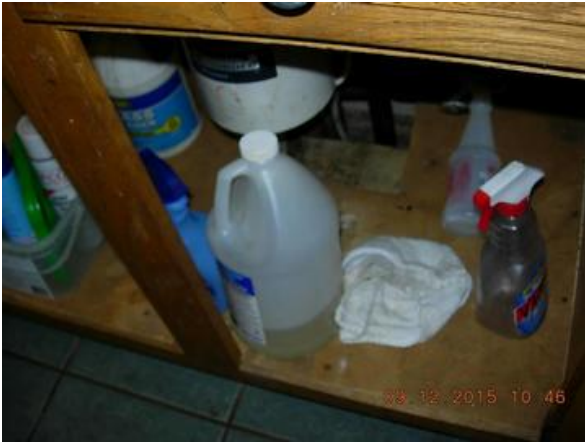
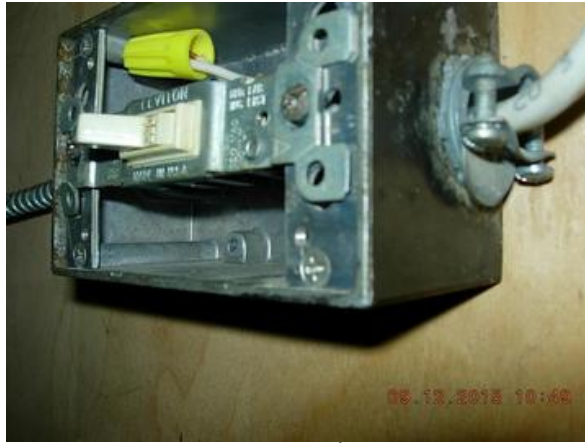
09/13/2015 Open electrical switch under kitchen sink that operates the garbage disposal. Recommend electrician repair as necessary.

Open Switch Box

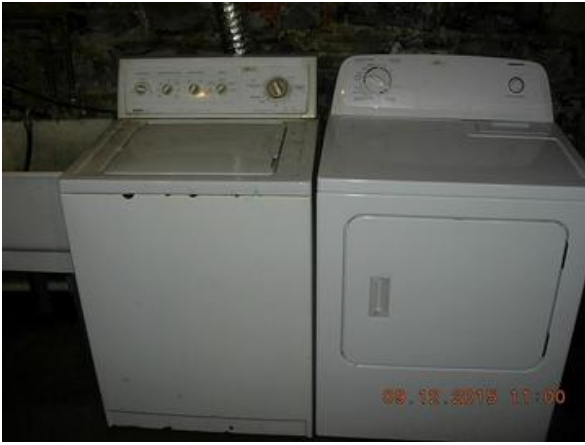
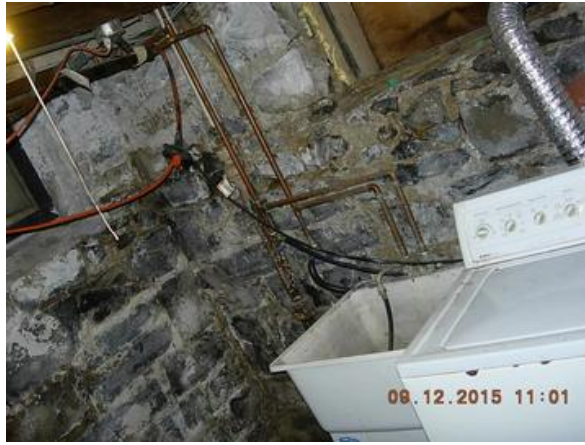
09/13/2015 The plug in the laundry area is not a GFCI and an extension cord is being used for the washer that travels directly over the utility sink. This could be a safety hazard. Recommend a qualified electrician repair as necessary.

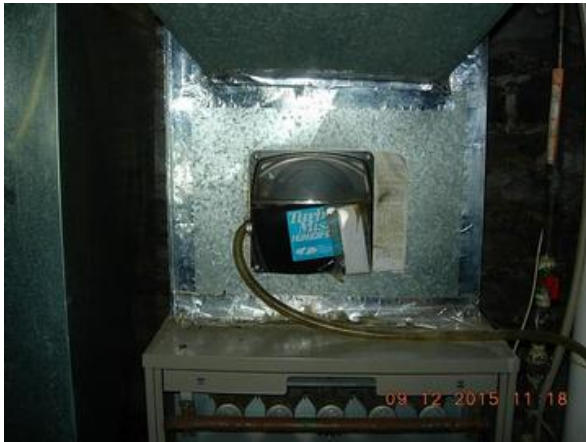
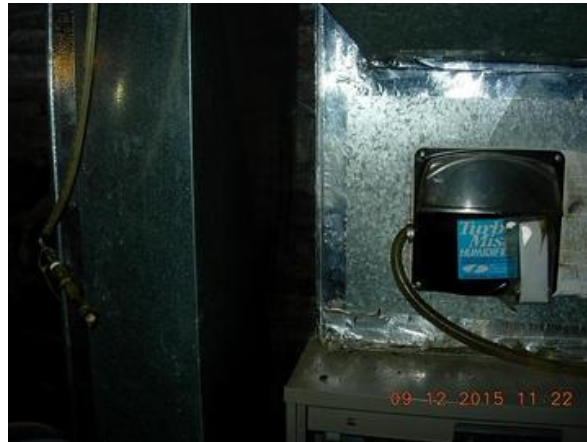
09/14/2015 Humidifier on furnace is disconnected and could be inoperable. Recommend a qualified HVAC specialist repair as necessary.

Humidifier on Furnace

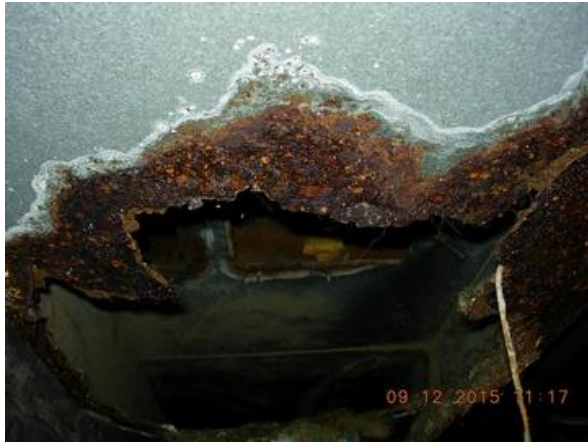
09/14/2015 Cold air return duct work has a large hole in it and should be repaired to avoid furnace drawing its cool air from the basement. Recommend a contractor repair as necessary.

Cold air return duct

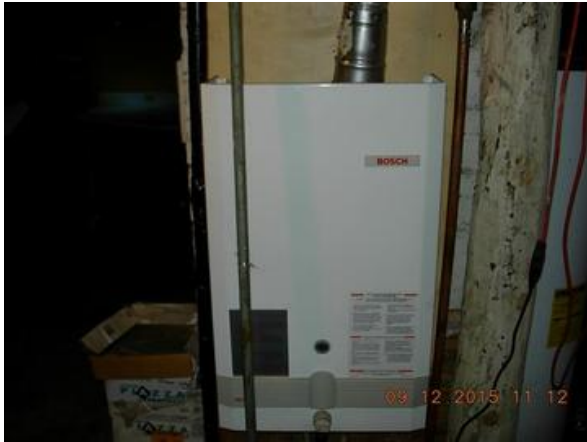
On demand unit had no supply valve in place to stop flow of water to the unit in case there was a leak. Recommend the installation of this valve to control possible flooding if the unit fails.

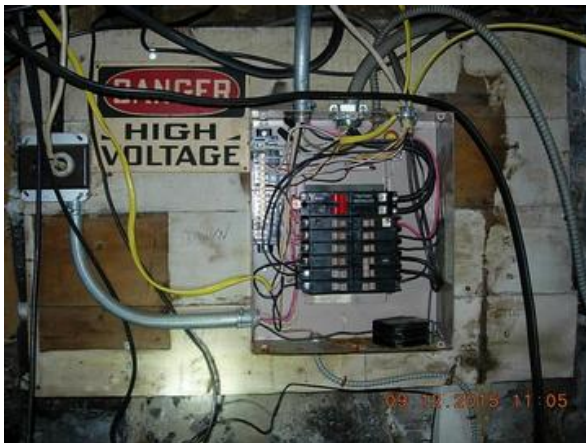
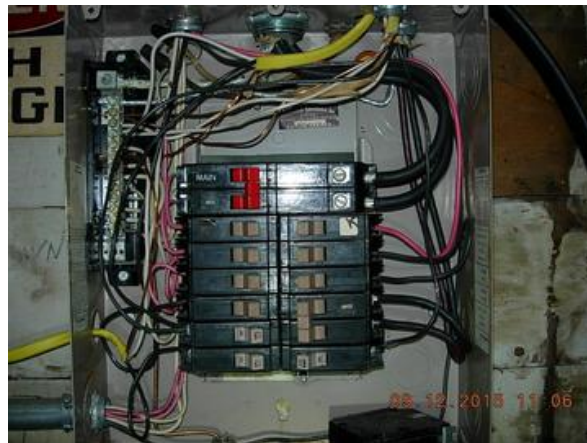
One or more circuit breakers are "double tapped", where 2 or more wires are clamped in a circuit breaker terminal and the circuit breaker was only designed for 1 wire. This is a safety hazard since wires may come loose and cause arcing, sparking and fires. Recommend having a licensed electrician repair as necessary.

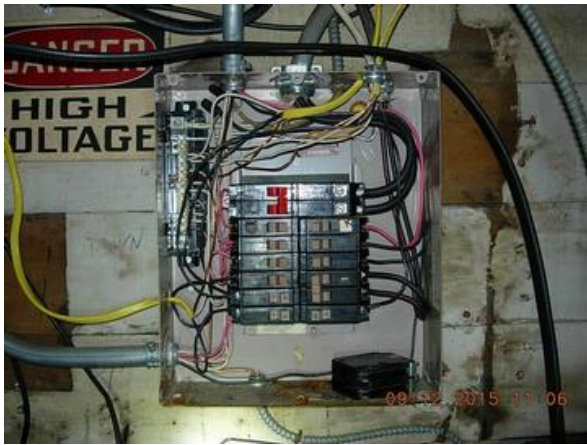
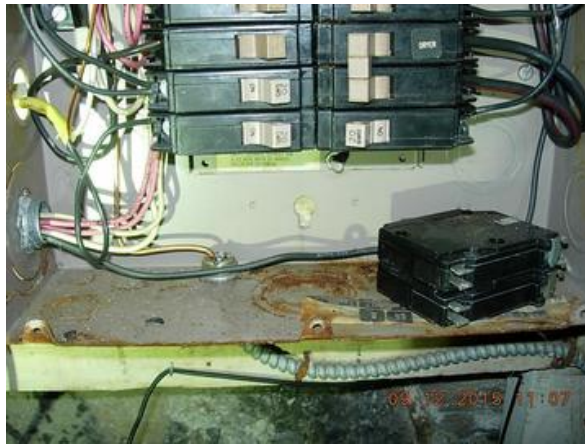
Extensive rust noted in Electric Service Panel. This can be hazardous. Recommend a licensed electrician repair as necessary.

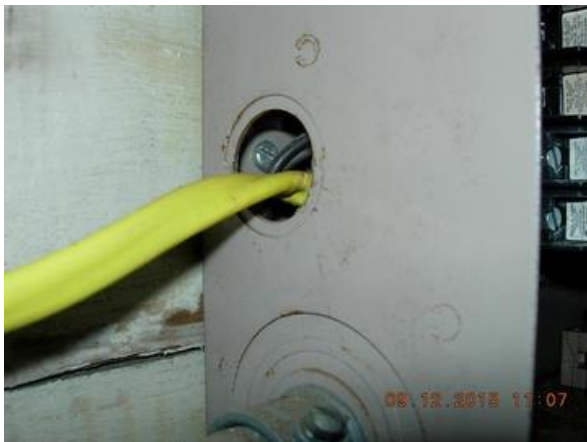
Branch wiring leaving the main panel is not properly secured to panel. This is a safety hazard as this could allow for contact inside the panel and possible electrocution. Recommend a contractor repair as necessary.

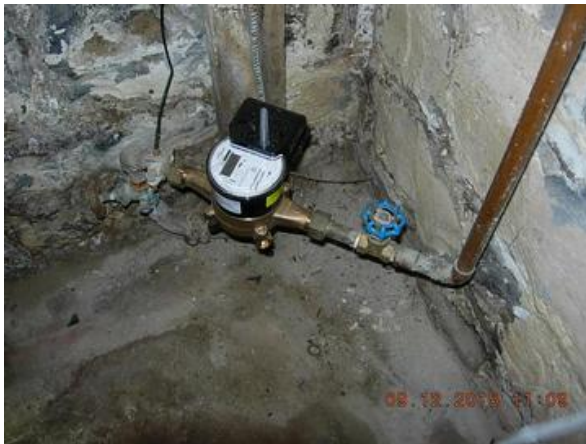
House water main shut off

09/14/2015 Tested the the main entrance pipe to the water system and discovered the pipe is made of Lead. Recommend a qualified contractor repair as necessary.

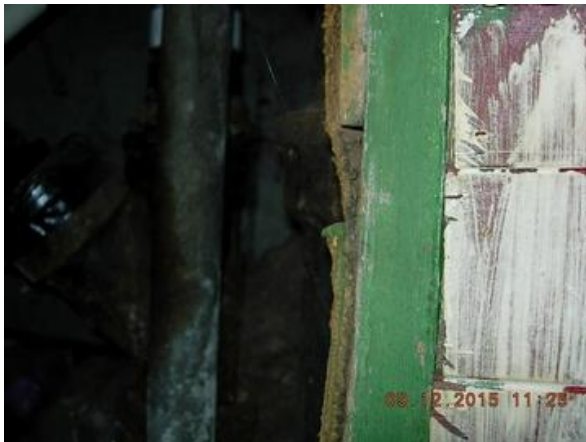
09/14/2015 Drain pipe from the home is improperly terminated into the main sewer pipe. This could allow for sewer gas to enter the area or leaking should the pipe become clogged. Recommend contractor repair as needed.

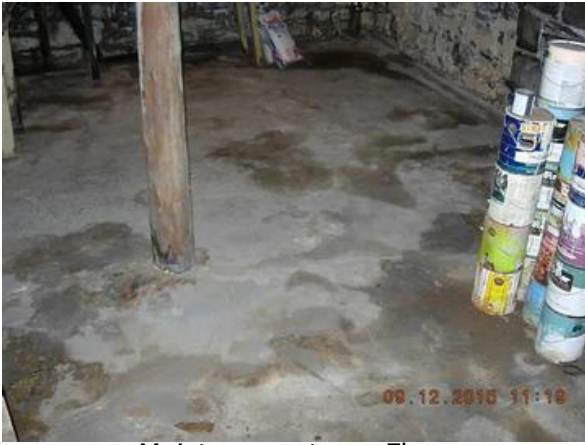
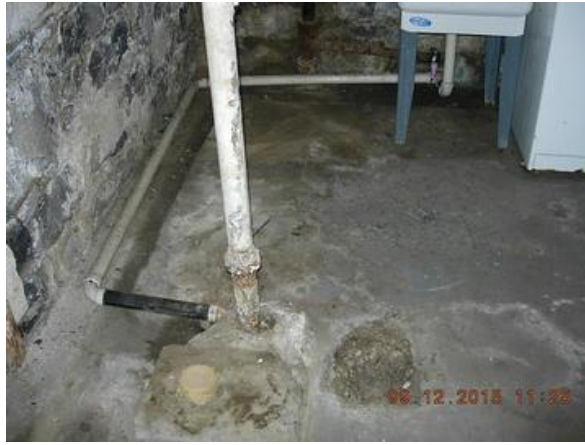
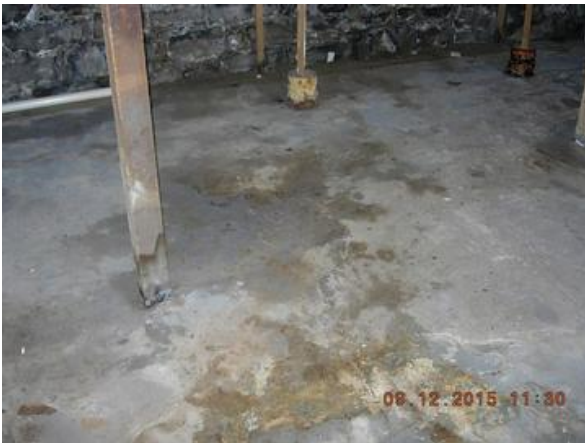
Some signs of moisture noted on foundation walls and floors. Recommend gutters be installed on house to keep water away from foundation.

Moisture spots on Floor

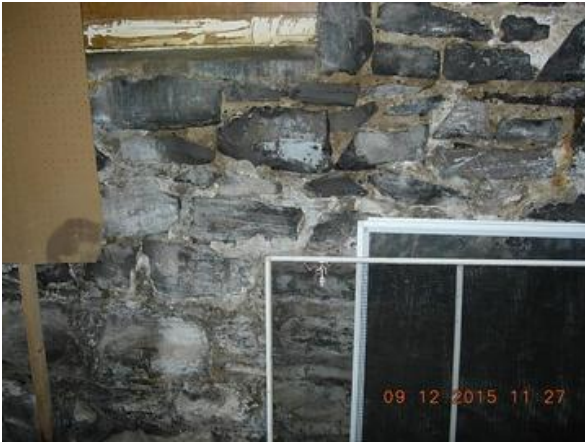
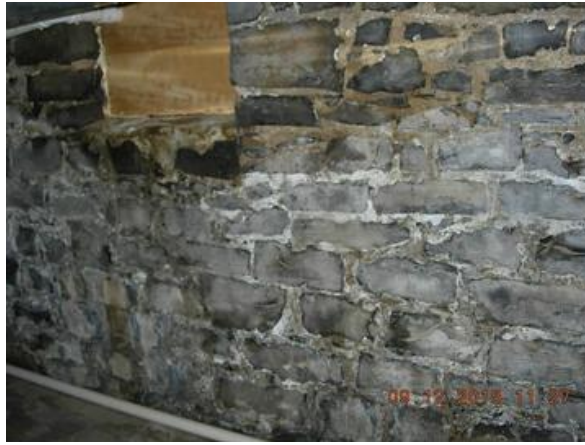
Lack of proper ventilation in the basement area noted. All basement windows were covered up and not available for use. This could allow excessive moisture to build up in the area and cause possible mold and other deterioration. Recommend a contractor repair as necessary.

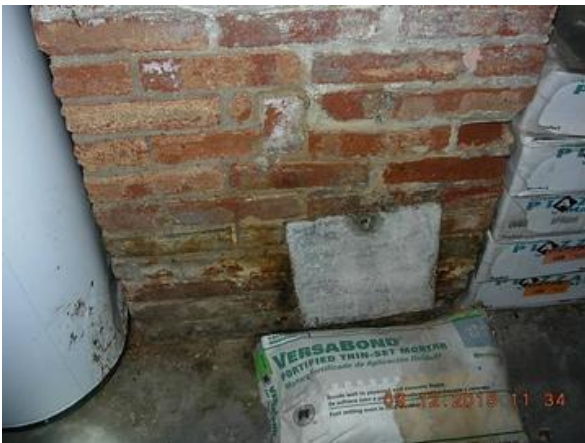
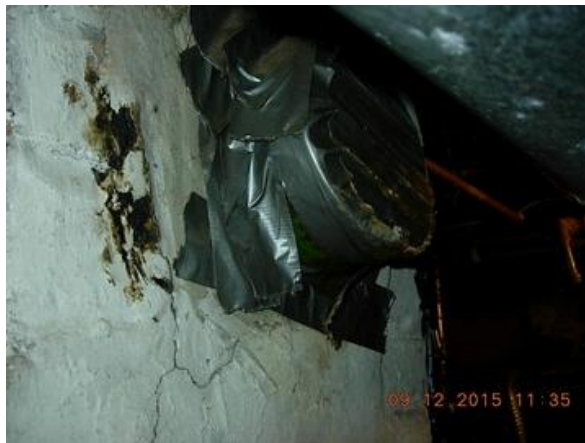
Opening in chimney in the basement area not properly covered. This could allow carbon monoxide into this area causing a health hazard. Recommend a contractor repair as necessary.

Proper chimney cap needed

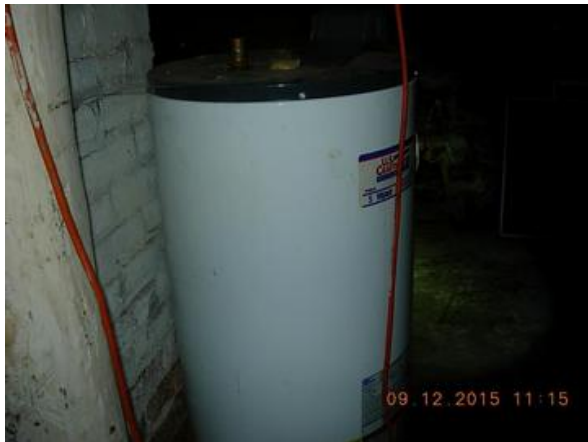
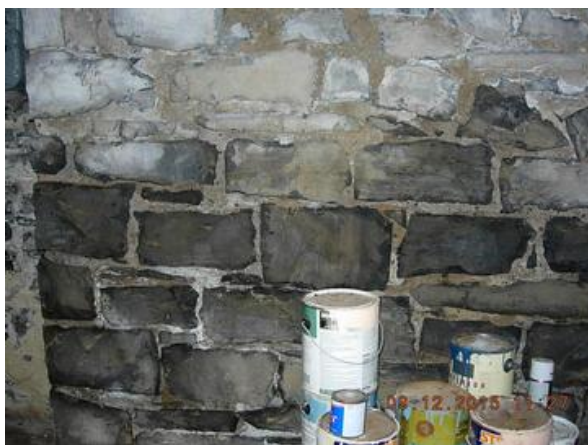
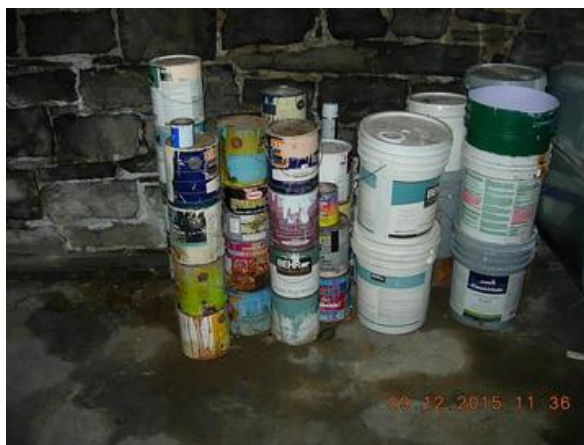
09/14/2015 Abandoned water heater tank and paint cans noted in the basement.  
Recommend these be removed prior to any sales transaction to provide broom clean conditions.

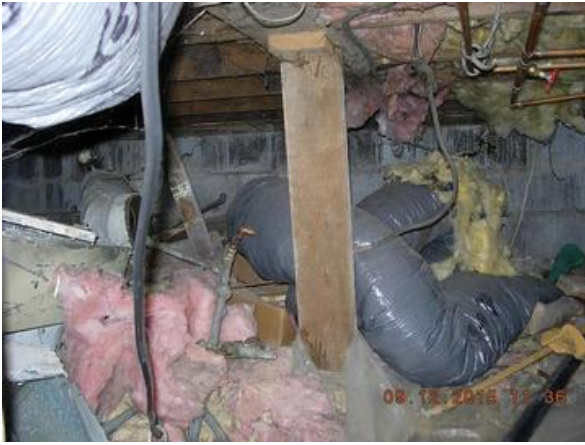
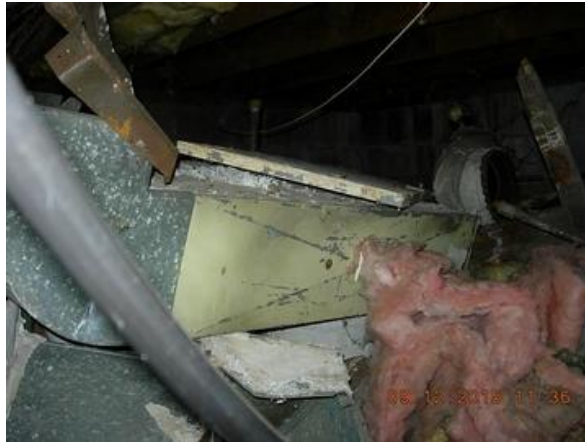
09/14/2015 No proper vapor barrier noted. Moisture from the ground can damage wood and insulation. Recommend a qualified contractor install a moisture barrier at least 6 mil in thickness.

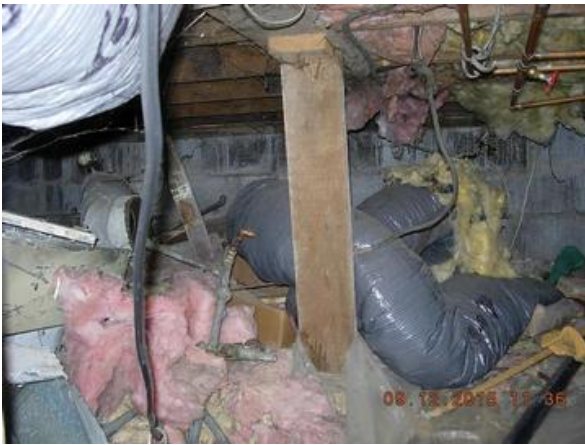
09/14/2015 Support beam in the middle of the crawlspace is resting on the ground and may be inadequate to properly support the homes load from above. Recommend a contractor repair as necessary.
