4 Seasons Sample Report
123 Maple Avenue
Kalispell, MT 59901
HIN™: 599014849
Email: edkahle3@gmail.com
Inspection Date: 07-31-2016

Welcome and thank you for choosing 4 seasons home inspections llc.
 This report is designed to be as thorough as possible, but also clear and concise.
 If you have any questions please call us at (406)-253-1064

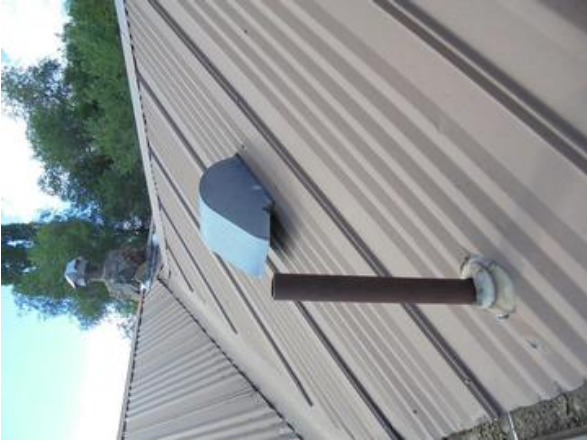
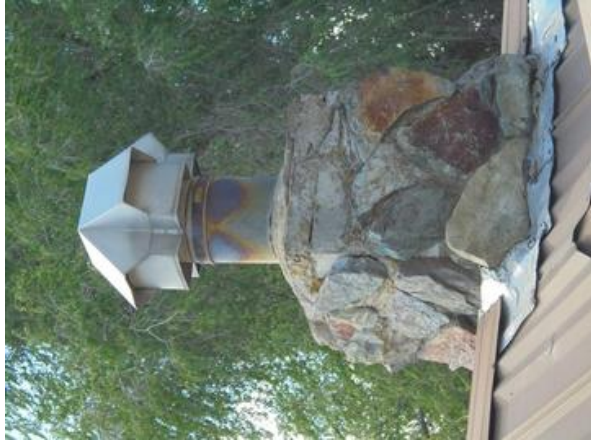
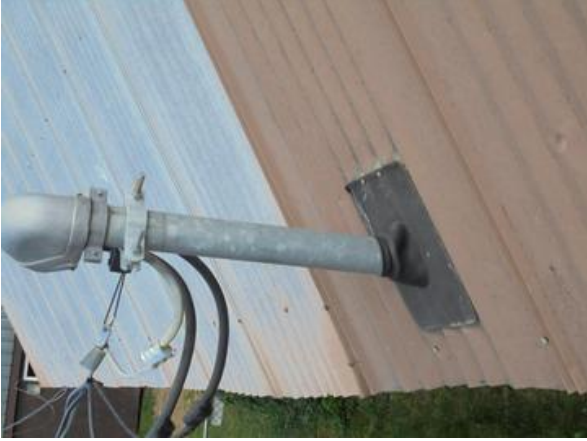
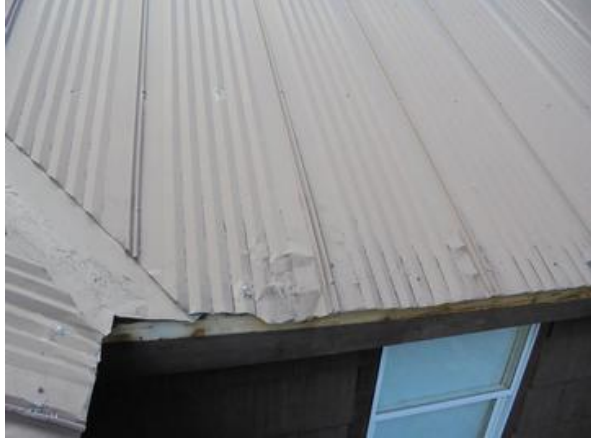
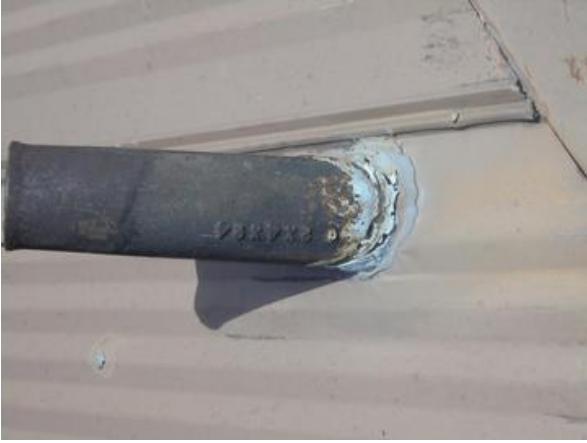
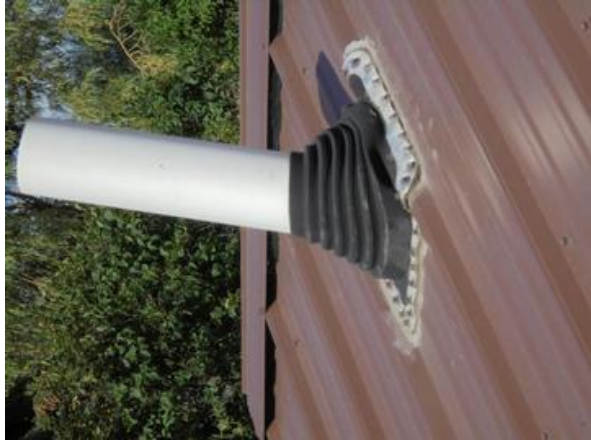
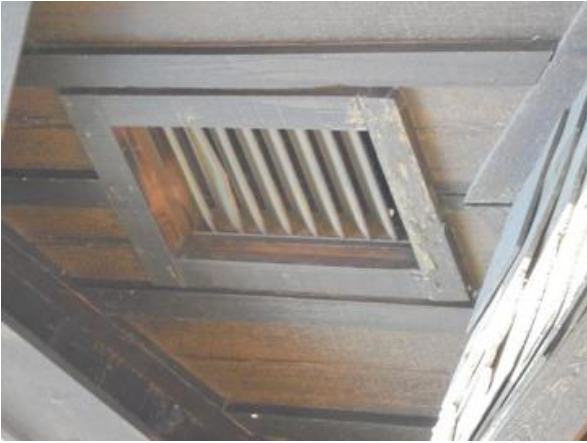
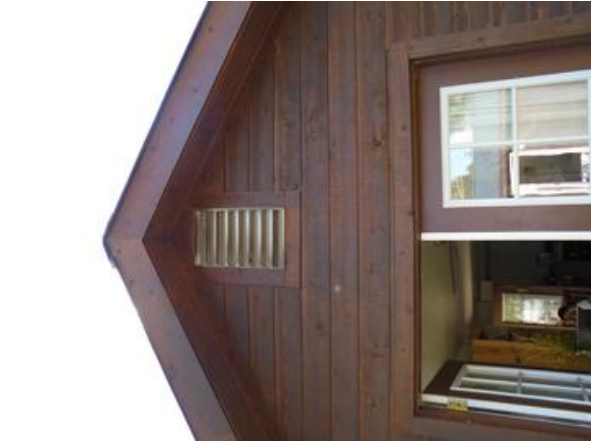
It appears the electric mast and plumbing vents need to be caulked. The attic ventilation appears to be insufficient. The bath fan vent terminations were not to be found. There were some loose nails found and some chimney flashing's appear to need fastening. These defects could cause roof leaking, moisture accumulation in the attic or excessive attic heat. Recommend a building/roofing contractor evaluate and correct.

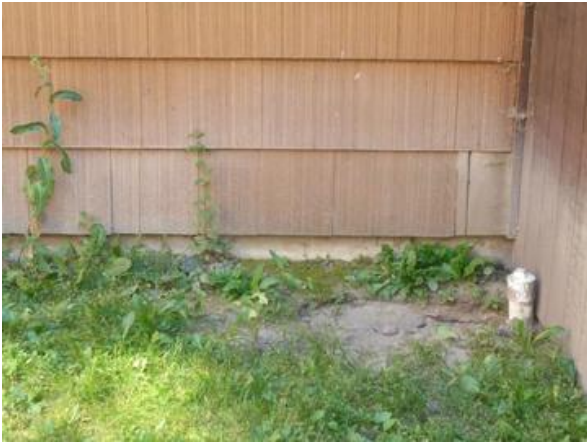
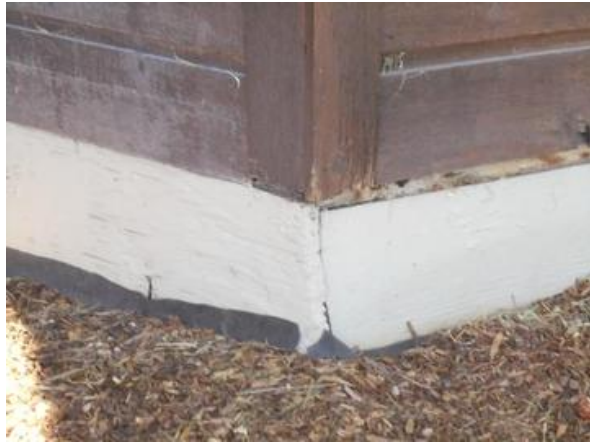
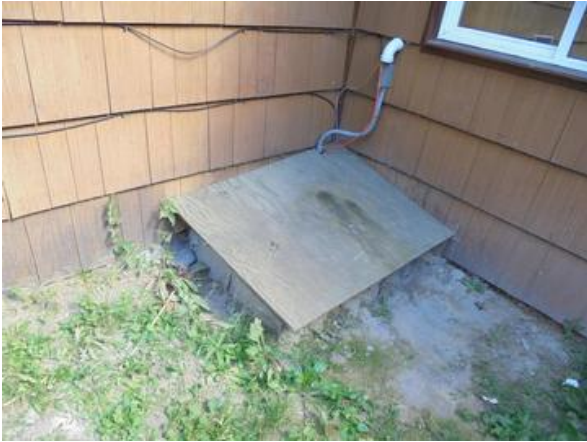
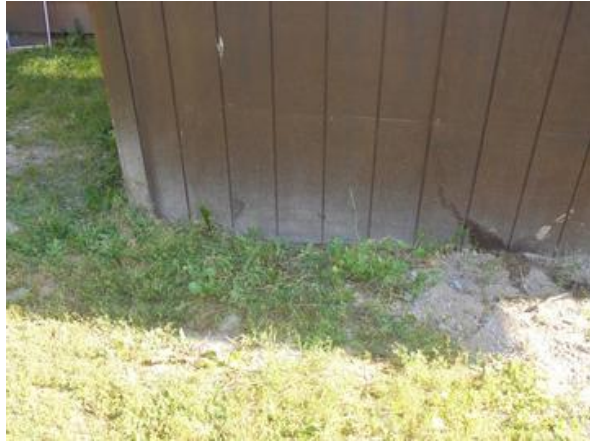
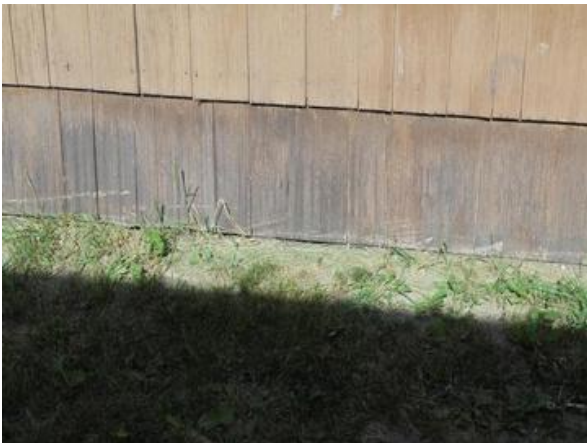
Some siding extends to ground or close to it. Industry standards call for siding to be no closer than 6 inches. This could possibly cause rot and decay of the exterior walls. Recommend a building contractor repair. Kitchen picture bay window is cracked and center section is cloudy. Possible seal failure. Recommend a building contractor repair.

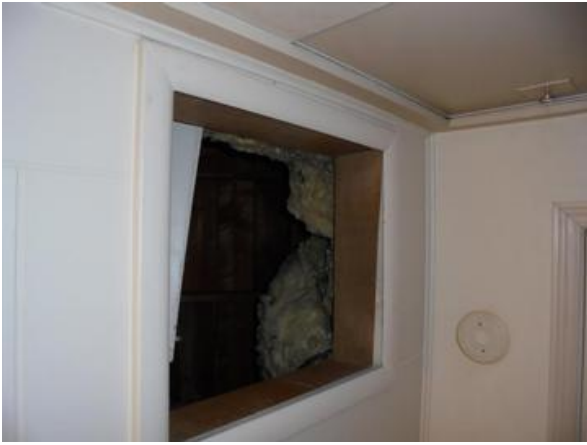
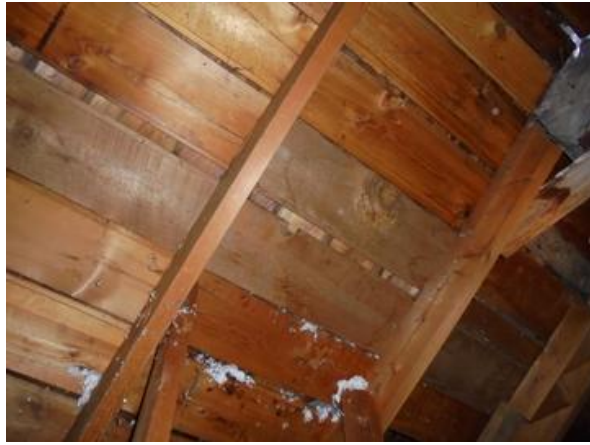
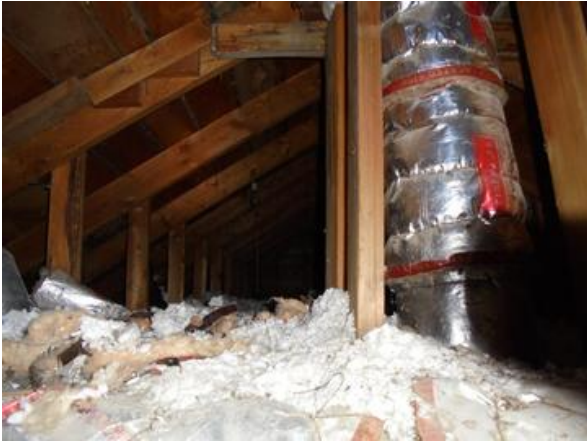
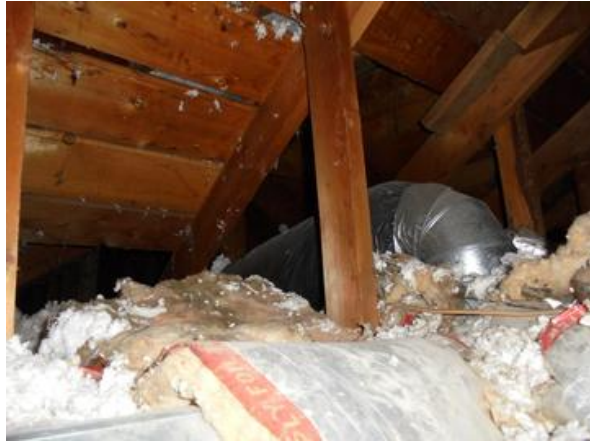
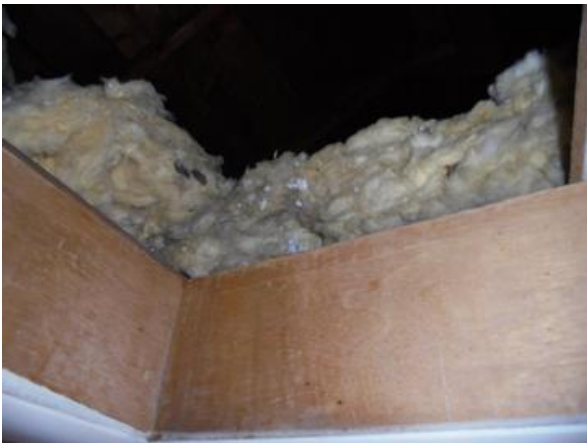
07/31/2016 Venting appears to be insufficient. Inadequate ventilation will cause excessive heat build up and moisture accumulation that may promote mold. Recommend a building contractor evaluate and repair.

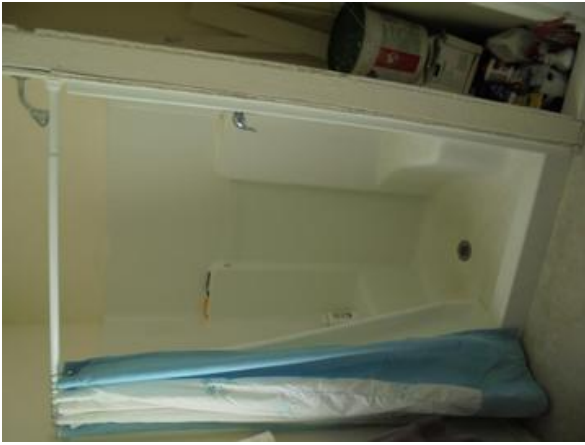
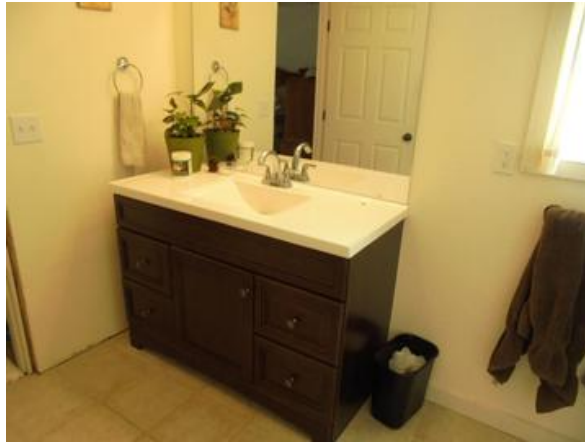
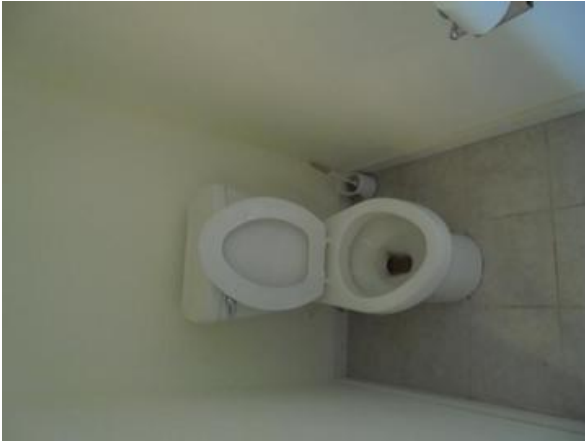
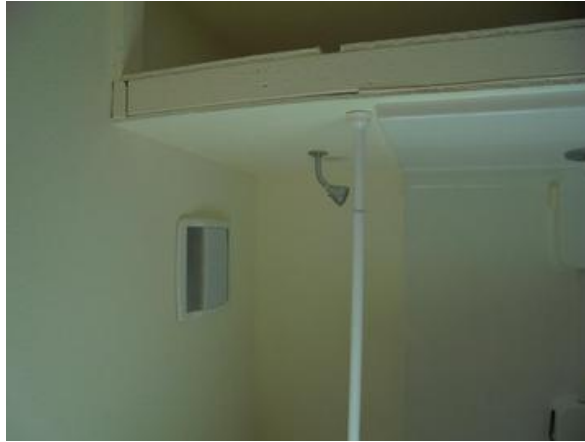
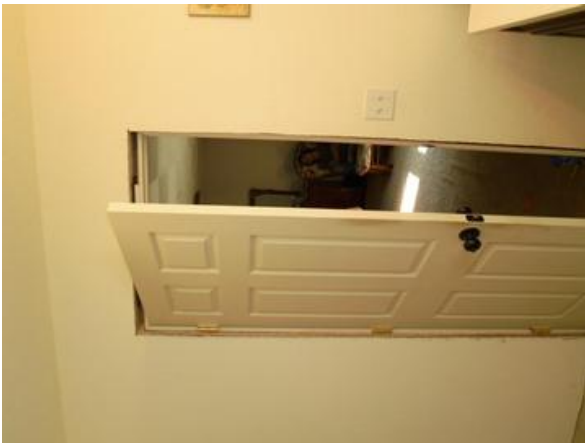
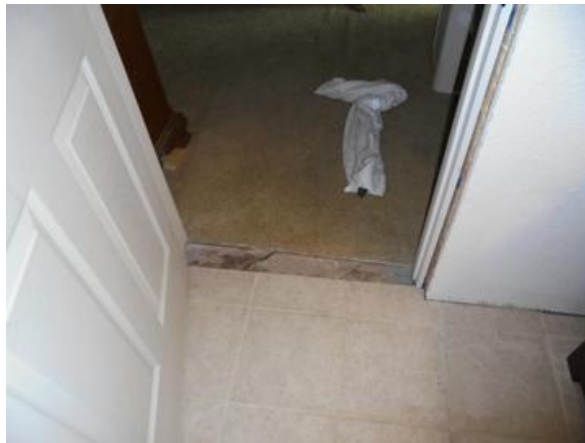
Toilet appears to be loose. This may be from a loose anchor bolt or damage to sub floor from a leak. Recommend a qualified contractor repair as necessary. Door trim missing. Door threshold missing. Miscellaneous trim missing.

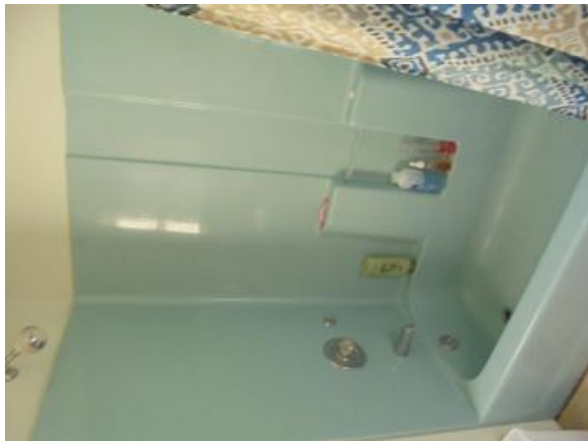
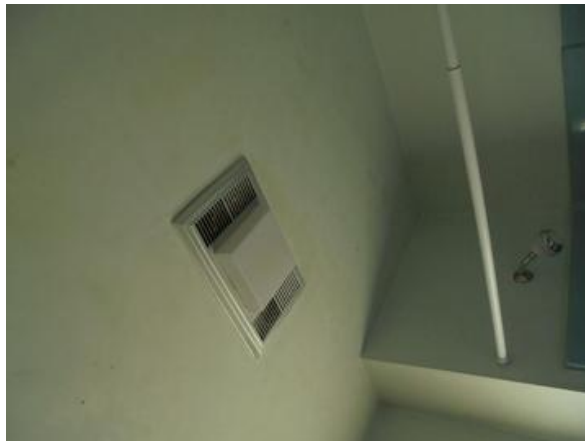
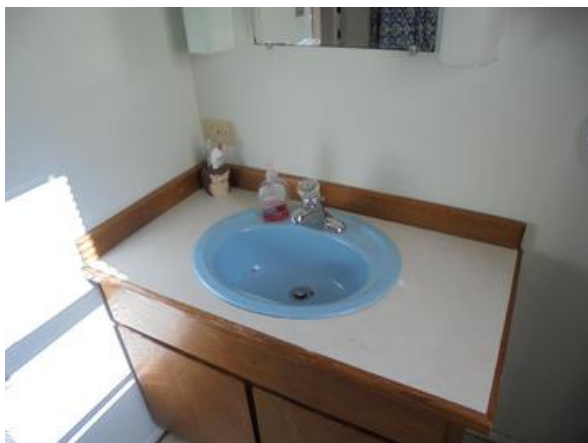
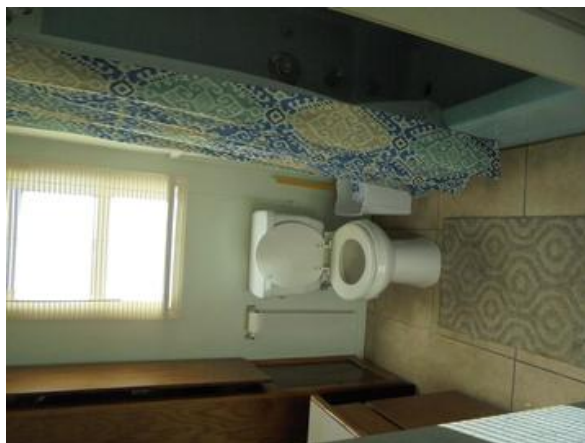
07/31/2016 No ground fault circuit interrupter (GFCI) outlets installed. GFCI outlets help prevent electric shocks in areas that may have water present. Recommend having a qualified electrician install one or more GFCI outlets, especially over counter tops and around sinks. The fan vent does not seem to work properly and may not be vented to the exterior. The bath room has a bad smell and paint peeling which could be mold or sewage leaking. Recommend a contractor evaluate and repair if necessary.

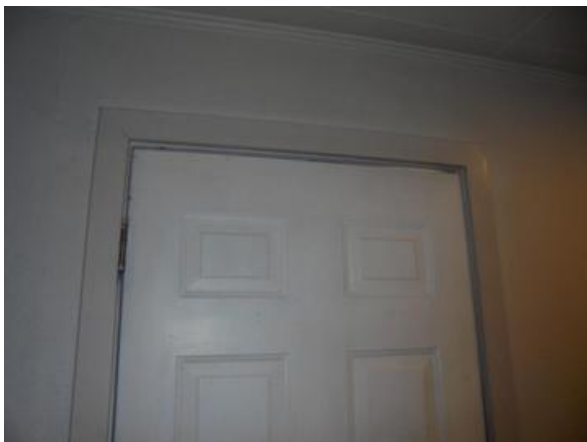
There are numerous two prong and open ground outlets. The un-grounded and obsolete outlets should be upgraded to include more modern and safer ones, which provide a pathway for the current to travel harmlessly to ground. The smoke detector for the bed room/ laundry room/ bath is missing. Recommend an electrician repair. The floor in the master bedroom is not level. It appears to have settled many years ago but appears to be stable. Recommend a building contractor evaluate. The carpet in the master bed room is loose and needs to be stretched. The door to the master bed room sticks. The door to a secondary bed room won't lock. An exterior hall way door needs to be adjusted as there is light showing through and air infiltration. Carpet in the Living room is stained and loose. The door to the bedroom off the Laundry room is dented in. There is a switch plate cover missing in the living room which is an electrical hazard. Center section of Kitchen bay window is cloudy. Possible seal failure. Side window of Kitchen bay is cracked. Living room window does not close and seal properly allowing air infiltration. Recommend a building contractor to make repairs.

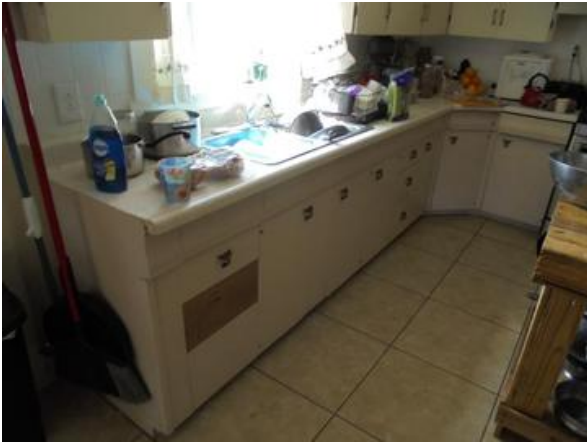
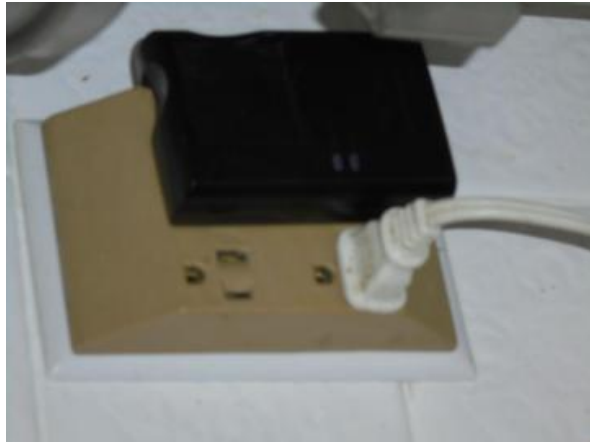
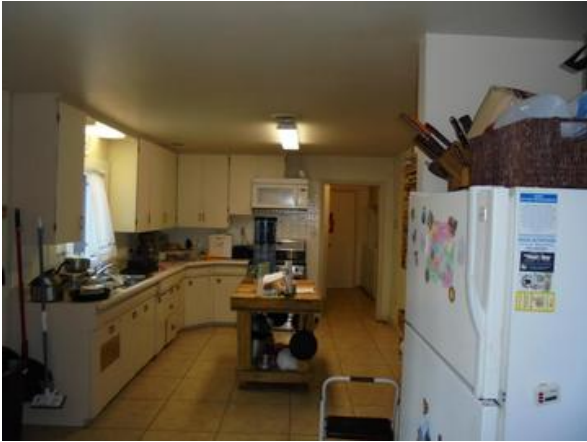
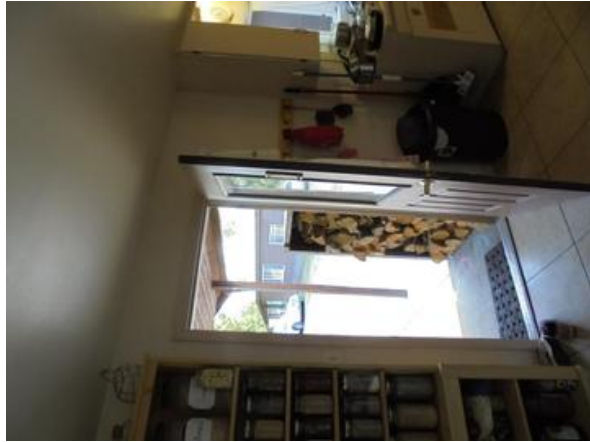
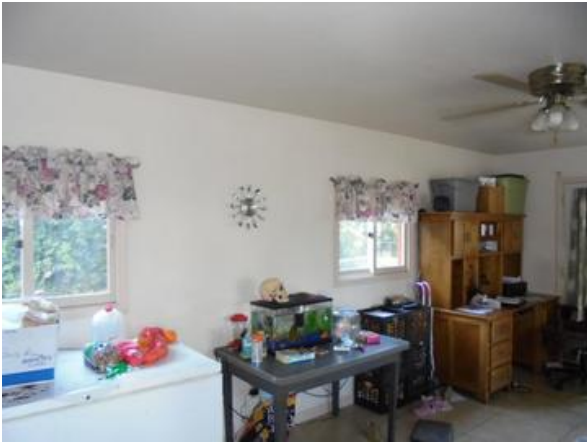
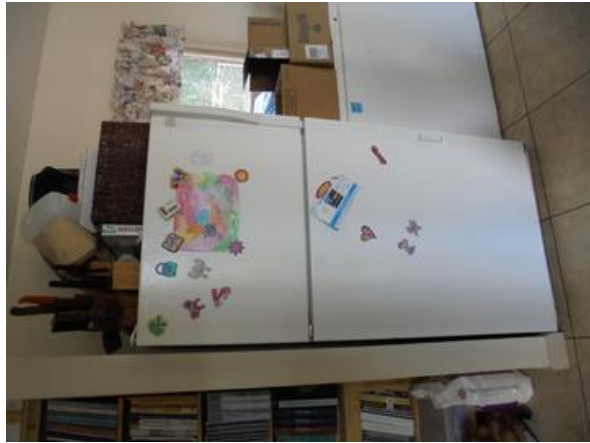
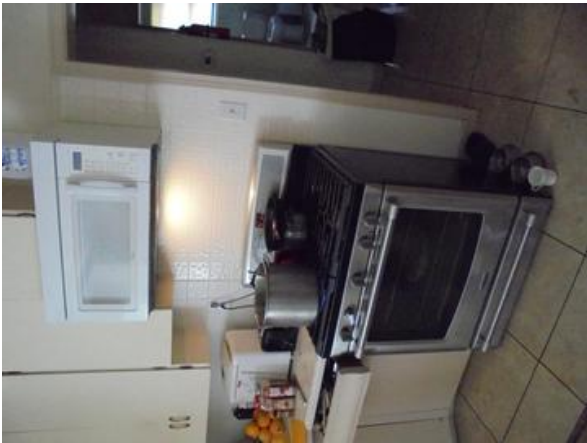
No ground fault circuit interrupter (GFCI) devices (outlets or circuit breakers) are visible for the kitchen. GFCI devices help prevent electric shocks in areas that may have water present. One outlet has open ground. One receptacle outlet has a three outlet conversion. Should be checked for proper wiring. Recommend having a qualified, licensed electrician install GFCI protection for outlets, over counter tops and around sinks and perform repairs. Three cabinets missing hardware. One drawer missing front and hardware. Base cabinet drawer is missing pull hardware and front finish. Corner Lazy Susan cabinet does not work. Bay window is cracked. Micro wave oven plastic vent cover is broken. Recommend a contractor repair.

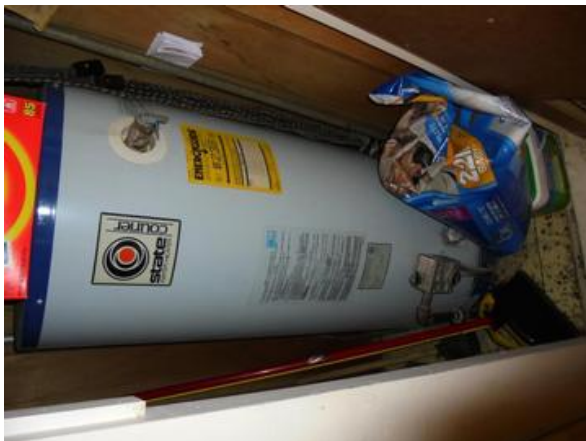
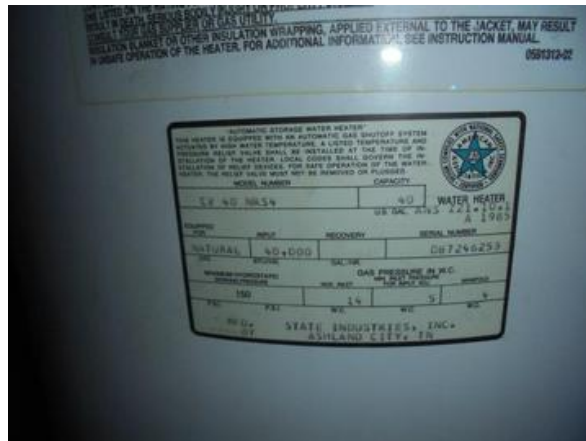
Water heater is installed over finished living space and has no catch pan and drain installed. Recommend installing catch pan and drain to prevent water damage to finished interior spaces below if/when the water heater develops a leak or is drained. Recommend plumber to install relief valve extension to floor into drain pan.

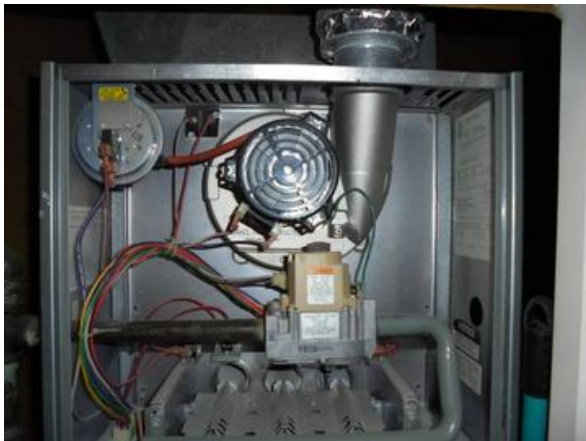
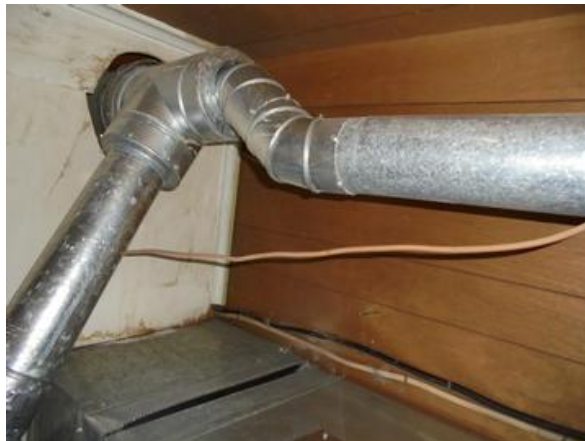
07/31/2016 Recommend a carbon monoxide alarm near the mechanical closet as both furnace and water heater are there together.

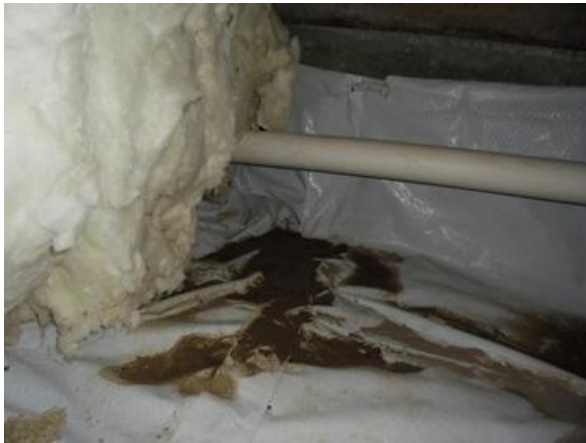
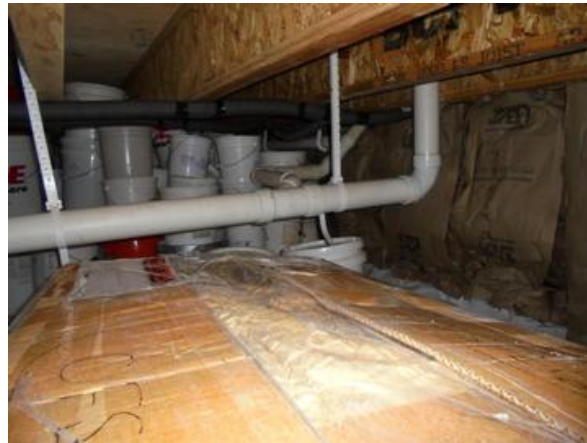
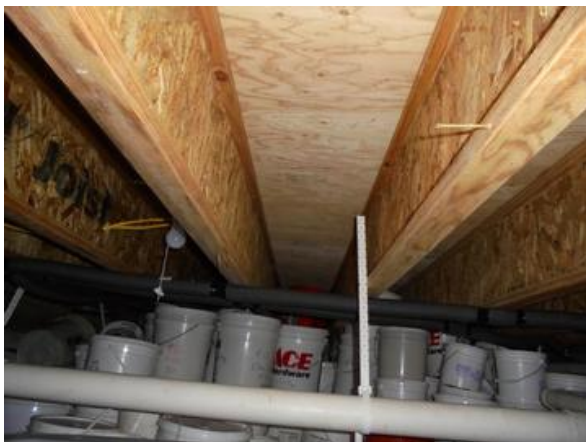
Small leak around sewer pipe penetration. Recommend building contractor seal and divert outside water away from area.
