SAMPLE REPORT

1 Sample Report Road
Porter Corners, NY 12859

Inspection Date: 05-06-2020

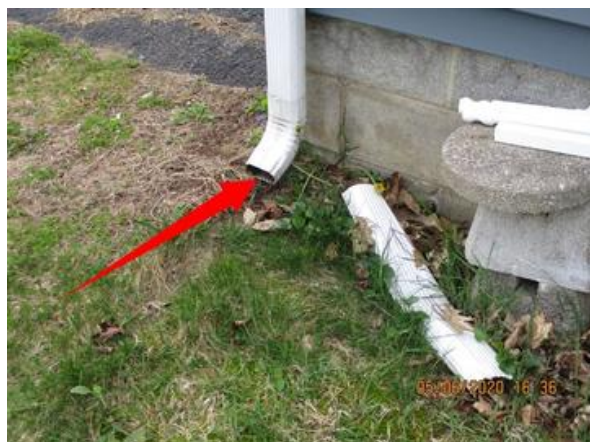
It was observed that the gutter extension at the right garage corner was disconnected. A complete and working gutter, downspout and gutter extension system is designed to carry rainwater away from the foundation and prevent water infiltration into the basement. Missing and damaged gutter extensions can allow water to accumulate next to the foundation which can lead to a wet basement. This is a very easy and inexpensive repair.

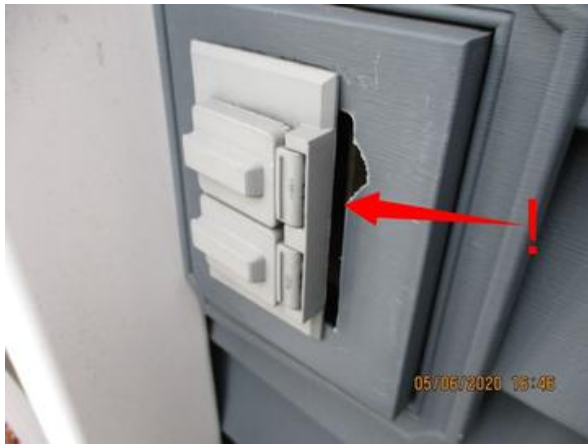
It was observed that the front electrical box and trim had a gap where wires could be observed inside. THis condition can lead to a shock and/or possible fire hazard and leaves the wires exposed to the elements. It is recommended that the gap be filled and the trim be repaired as necessary.

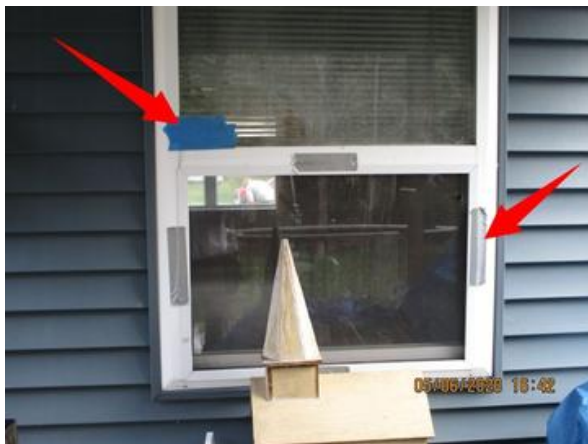
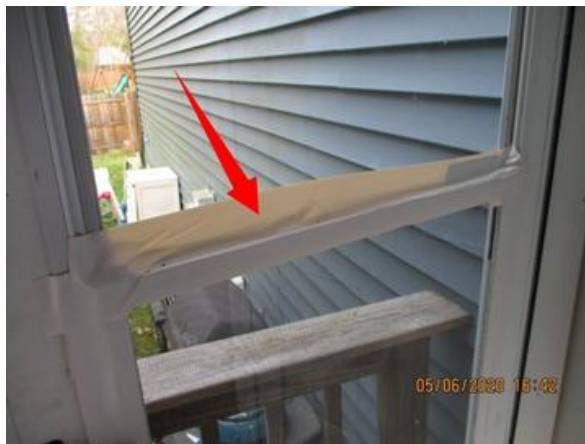
It was observed that a window and storm door frame has been taped for repairs at the rear porch. This condition is a temporary fix and indicates permanent repairs are required. It is recommended that these items be repaired in a manner that is consistent with standard building practices.

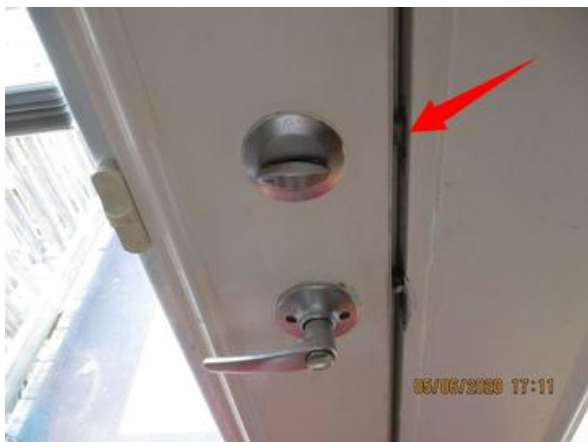
It was observed that the rear door to the porch located in the kitchen had a deadbolt that was not engaging the strike plate preventing the door from locking. It is recommended that the deadbolt be adjusted and/or repaired as necessary to allow for proper function.

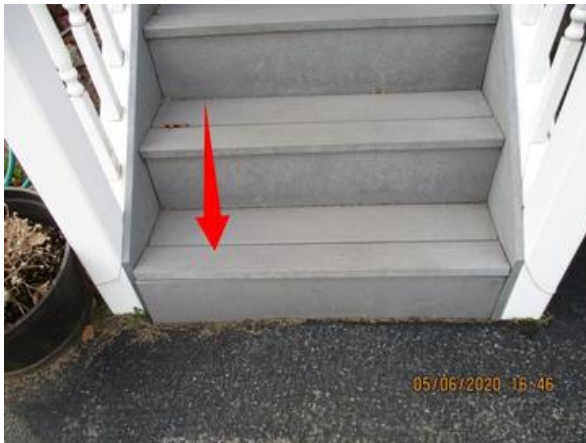
05/07/2020 It was observed that the front entry porch had a loose and uneven first tread. This condition can lead to a fall and/or trip hazard. It is recommended that the tread be repaired as necessary to provide a flush even tread.

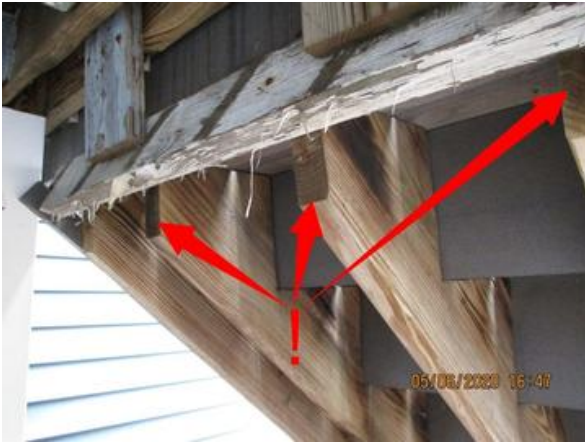
05/07/2020 It was observed that the front entry porch stringers were not properly anchored to the porch structure and is not framed per standard building practices. This condition can lead to the stairs coming loose from the frame. It is recommended that the stringers be fastened and framed permanently.

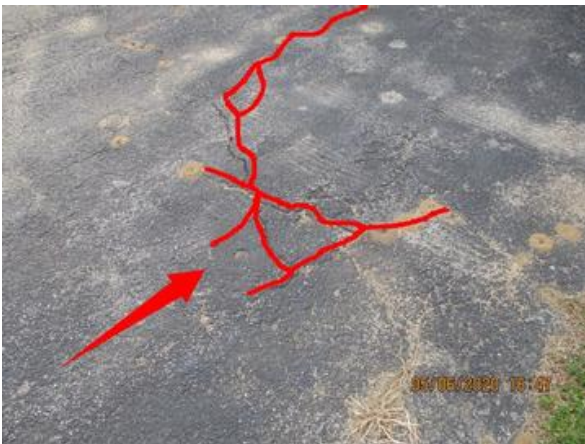
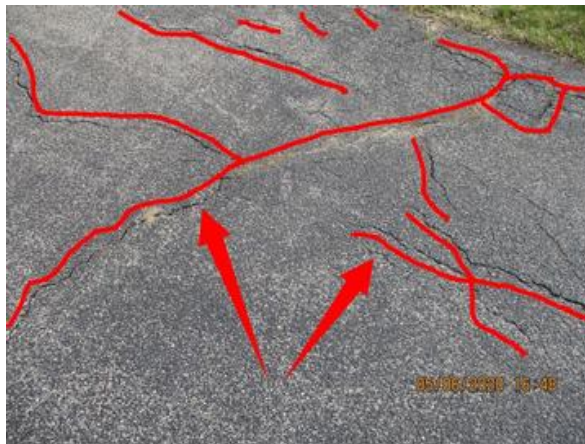
It was observed that the driveway had large cracks. Cracks in a driveway can allow water to enter and cause further deterioration during freeze thaw cycles. Repairs to the driveway should be considered to prevent further deterioration.

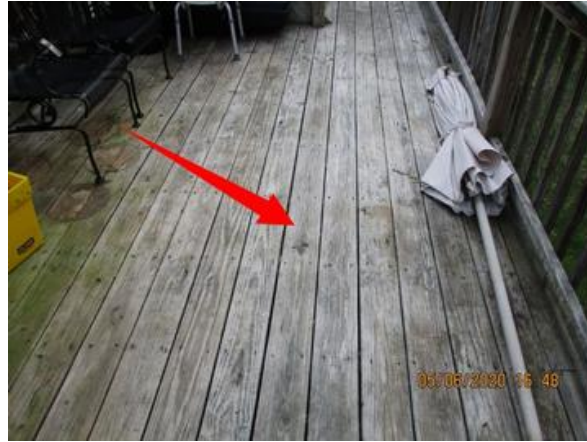
It was observed that decks, wood guardrails and stairs were not painted or stained. Staining and/or painting of decks and wood guardrails and stairs can preserve wood, protecting it from the elements and prolonging life. This will minimize overall maintenance and prevent discoloration. It is recommended that unpainted/unstained decks and wood guardrails and stairs be coated as necessary.

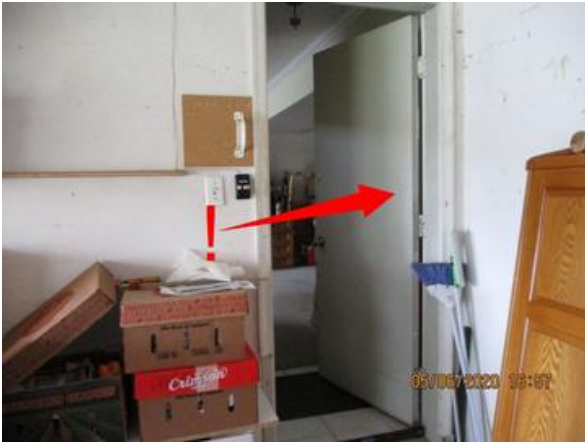
It was observed that the garage to house door isn't auto-closing. This condition can allow vehicle fumes, deadly carbon monoxide gas or fire to enter the building. It is Recommended that spring loaded hinges or door closer be installed so the door will close automatically to prevent vehicle fumes or fire from entering building.

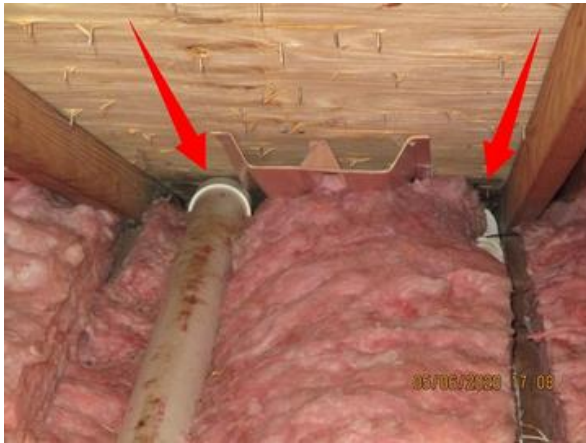
and exceeds 10sf, stop work and call a mold assessor. The vents should be relocated out of the soffit area.

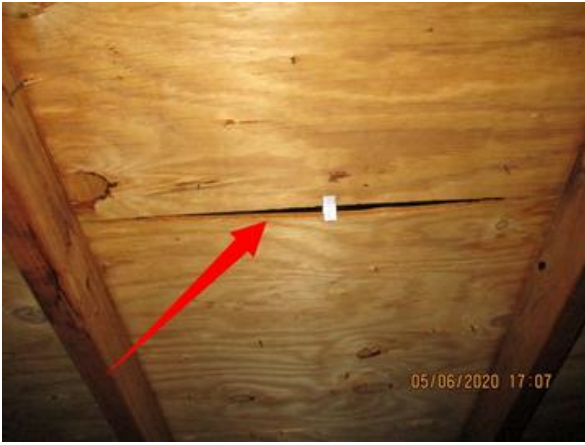
It was observed that an area of roof decking was sagging and separating at the seam. This condition could potentially cause damage to the roof membrane which could potentially lead to a roof leak. It is recommended that the seam be repaired and shored as necessary.

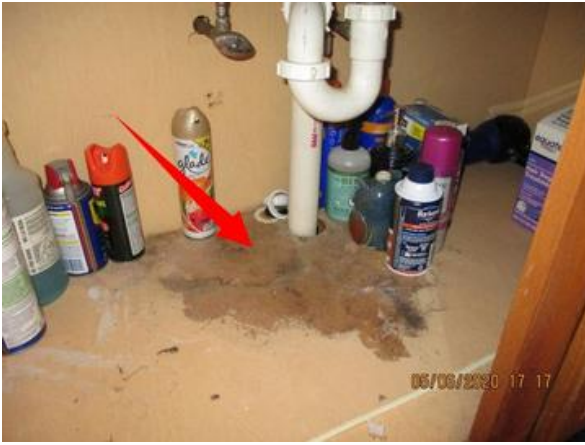
It was observed that a mold-like substance was present in the full bathroom under the sink. The mold-like substance area was less than 10sf. Some people are sensitive to molds. For these people, exposure to molds can cause symptoms such as nasal stuffiness, eye irritation, wheezing, or skin irritation. Some people, such as those with serious allergies to molds, may have more severe reactions. Areas smaller than 10sf should be cleaned, but do not require professional remediation. Follow the Mold Cleanup Tips and Techniques found on the EPA's website at: [EPA](#). If during the performance of this work any concealed mold contamination is uncovered and exceeds 10sf, stop work and call a mold assessor. There did not appear to be an ongoing leak.

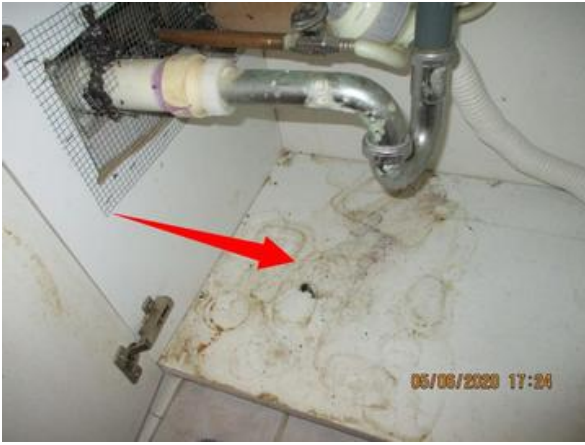
It was observed that a mold-like substance was present in the basement full bathroom under the sink. The mold-like substance area was less than 10sf. Some people are sensitive to molds. For these people, exposure to molds can cause symptoms such as nasal stuffiness, eye irritation, wheezing, or skin irritation. Some people, such as those with serious allergies to molds, may have more severe reactions. Areas smaller than 10sf should be cleaned, but do not require professional remediation. Follow the Mold Cleanup Tips and Techniques found on the EPA's website at: [EPA](#). If during the performance of this work any concealed mold contamination is uncovered and exceeds 10sf, stop work and call a mold assessor. There did not appear to be an ongoing leak.

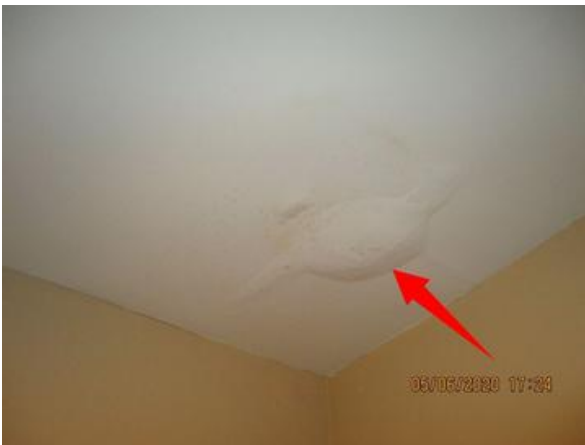
It was observed that the ceiling in the basement full bathroom appeared to have water damage from above. Water leaks were not discovered, however, it is recommended that the ceiling cavity be explored for possible leaks and/or mold damage. It is recommended that a qualified contractor be contacted for further evaluation and necessary repairs. If during the performance of this work any concealed mold contamination is uncovered and exceeds 10sf, stop work and call a mold assessor.

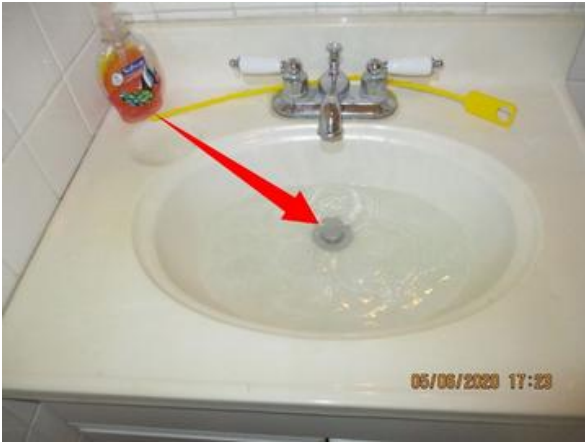
It was observed that the fixtures drained slowly. A slow draining fixture can be indicative of a lack of proper plumbing vent and/or a clogged drain. It is recommended that the drain be treated for a clog and if the drain still performs slowly, a qualified plumber be contacted for further evaluation and necessary repairs.

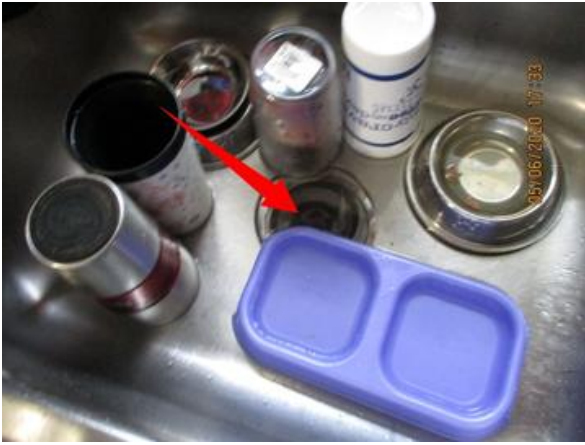
It was observed that the kitchen sink drained slowly. A slow draining fixture can be indicative of a lack of plumbing vent and/or a drain clog. It is recommended that the drain be treated for a clog and if the drain still performs slowly, a qualified contractor should be contacted for necessary repairs.

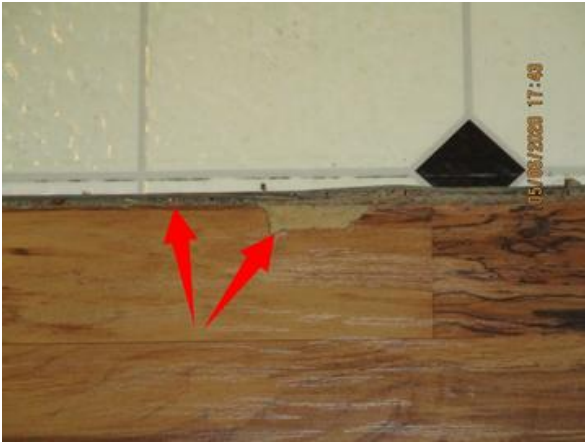
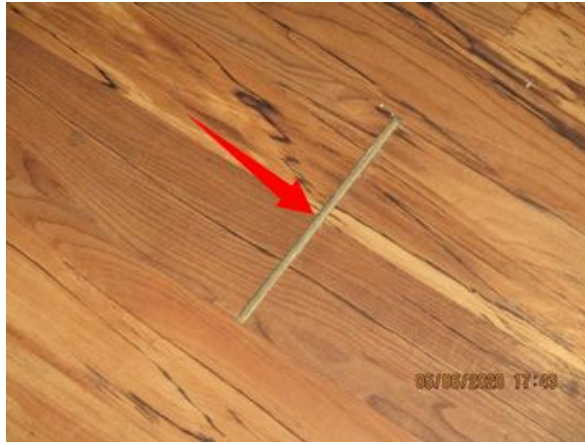
It was observed that the engineered wood flooring at the 1st floor appeared to be in worn condition indicating that the floor surface is approaching the end of its useful life. The wood surface has several gaps, loose boards, missing thresholds, peeling surfaces and puckering due to water damage. The floor likely requires replacement and cannot be repaired. Due to the possibility of these repairs to exceed \$1,500, these repairs as a whole should be considered a substantial defect. It is recommended that a qualified contractor be contacted for necessary repairs.

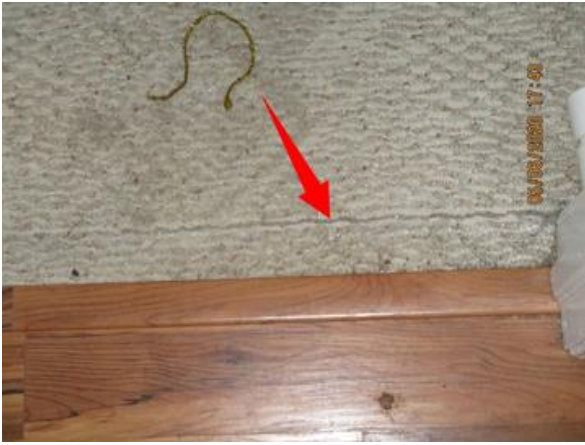
It was observed that a bedroom carpet had a large run at the door threshold and requires repair.

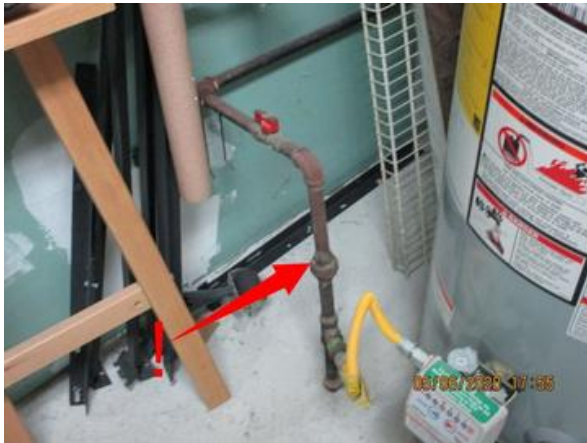
It was observed that the gas line to the domestic water heater was loose and not anchored to the wall. This condition could allow the gas line to be broken or rupture. It is recommended that the gas line be properly mounted or anchored to the wall to prevent movement in the rigid line.

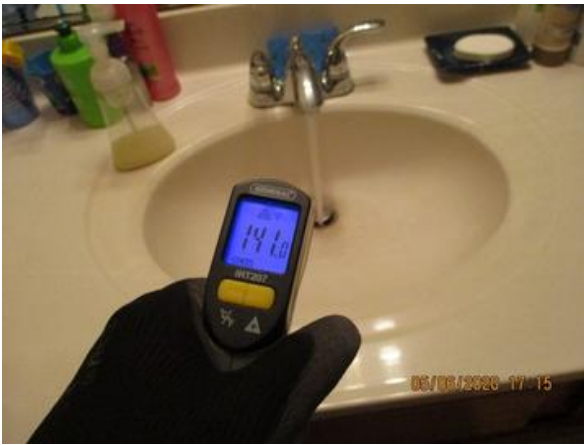
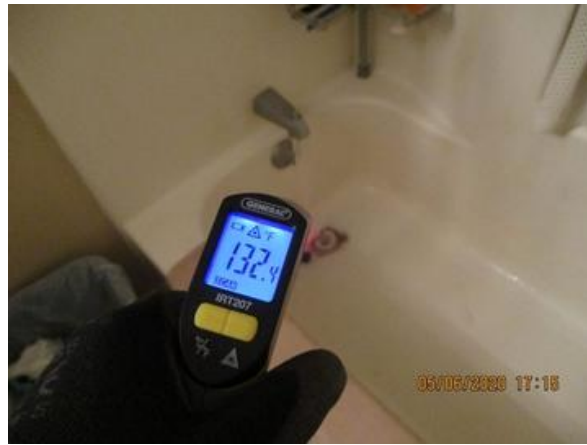
In general, 120 degrees Fahrenheit is the maximum safe hot water temperature that should be delivered from a fixture. Therefore hot water above 120 degrees Fahrenheit can be considered hazardous. Supply settings that are acceptable for far reaching fixtures may be too hot for closer fixtures. This condition should be verified and mixing valves should be installed as necessary. A mixing valve will allow regulation of difficult fixtures. The user should always reference the user manual for their specific product and adjust the water temperature as necessary.

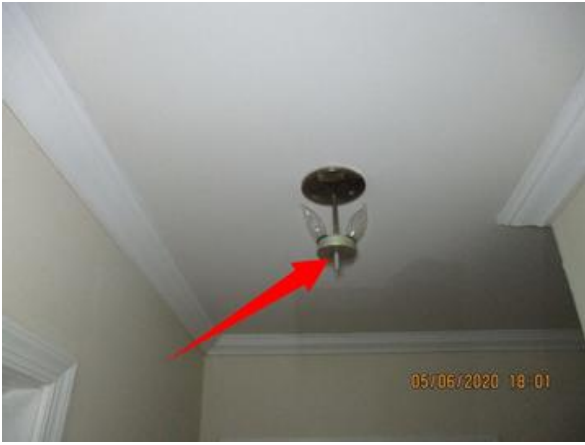
It was observed that the hallway light fixture was missing a light shade. It is recommended that the light shade be installed for aesthetic purposes only.
