### SAMPLE REPORT

**1 Sample Report Road**

**Inspection Date:** 08-22-2020

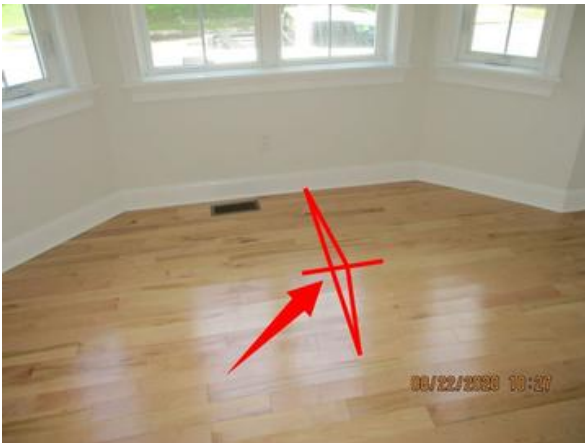
08/23/2020	It was observed that several areas of underlying structure were out of plumb, uneven or unlevel. As per the Report Header, these conditions may be characteristic of the underlying original structure. Physical defects were not observed due to coverings and finishes. This condition is being written to document and verify that these conditions have been observed during the home inspection process. The conditions should be reviewed with the homeowner and considered carefully. If concerns are verified, it is recommended that a licensed New York State Professional Engineer be contacted for further evaluation and identification of potential repairs. Please be advised, photograph illustrations may be slightly exaggerated to identify the areas of concern. The locations
------------	--

should be observed in the field.

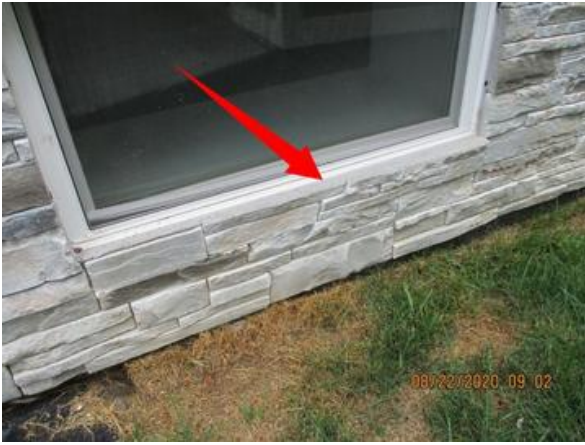
08/24/2020 It was observed that stone veneer covering on the exterior foundation was loose at some locations and requires reattachment.

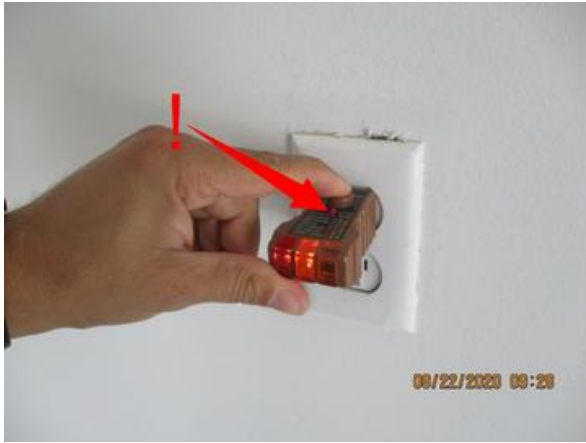
It was observed that no ground fault circuit interrupter (GFCI) outlets are installed in the garage. GFCI outlets help prevent electric shocks in areas that may have water present. Garages are typically included under this criteria. It is recommended that GFCI outlets be installed in the garage area.

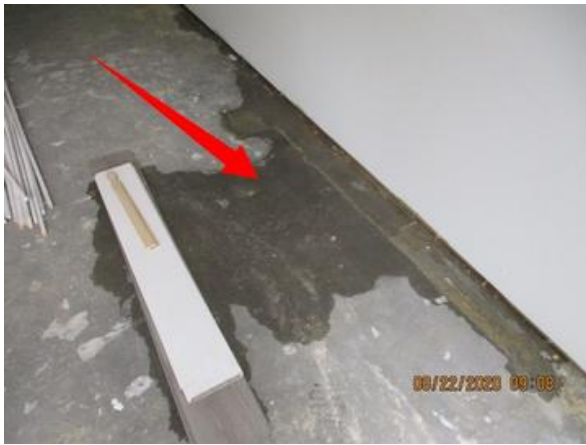
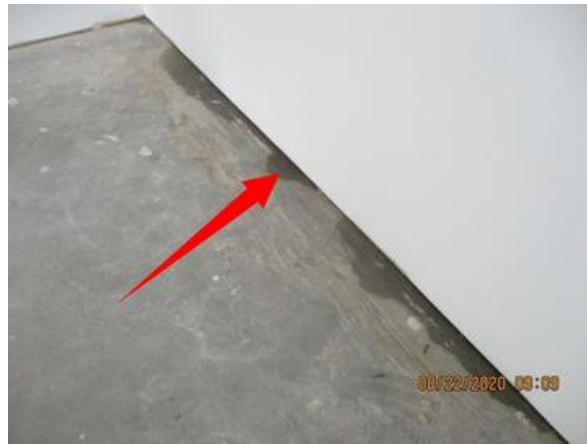
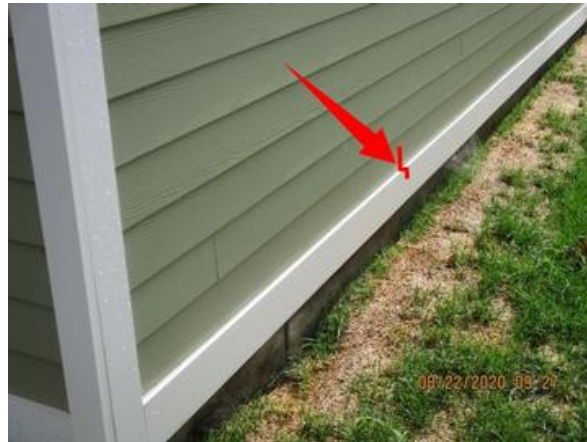
It was observed that the detached garage exterior walls were missing integral and very important counter flashing at rim boards and any protruding features such as window and door heads and upper band boards. This condition is the likely result of water inside the structure. It is recommended that a counter flashing be installed at the rear over sized concrete slab that projects from the rear of the structure.

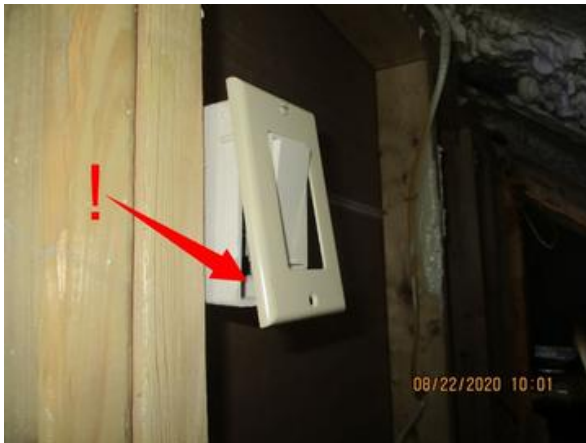
08/24/2020 It was observed that an electrical cover was missing in the attic. Electrical covers protect from the risk of shock, especially for younger children. It is recommended that electrical covers are installed.

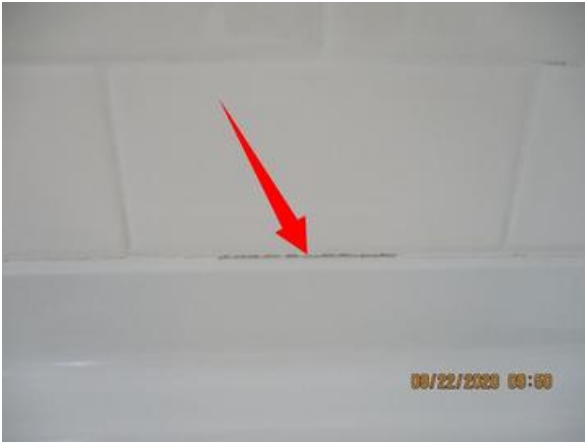
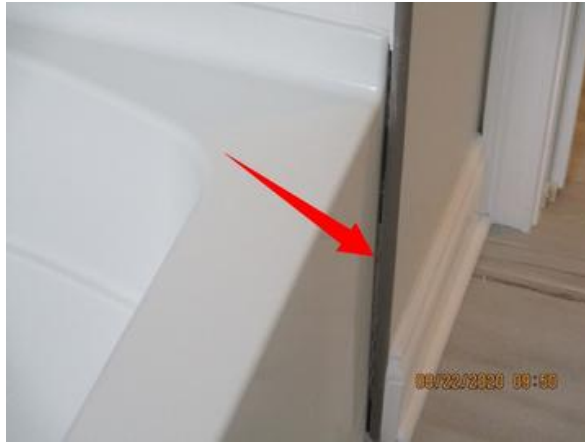
It was observed that there was missing caulk around bathroom fixtures. Missing caulk may allow water penetration to effect adjacent areas and may cause further damage. It is recommended that caulk be installed and maintained as necessary.

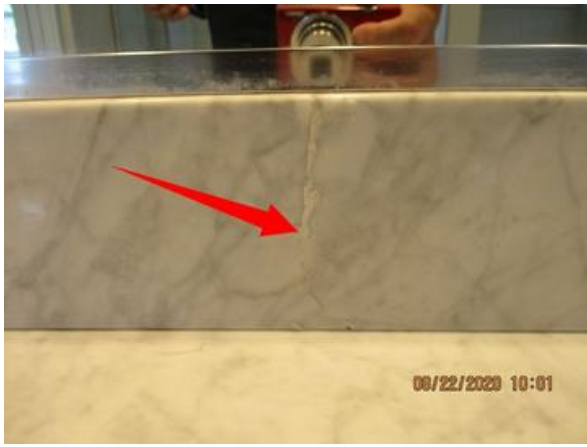
It was observed that the master bathroom marble backslash was damaged and requires proper repair.

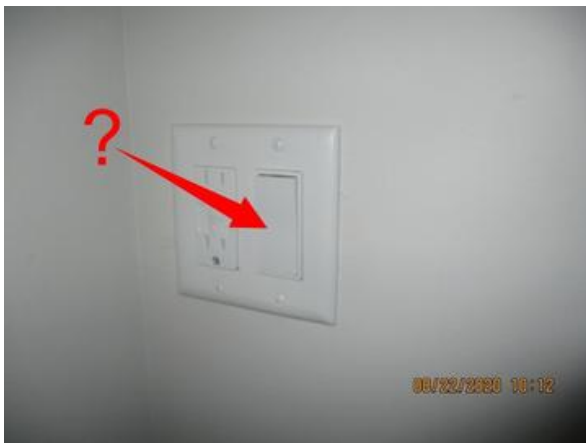
It was observed that the half bathroom had a light switch that was not operating a fixture. It is possible that the switch is roughed in for a future vanity light. It is recommended that the purpose of the light switch be discussed with the current homeowner.

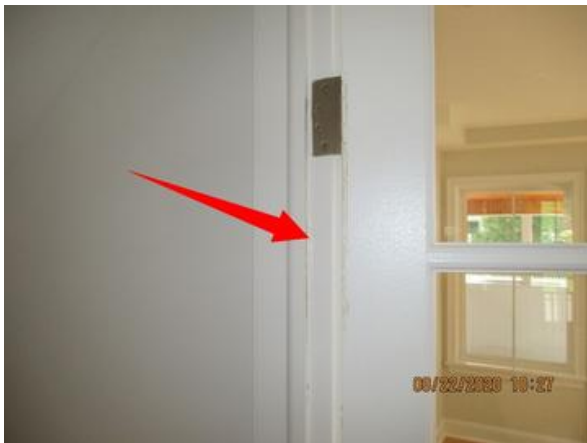
It was observed that the entry door to the basement area needs a small amount of touch-up paint at the jam area for aesthetic purposes only.

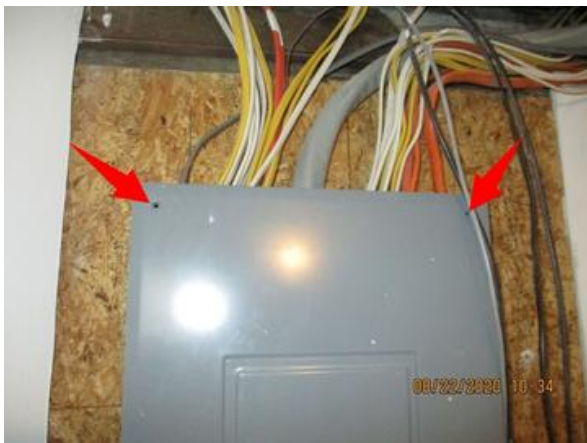
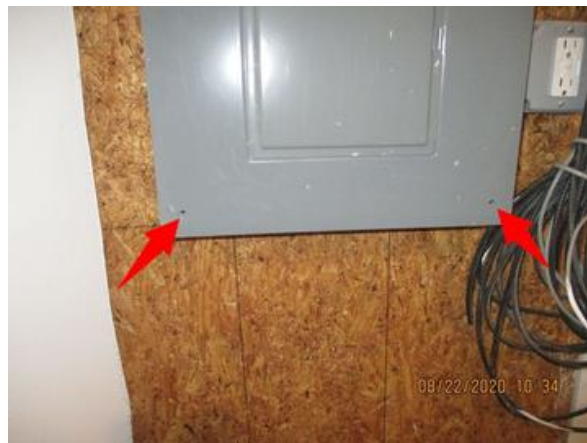
08/24/2020 It was observed that the electrical panel cover was missing several fasteners. It is recommended that the missing fasteners be installed.

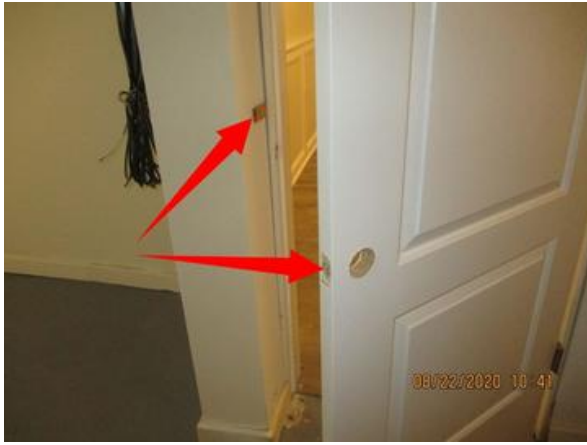
It was observed that a door in the basement was missing a hardware set and was unfinished. It is recommended that the hardware set be installed and the door jambs be finished.
