## Client

**Jon Doe**  
**123 Your Street**  
**Your Town, NY 13440**  
**HIN™: 134403026**  
**Email:**  
**Inspection Date:** 09-12-2015

Welcome and thank you for choosing Superior Quality Home Inspections.  
 This report is designed to be as thorough as possible, but also clear and concise.  
 If you have any questions please call us at (315)-794-1565.

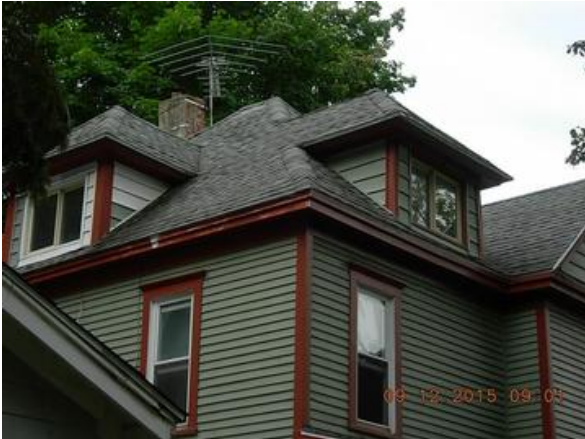
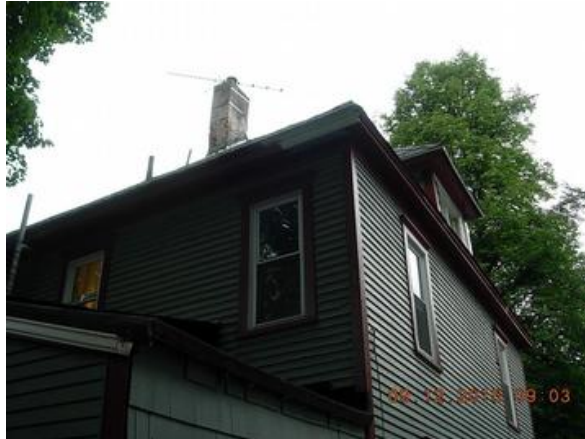
One or more gutters are missing. Recommend installing gutters, downspouts and extensions such as splashblocks or a drain line to carry rain water away from the house

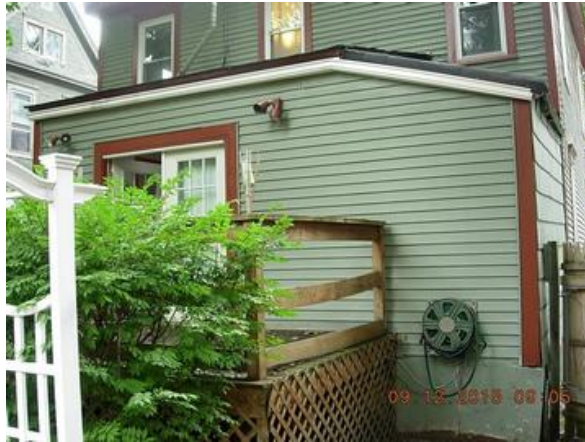
No gutter downspouts and extensions noted. This can cause accumulation of water next to the foundation which can lead to a wet basement. Recommend adding gutter downspouts with extensions.

No Gutter Downspouts

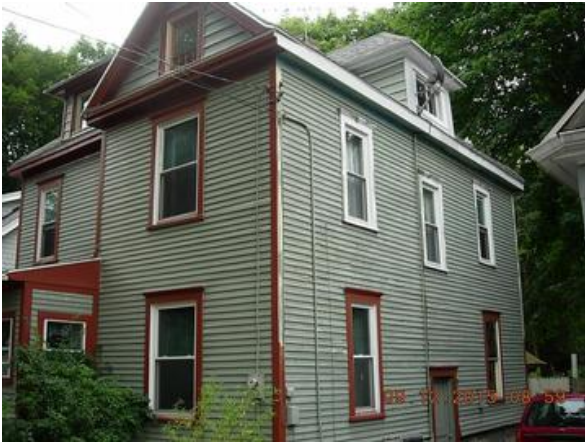
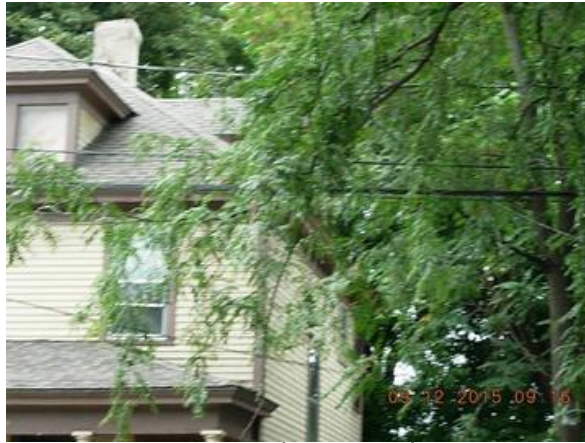
Service wires from pole are threatened by tree overhang and should have Electric Company inspect and provide remedy.

Wires Threatened

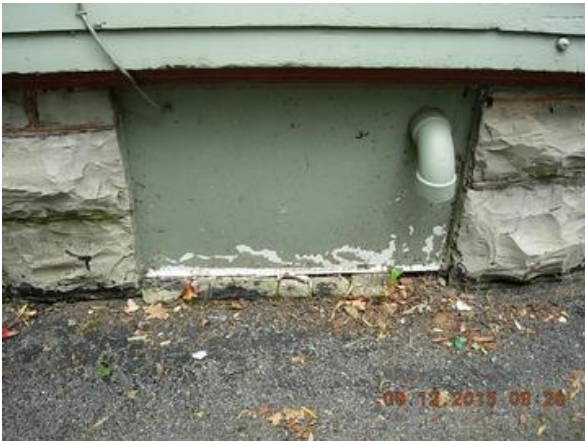
High efficiency vent pipe is too low to grade and vents below a window of the home. This could become blocked by snow or ice buildup and cause a backdraft of carbon monoxide into dwelling. Recommend a qualified contractor repair as necessary.

High Efficiency Pipe too Low

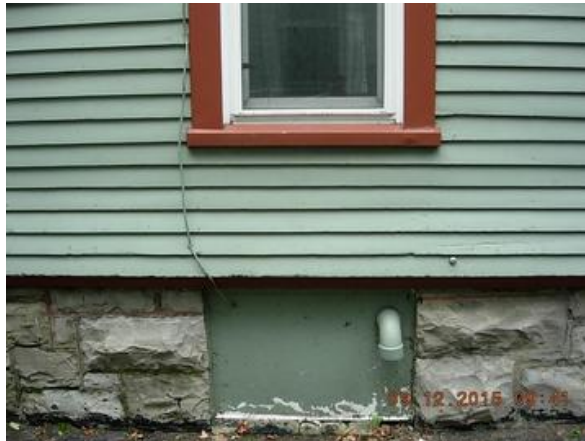
High Efficiency Pipe below window

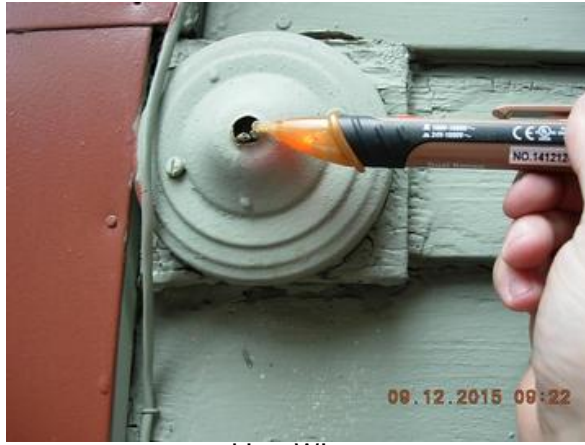
09/12/2015 Open light fixture on the outside the home has live wires exposed to the elements. This is a fire/safety hazard. Recommend a qualified electrician repair as necessary.

Live Wires

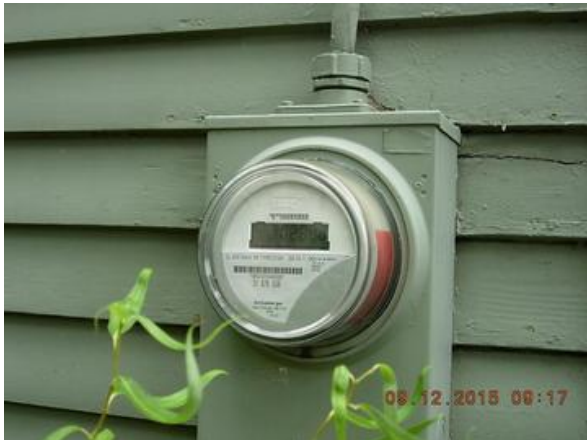
09/12/2015 Meter caulking is insufficient and needs to be recaulked. Moisture penetration is possible. Recommend a qualified contractor repair as necessary.

Meter Caulk Missing

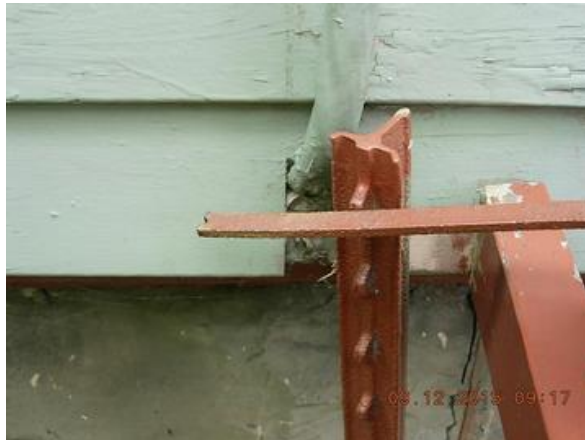
Caulking Needed

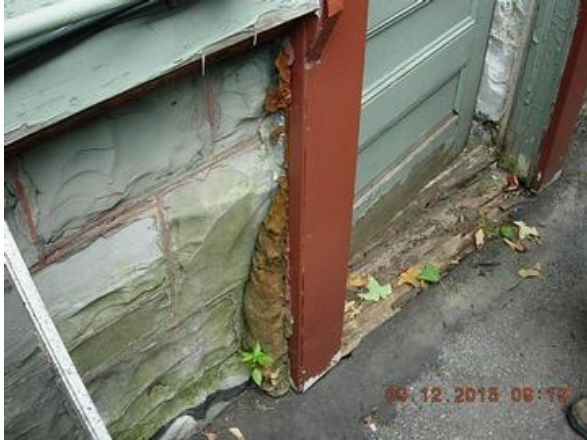
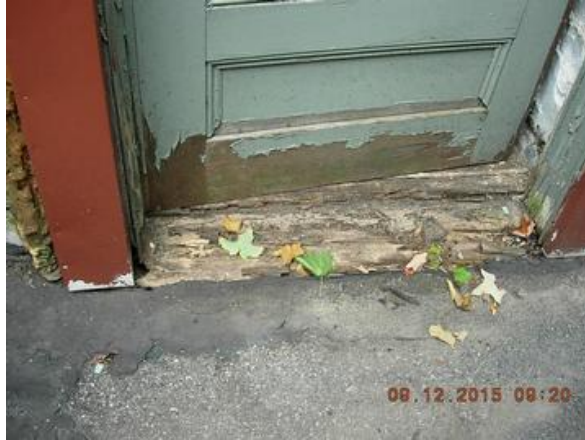
09/12/2015 Wooden door and its threshold on the side of the home is deteriorated and have extensive areas of rot. This could allow water intrusion into the home. Recommend contractor repair as necessary.

Deteriorated Door and Threshold

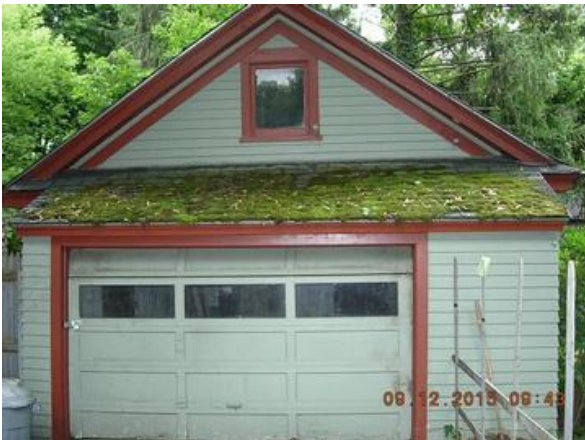
09/12/2015 Scope of the garage's inspection was limited to the exterior due to garage door being locked on the day of the inspection.

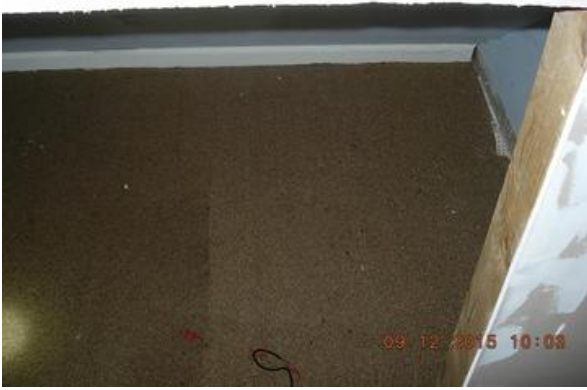
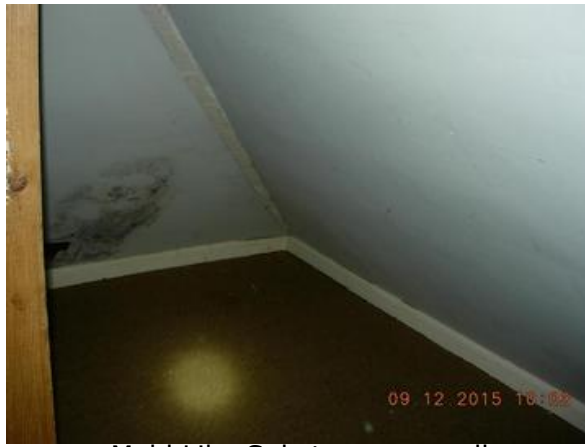
09/13/2015 Third floor storage area has a mold like substance on the wall

Mold Like Substance on wall

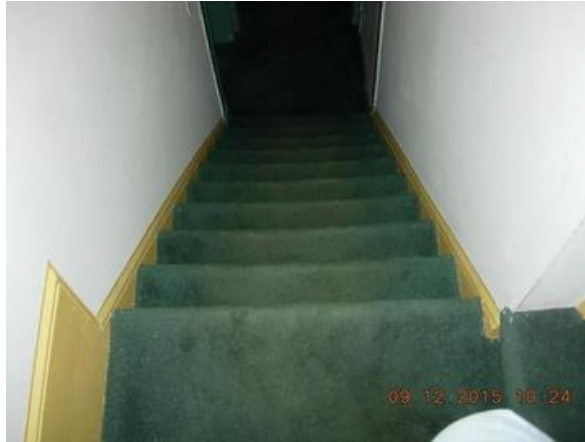
09/13/2015 No railing noted on the stairs to the second floor. This is a safety hazard and should be addressed. Recommend a contractor repair as necessary.

Stairs without Railing

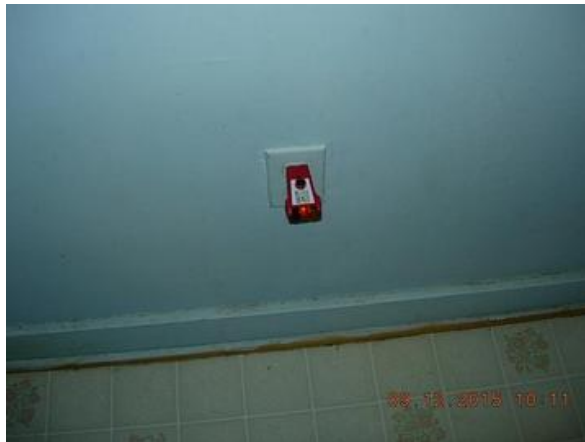
09/13/2015 One or more open ground outlets. Recommend having a licensed electrician either replace these outlets with 2-pronged outlets, or establish a proper ground wire.

Open Ground Outlets

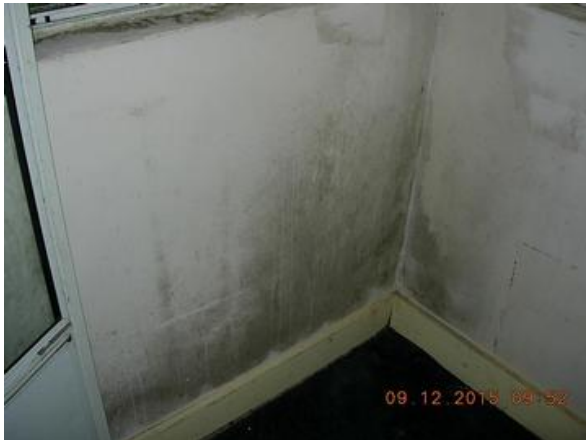
A window in the front entry porch shows extensive signs of water intrusion/moisture. The heavy water stains and moisture meter show the area to be currently damp. There is also a mold like substance on the wall below this window. Recommend a qualified contractor repair as necessary.

Mold Like Substance on wall

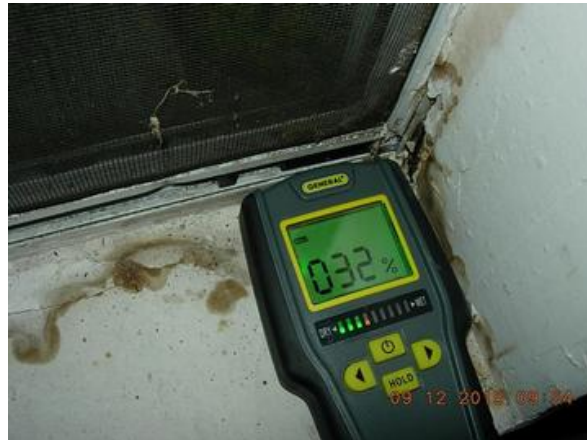
Moisture in the area of the window

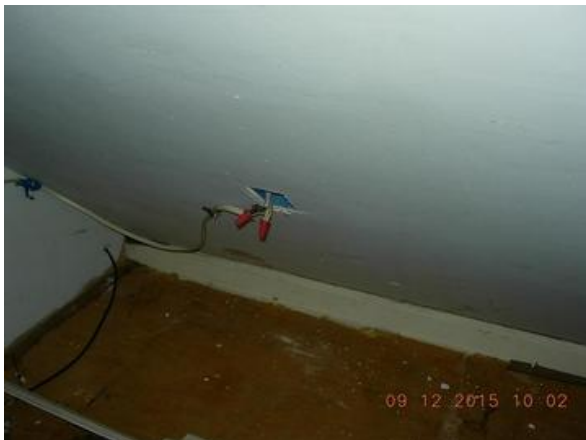
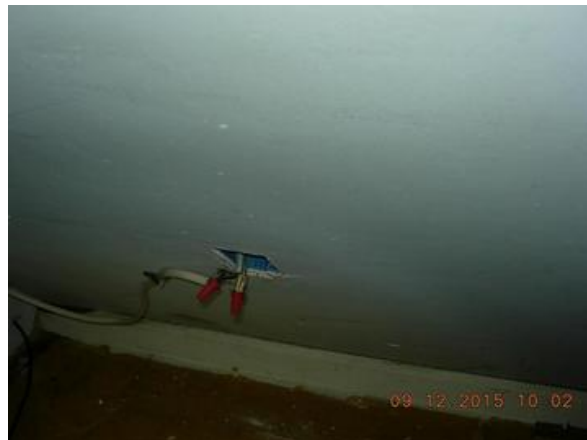
Third floor storage space has unprotected wiring that is exposed. Recommend a qualified electrician repair as necessary.

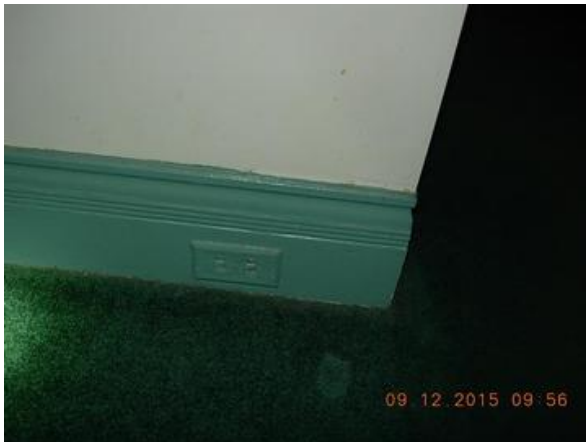
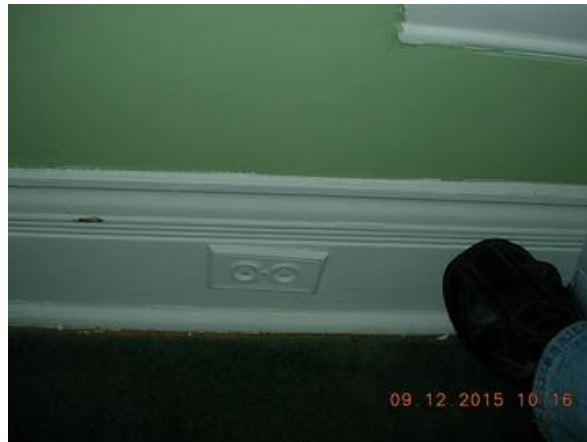
09/13/2015 The ungrounded and obsolete outlets should be upgraded to include more modern and safer ones, which provide a pathway for the current to travel harmlessly to ground.

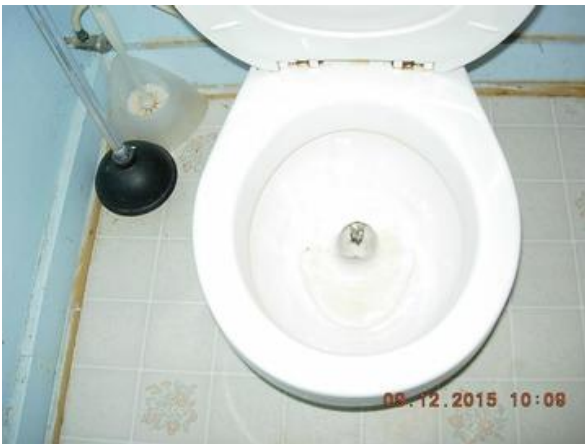
09/13/2015 Toilet did not have water turned on the day of the inspection. Could not fully inspect the toilet's operation.

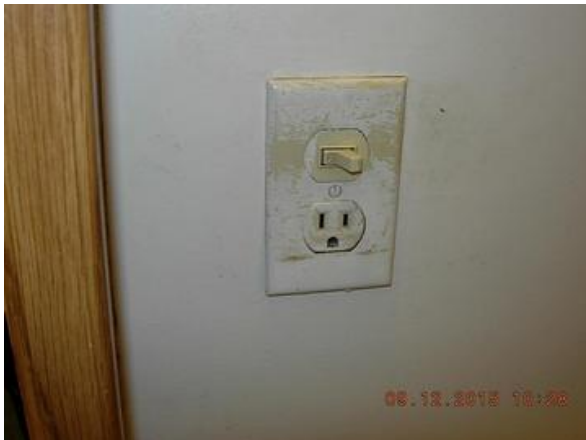
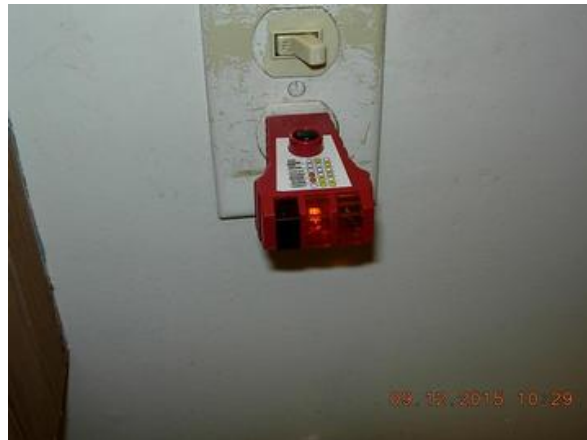
No ground fault circuit interrupter (GFCI) outlets installed. GFCI outlets help prevent electric shocks in areas that may have water present. Recommend having a qualified electrician install one or more GFCI outlets, especially over counter tops and around sinks.

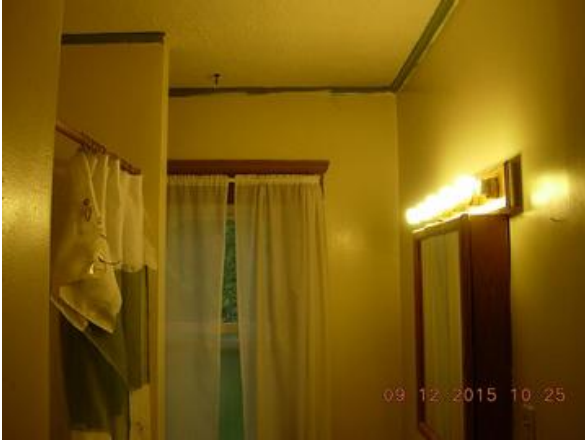
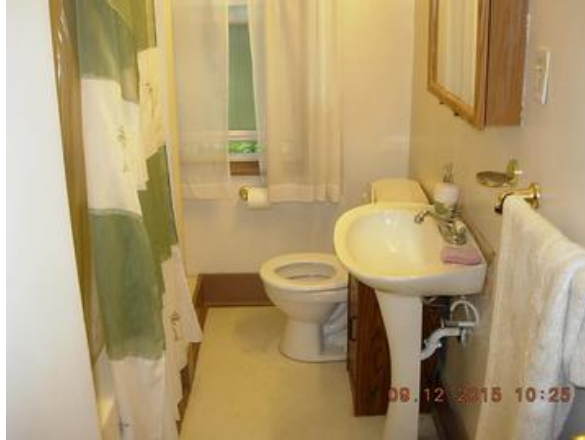
09/13/2015 No exhaust fan noted in bathroom. This will allow excessive moisture to build up in this area which can cause extensive damage. Recommend a contractor repair as necessary.

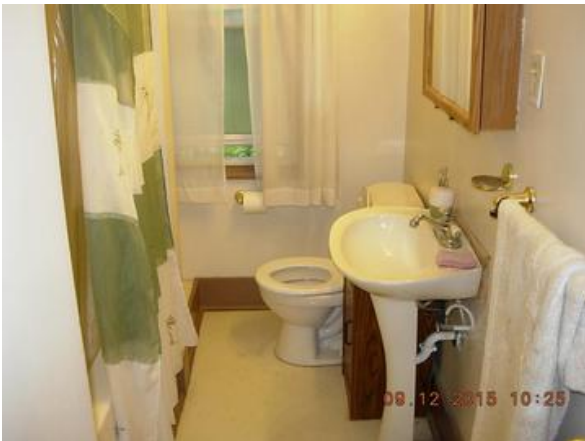
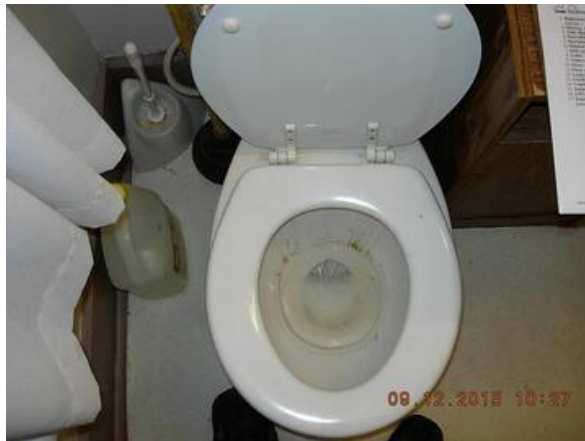
09/13/2015 Toilet would not stop filling on the day of the inspection after it was flushed. Water was turned off at the toilets shut off valve and was not inspected any further the day of the inspection. Recommend contractor repair as necessary.

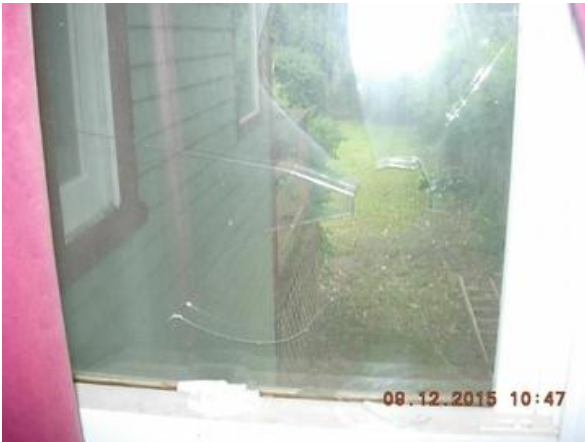
09/13/2015 Partially broken window in the kitchen area. Recommend contractor repair as necessary.

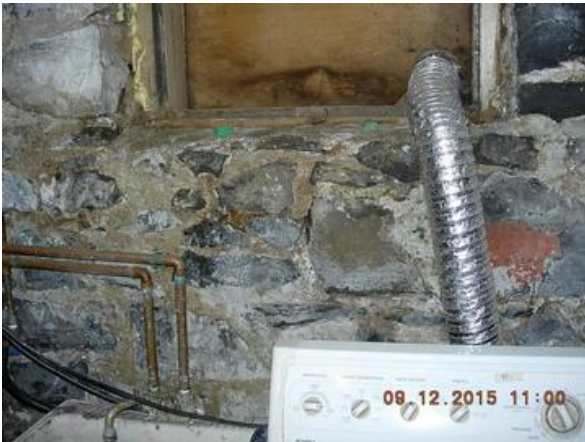
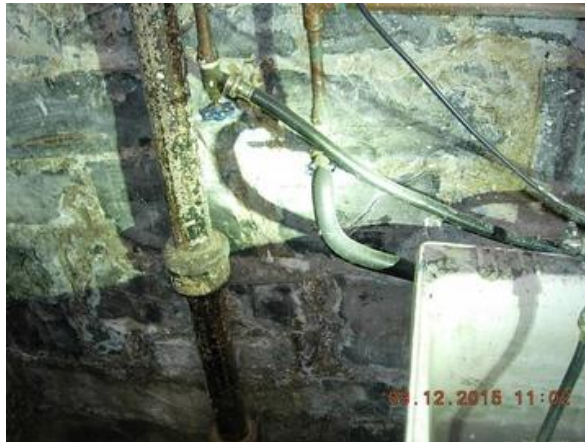
Bulging water line running to the washing machine noted the day of the inspection. This could burst and cause the basement/laundry area to flood with water. Recommend a contractor repair as necessary.

Bulging water line

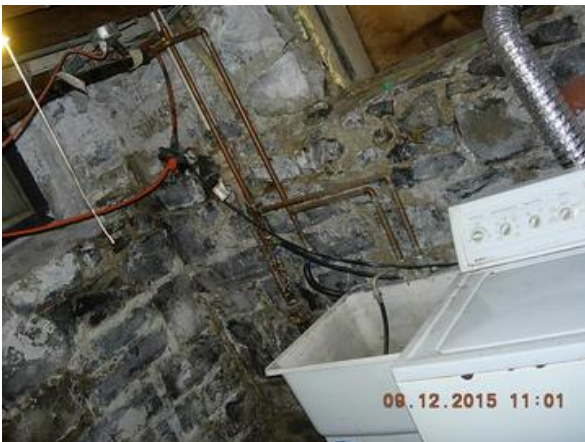
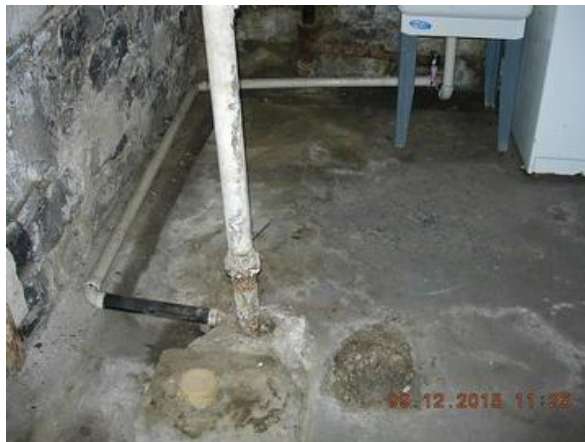
Washer drain is improperly run. The washer drains into the utility sink which drains into the basements floor drain. This could easily overflow and flood the basement area. Recommend a qualified plumber repair as necessary

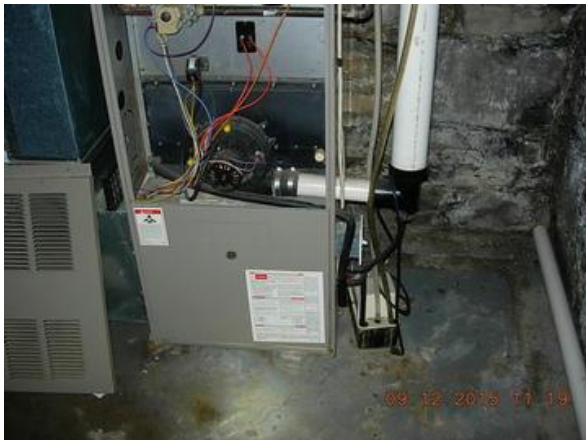
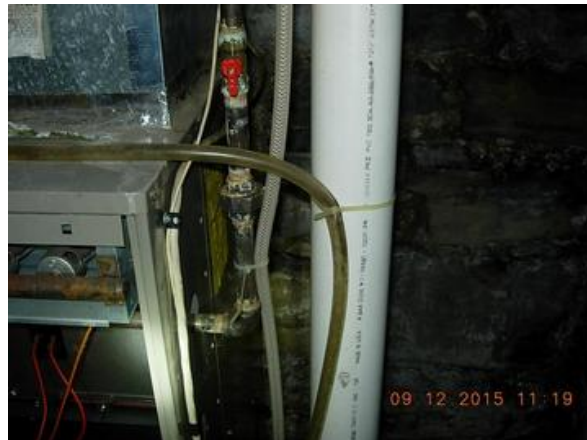
09/14/2015 No drip leg extension noted on the gas line to the furnace. This will cause erratic operation and will make system less efficient. Recommend repair by a qualified contractor.

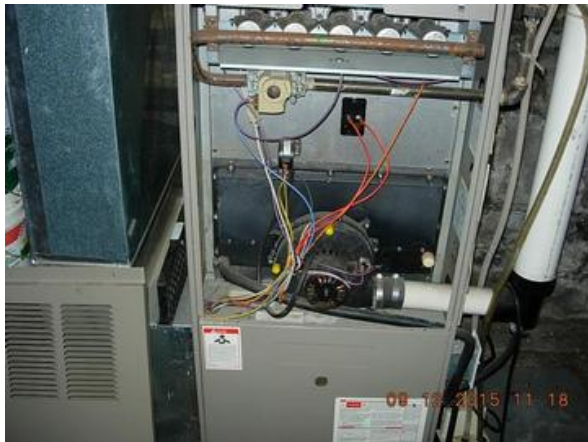
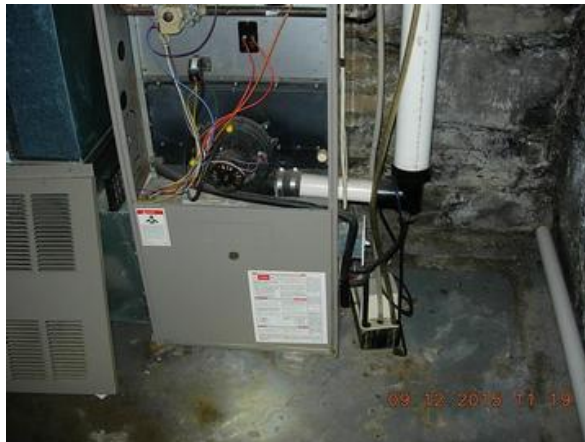
09/14/2015 System operated as designed on day of inspection.

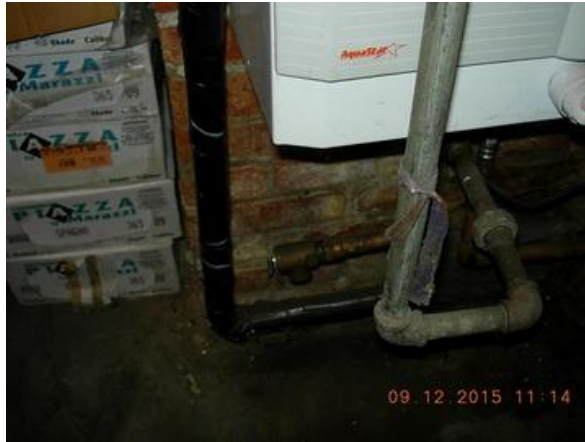
On demand unit had no supply valve in place to stop flow of water to the unit in case there was a leak. Recommend the installation of this valve to control possible flooding if the unit fails.

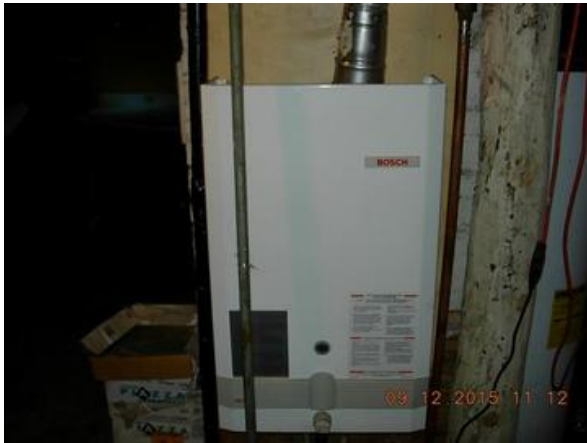
Hot water heater operated as designed on the day of the inspection.

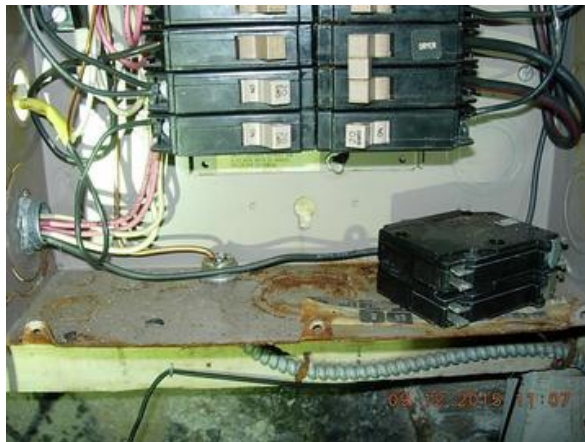
Branch wiring leaving the main panel is not properly secured to panel. This is a safety hazard as this could allow for contact inside the panel and possible electrocution. Recommend a contractor repair as necessary.

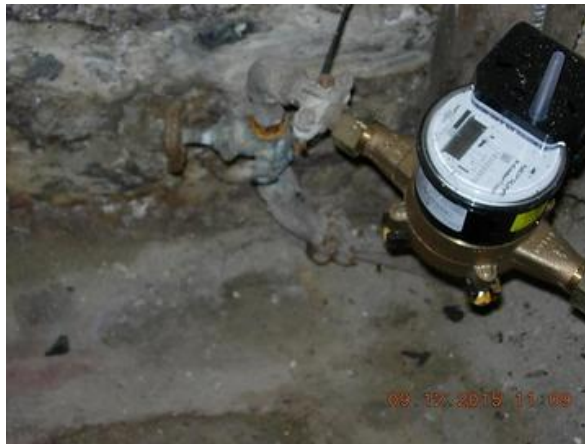
Lead Main Entry Pipe

09/14/2015 Tested the the main entrance pipe to the water system and discovered the pipe is made of Lead. Recommend a qualified contractor repair as necessary.

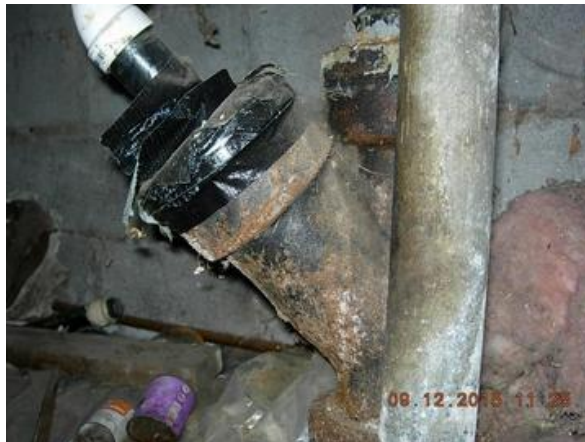
09/14/2015 Drain pipe from the home is improperly terminated into the main sewer pipe. This could allow for sewer gas to enter the area or leaking should the pipe become clogged. Recommend contractor repair as needed.

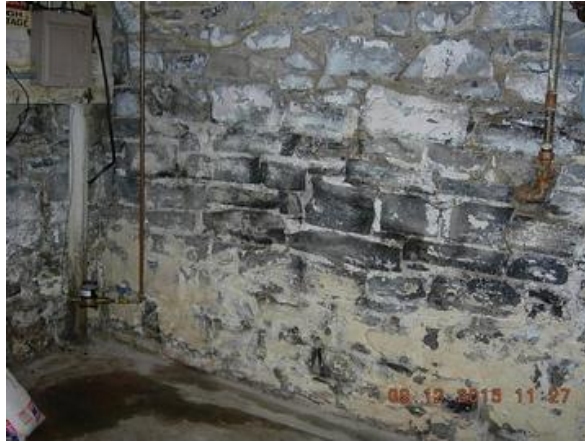
Lack of proper ventilation in the basement area noted. All basement windows were covered up and not available for use. This could allow excessive moisture to build up in the area and cause possible mold and other deterioration. Recommend a contractor repair as necessary.

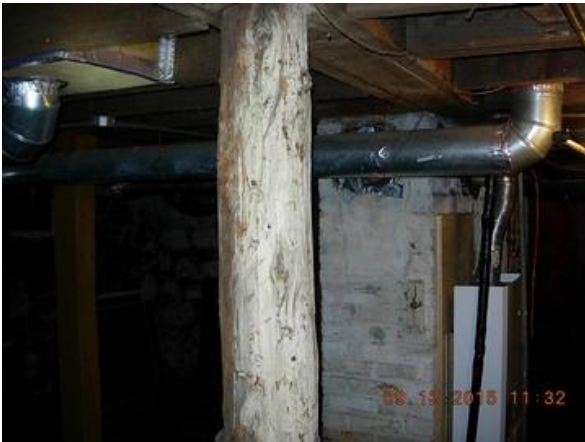
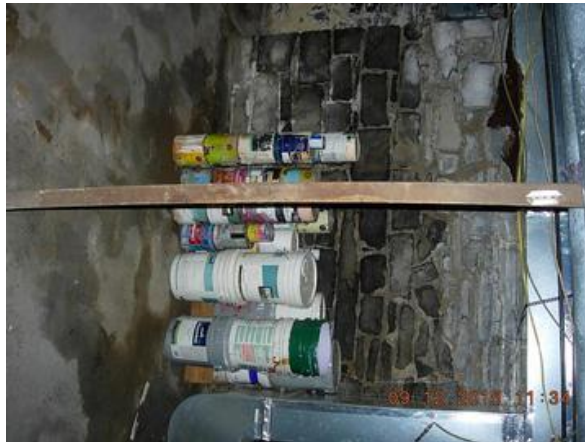
One or more wood support columns in the basement are bowed or cracked. This can allow for additional settling of the home and or cracks in the walls. Recommend contractor repair as necessary.

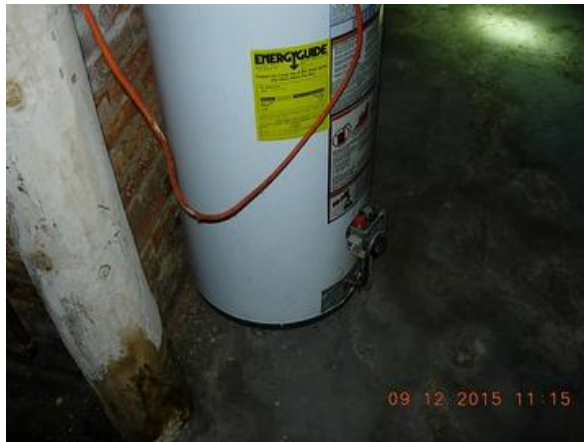
09/14/2015 Abandoned water heater tank and paint cans noted in the basement.  
Recommend these be removed prior to any sales transaction to provide broom clean conditions.
