SAMPLE REPORT

1 Sample Report Road
Porter Corners, NY 12859

Inspection Date: 05-06-2020

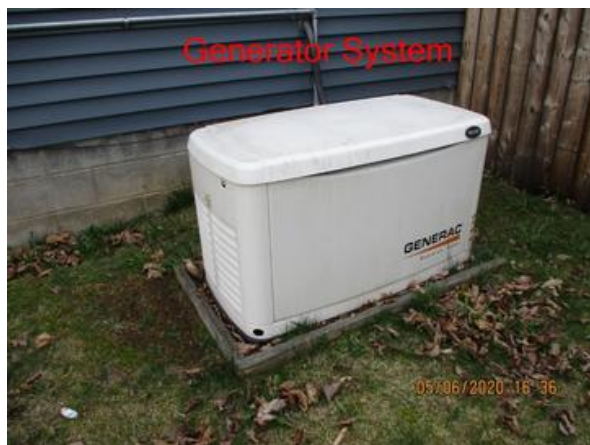
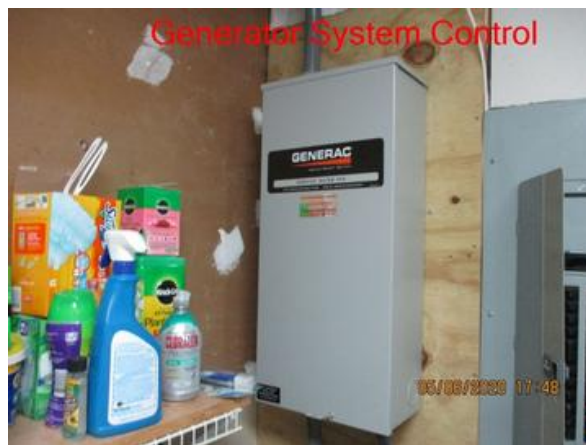
05/07/2020 Please be advised that at the time of this inspection an existing generator system with controls was excluded from the inspection. It is recommended that a qualified contractor be contacted for inspection of the generator system with controls. These items are typically not part of the main structure and are excluded per NYS standards of practice.

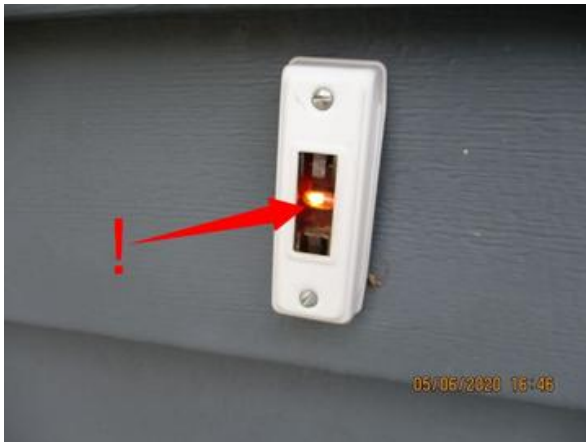
It was observed that the main entry doorbell was damaged. This condition may cause a shock and/or fire hazzard. The doorbell is a common courtesy for guests to conveniently alert the residents they have arrived. It is recommended that the doorbell be repaired as necessary.

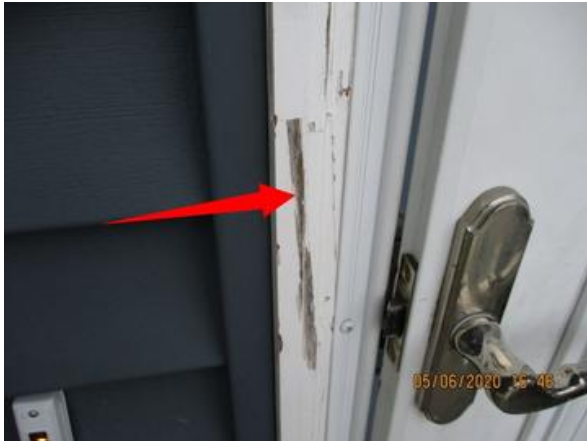
It was observed that there were areas of exposed wood and/or missing paint on exterior trims. This is exposing bare wood to the elements. Exposed wood can soften which may cause the wood deteriorate over time. It is recommended that all exterior wood exposed to the elements be periodically scraped and painted to protect the wood from deterioration including decay and rot.

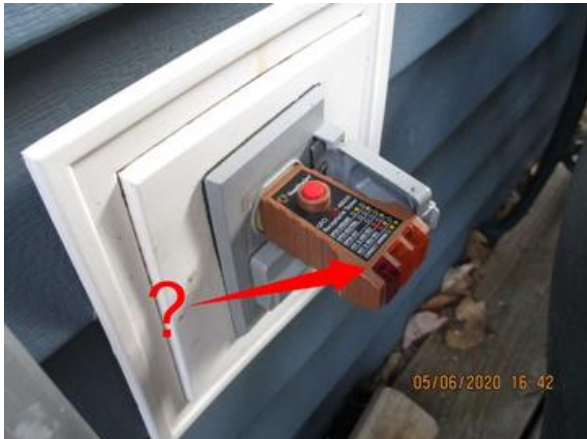
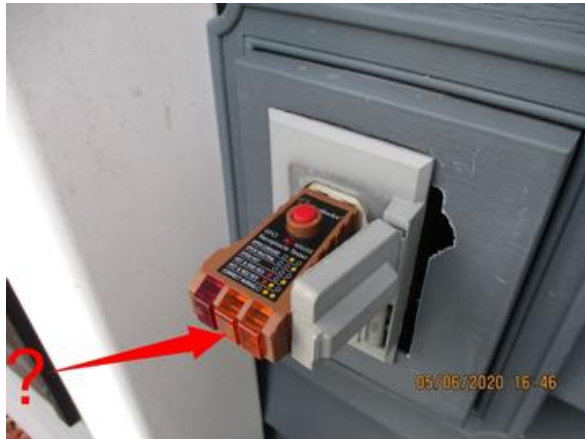
Exterior receptacles did not have power preventing inspection for proper operation of ground fault circuit interrupter (GFCI) protection. GFCI outlets help prevent electric shocks in areas that may have water present, especially at the exterior. It is recommended that once power is restored, exterior receptacles be reevaluated for properly operating GFCI protection. If GFCI protection is not present, it is recommended that GFCI's be installed as necessary.

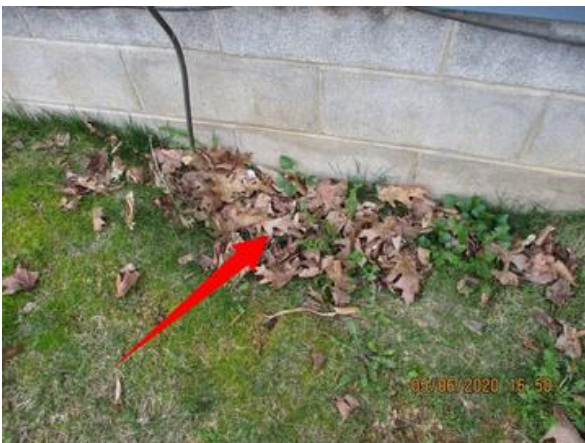
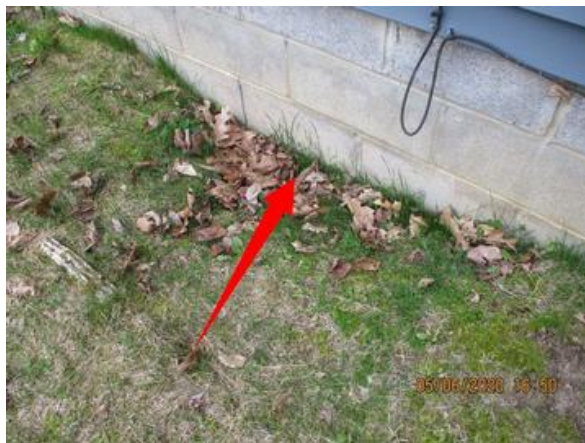
It was observed that areas where grade slopes toward the foundation existed. Areas where grade slopes toward the foundation can facilitate the entry of groundwater runoff which can lead to damage of the foundation structure and interior finishes. In some cases this can lead to high interior relative humidity which can be conducive to mold growth. It is recommended that these areas be regraded away from the foundation to promote groundwater runoff to move away from the foundation.

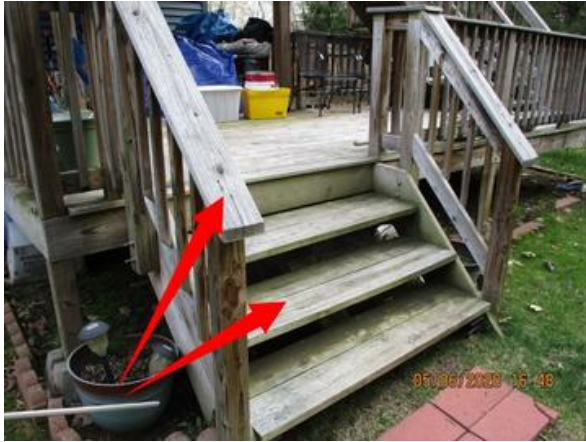
It was observed that decks, wood guardrails and stairs were not painted or stained. Staining and/or painting of decks and wood guardrails and stairs can preserve wood, protecting it from the elements and prolonging life. This will minimize overall maintenance and prevent discoloration. It is recommended that unpainted/unstained decks and wood guardrails and stairs be coated as necessary.

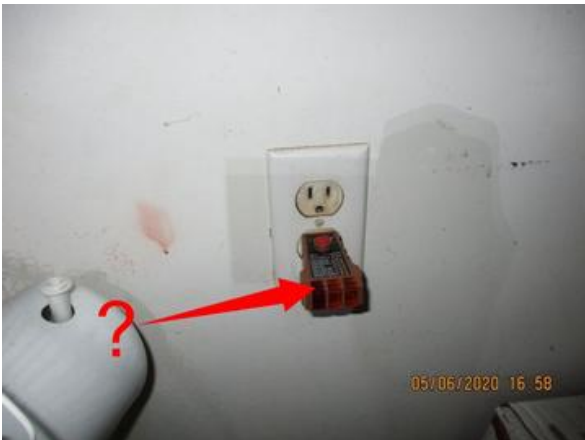
Attached garage receptacles did not have power preventing inspection for proper operation of ground fault circuit interrupter (GFCI) protection. GFCI outlets help prevent electric shocks in areas that may have water present, especially at the exterior. It is recommended that once power is restored, exterior receptacles be reevaluated for properly operating GFCI protection. If GFCI protection is not present, it is recommended that GFCI's be installed as necessary.

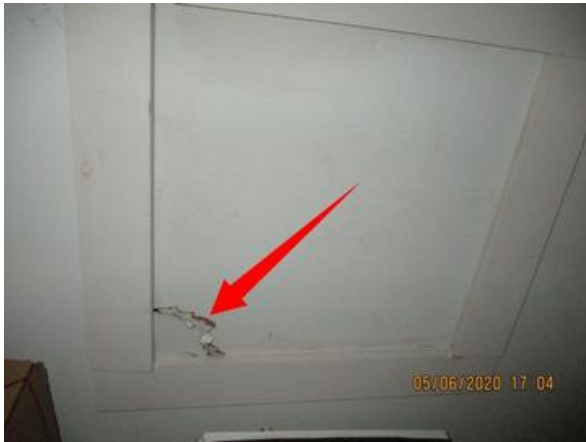
It was observed that the attic hatch cover was damaged and requires replacement.

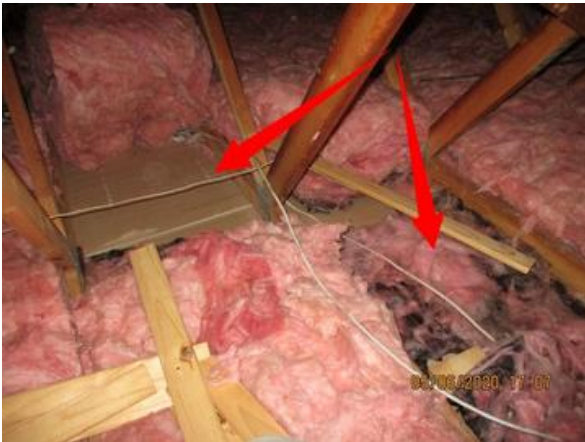
05/07/2020 It was observed that portions of the attic were not covered with adequate insulation thickness. For more information on insulation standards please visit: [Insulation Institute](https://www.insulationinstitute.org/). It is recommended that insulation be installed as necessary.

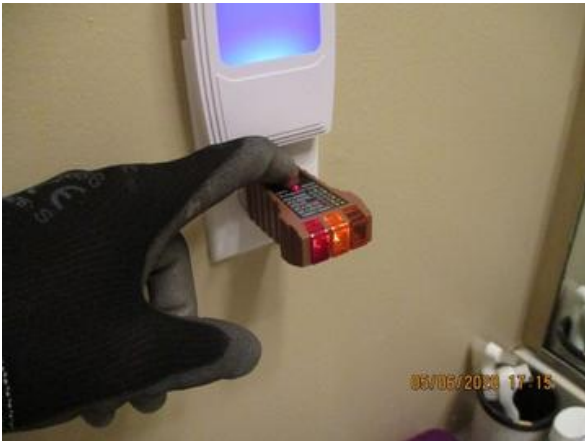
It was observed that the ground fault circuit interrupter (GFCI) outlets are not functioning as intended. GFCI outlets help prevent electric shocks in areas that may have water present. It is recommended that GFCI's be installed as necessary, especially over counter tops and around sinks.

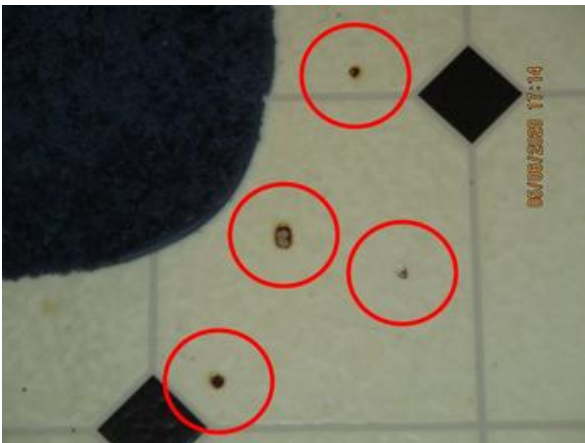
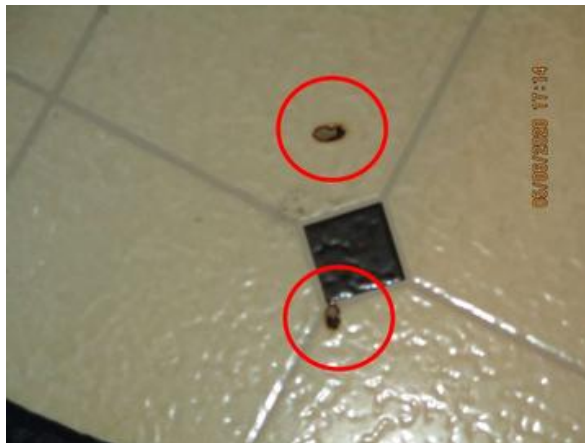
It was observed that the full bathroom floor had cigarette burns and requires repair.

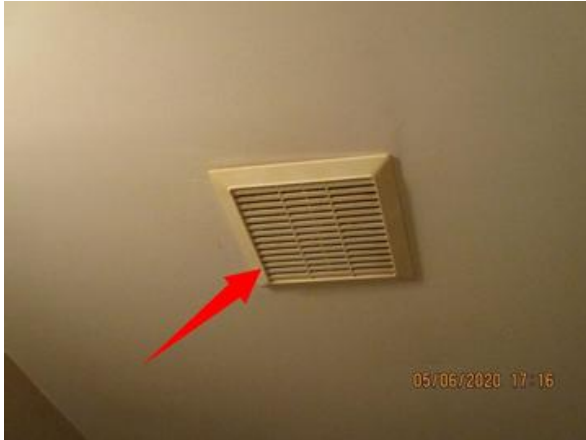
It was observed that the bathroom exhaust fan operated loudly when toggling the wall switch indicating the fan may not be operating properly. The lack of ventilation can prevent the ability to eliminate stale, impure and very humid air thereby decreasing the quality of indoor air and potentially cause moisture buildup which can lead to mildew and other high moisture issues. It is recommended that the bathroom exhaust fan be repaired as necessary.

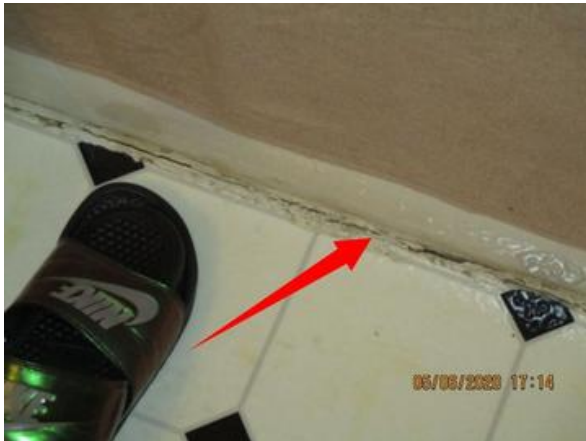
It was observed that caulking around bathroom fixtures requires repair. Deteriorated and/or poor caulking can lead to water infiltration into the walls and floors of bathroom areas which can lead to water damage. It is recommended that general caulking maintenance be conducted as necessary.

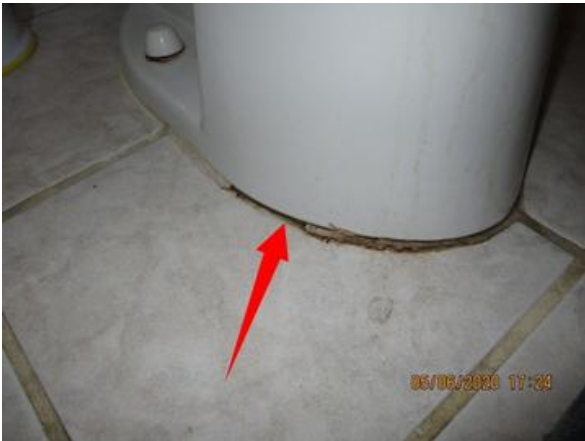
It was observed that caulking around bathroom fixtures requires repair. Deteriorated and/or poor caulking can lead to water infiltration into the walls and floors of bathroom areas which can lead to water damage. It is recommended that general caulking maintenance be conducted as necessary.

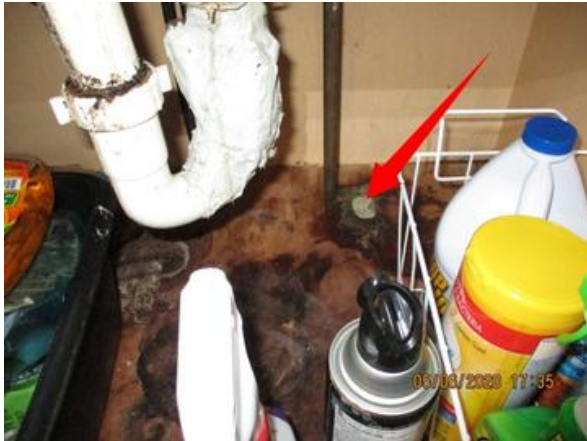
It was observed that a mold-like substance was present in the kitchen under the sink. The mold-like substance area was less than 10sf. Some people are sensitive to molds. For these people, exposure to molds can cause symptoms such as nasal stuffiness, eye irritation, wheezing, or skin irritation. Some people, such as those with serious allergies to molds, may have more severe reactions. Areas smaller than 10sf should be cleaned, but do not require professional remediation. Follow the Mold Cleanup Tips and Techniques found on the EPA's website at <https://www.epa.gov/mold/mold-cleanup-your-home>. If during the performance of this work any concealed mold contamination is uncovered and exceeds 10sf, stop work and call a mold assessor.

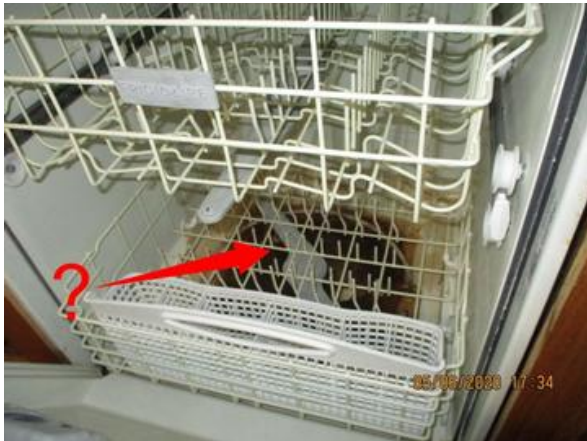
At the time of this inspection the dishwasher appliance was not properly operated and requires cleaning. It is recommended that a qualified technician be contacted for necessary repairs or replacement.

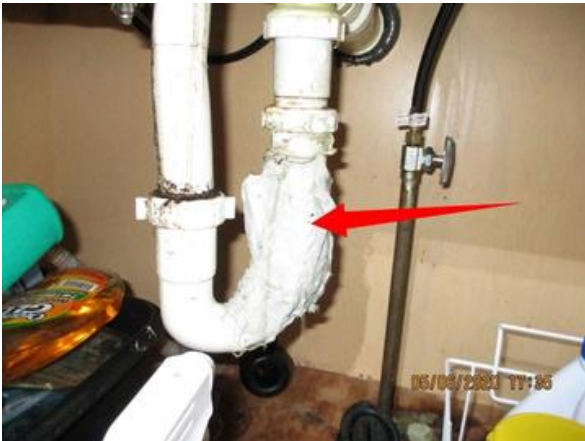
It was observed that there was a leaking trp drain kitchen sink. The trap was currently repaired in a manner that is not consistent with standard building practices. It is recommended that a qualified contractor be contacted for necessary repairs.

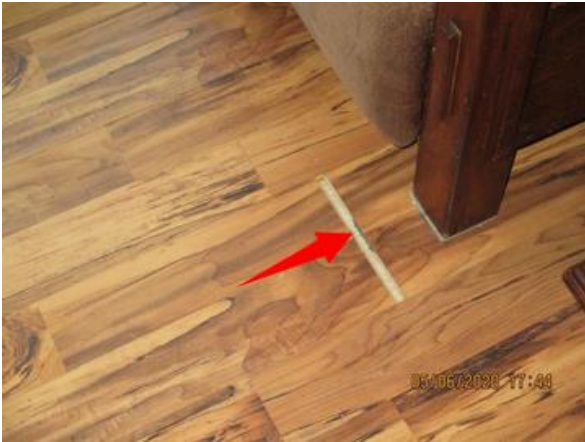
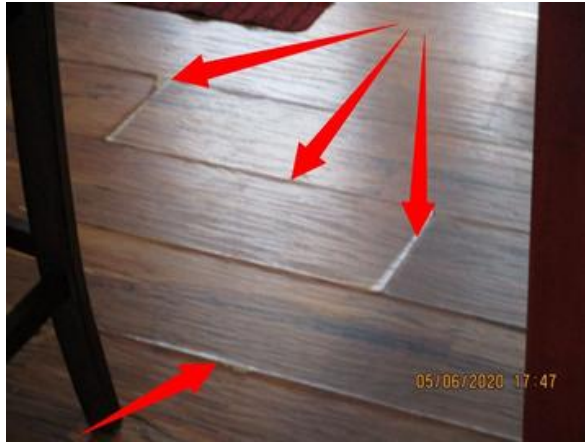
It was observed that the engineered wood flooring at the 1st floor appeared to be in worn condition indicating that the floor surface is approaching the end of its useful life. The wood surface has several gaps, loose boards, missing thresholds, peeling surfaces and puckering due to water damage. The floor likely requires replacement and cannot be repaired. Due to the possibility of these repairs to exceed \$1,500, these repairs as a whole should be considered a substantial defect. It is recommended that a qualified contractor be contacted for necessary repairs.

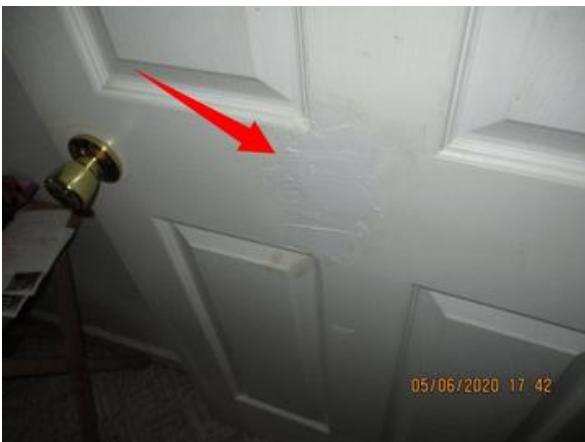
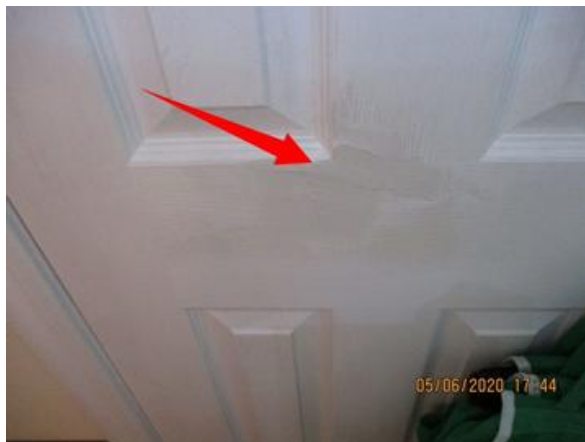
It was observed that several interior bedroom doors were damaged and patched in a manner which is inconsistent with standard building practices. Typically hollow core doors require replacement to restore their original aesthetic appearance and can not be patched due to wood grain finish. It is recommended that the doors be replaced as necessary.

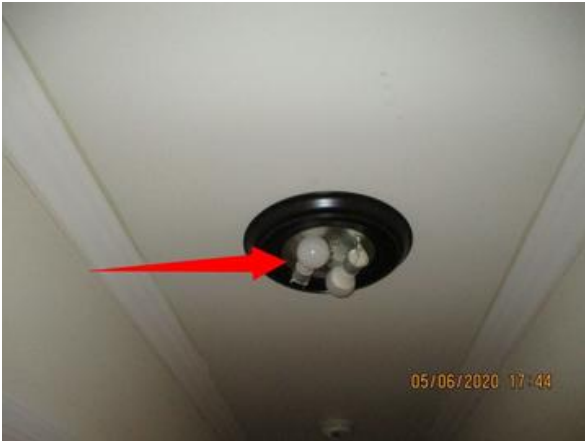
05/07/2020 It was observed that the hallway light fixture was missing a light shade. It is recommended that the light shade be installed for aesthetic purposes only.

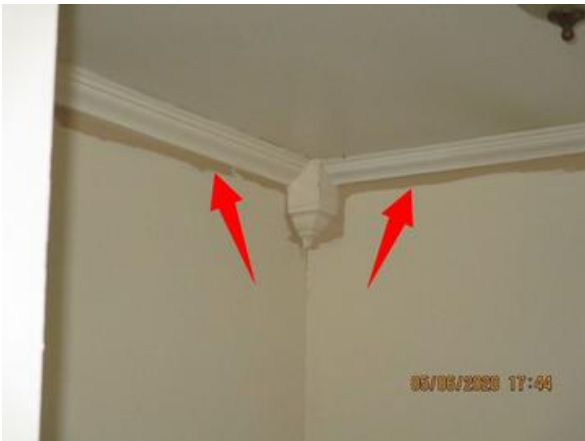
05/07/2020 It was observed that paint in the foyer area at crown molding was incomplete. It is recommended that the painting be completed for aesthetic purposes only.

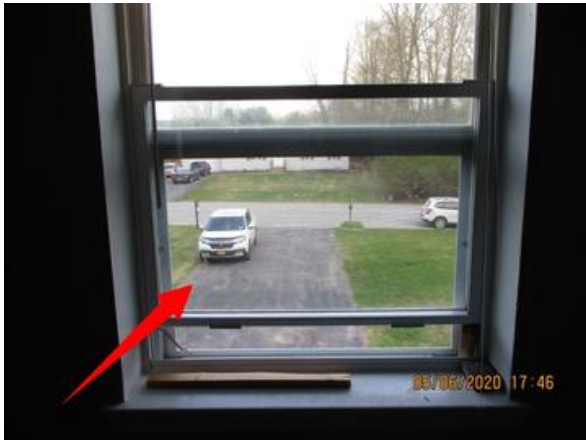
It was observed that several interior windows operated difficultly. The window frames and sash appeared to be in good condition, however, it is recommended that the windows be greased and/or adjusted as necessary to allow for smooth and easy operation.

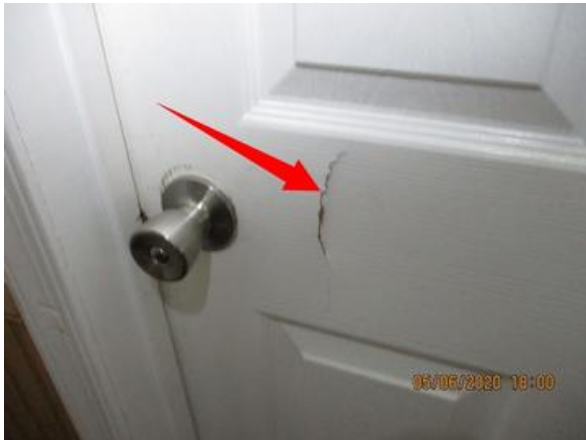
It was observed that the basement full bathroom door was damaged. Typically hollow core doors require replacement to restore their original aesthetic appearance and can not be patched due to wood grain finish. It is recommended that the doors be replaced as necessary.

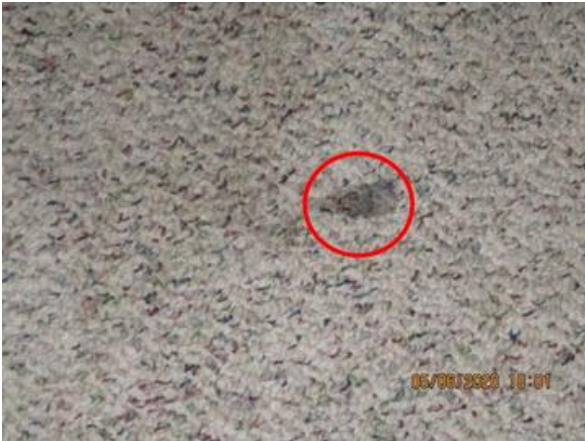
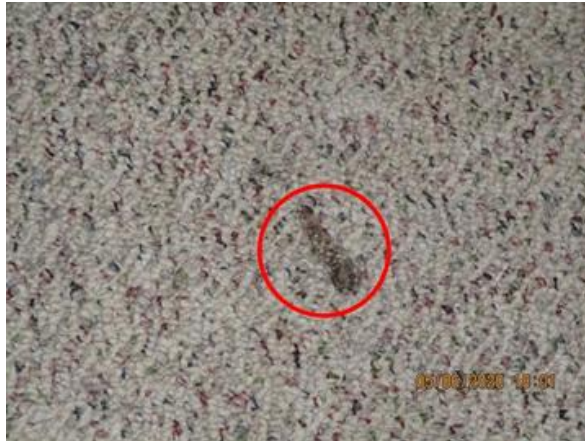
05/07/2020 It was observed that the basement carpet had cigarette burns and requires repair.
