### SAMPLE REPORT

**1 Sample Report Road**

**Inspection Date:** 08-22-2020

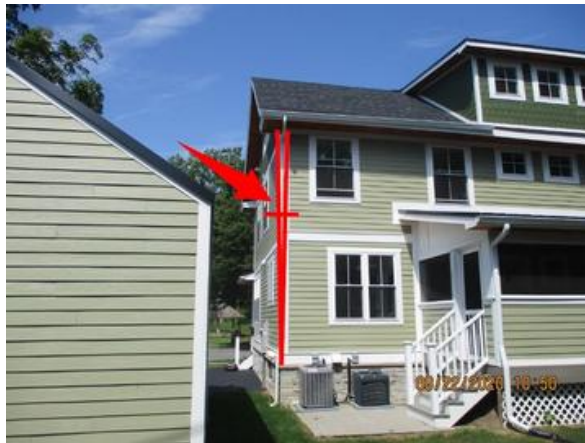
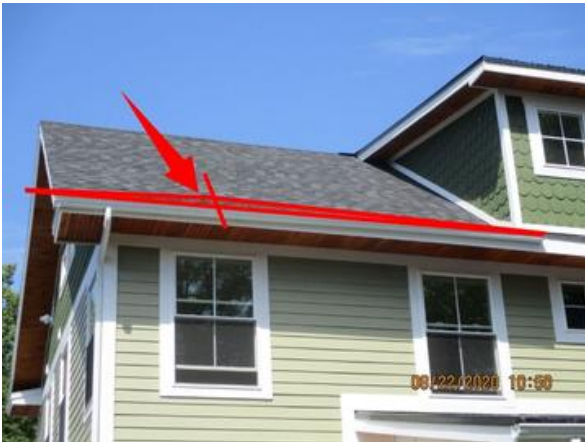
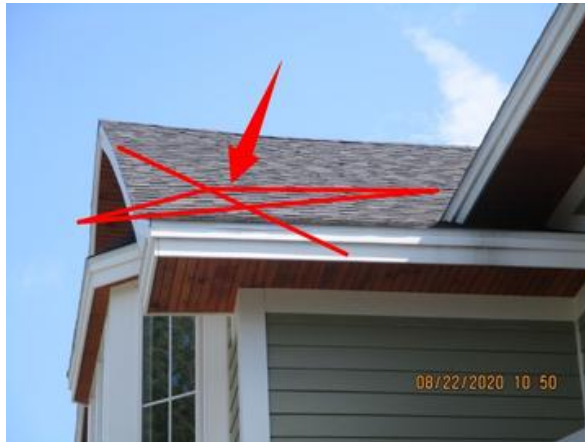
08/23/2020	It was observed that several areas of underlying structure were out of plumb, uneven or unlevel. As per the Report Header, these conditions may be characteristic of the underlying original structure. Physical defects were not observed due to coverings and finishes. This condition is being written to document and verify that these conditions have been observed during the home inspection process. The conditions should be reviewed with the homeowner and considered carefully. If concerns are verified, it is recommended that a licensed New York State Professional Engineer be contacted for further evaluation and identification of potential repairs. Please be advised, photograph illustrations may be slightly exaggerated to identify the areas of concern. The locations
------------	--

should be observed in the field.

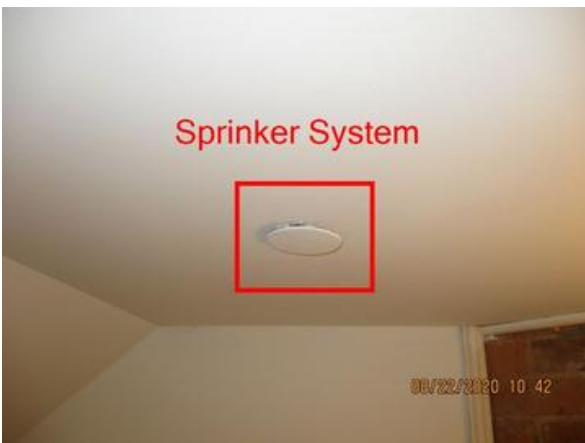
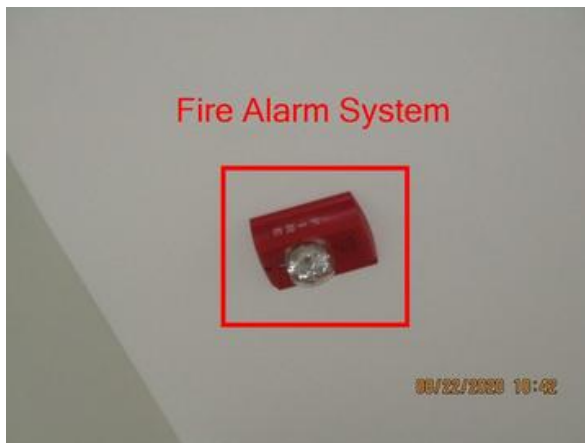
Please be advised that at the time of inspection an existing sprinkler system and fire alarm system was present on the property. It is recommended that a qualified contractor who is familiar with these systems and their operation be contacted for further evaluation and inspection. These items are accessories of the main structure and are excluded per NYS standards of practice.

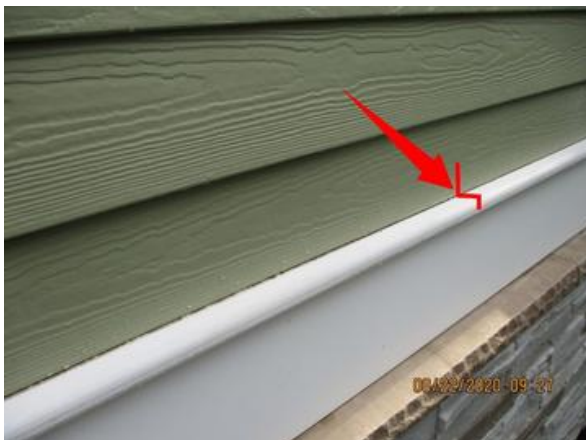
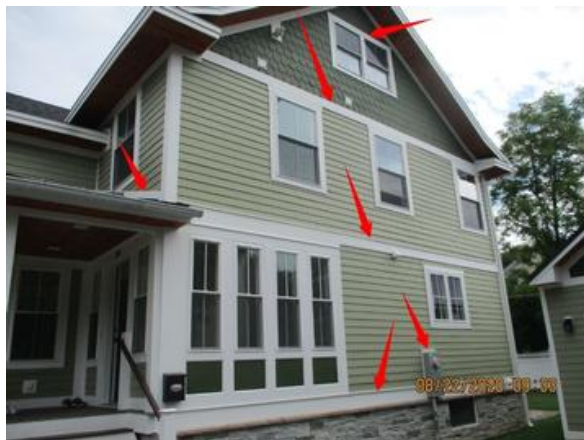
As with the detached garage, it was observed that the detached garage exterior walls were missing integral and very important counter flashing at rim boards and any protruding features such as window and door heads and upper band boards. No water was observed on the interior. It is recommended that a counter flashing be installed as necessary.

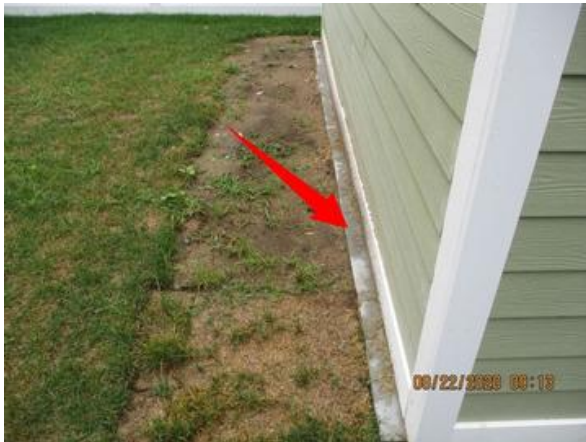
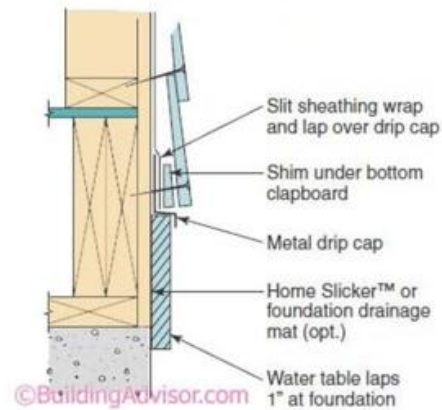
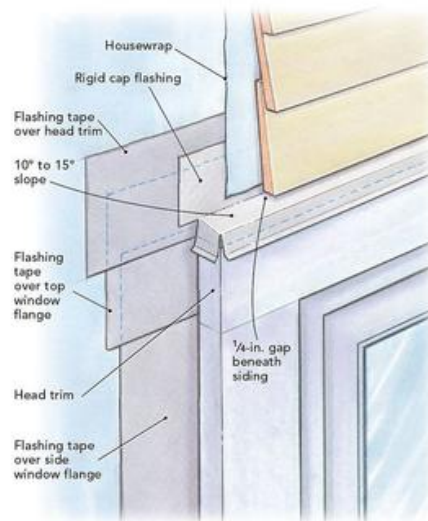
It was observed that the detached garage exterior walls were missing integral and very important counter flashing at rim boards and any protruding features such as window and door heads and upper band boards. This condition is the likely result of water inside the structure. It is recommended that a counter flashing be installed at the rear over sized concrete slab that projects from the rear of the structure.

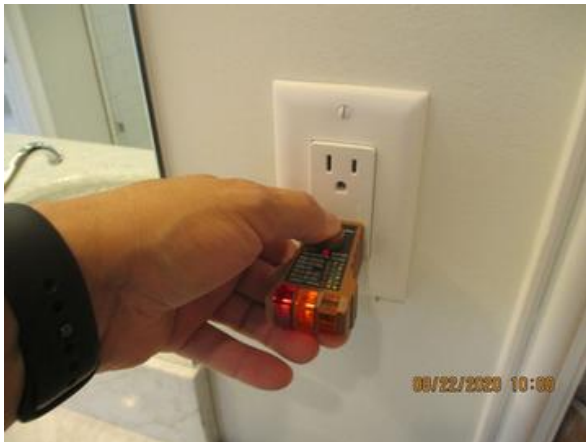
It was observed that no ground fault circuit interrupter (GFCI) outlets are installed. GFCI outlets help prevent electric shocks in areas that may have water present. It is recommended that a licensed electrician be contacted to evaluate and make repairs as necessary, especially over counter tops and around sinks.

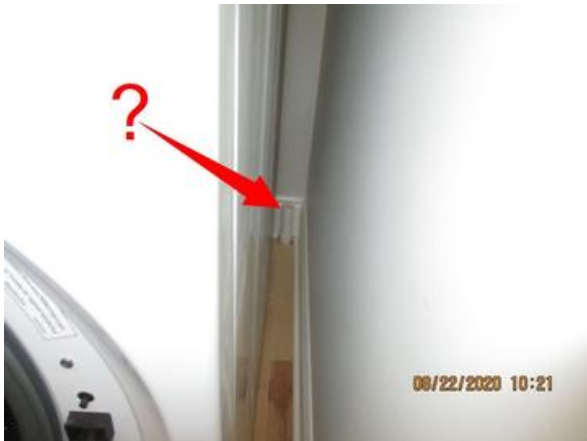
It was observed that a pipe was protruding from the floor behind the laundry equipment. the purpose of the pipe could not be identified, however, it is possible that the drain on the washing machine is not hooked up. It is recommended that the drain pipe be discussed with the current homeowner.

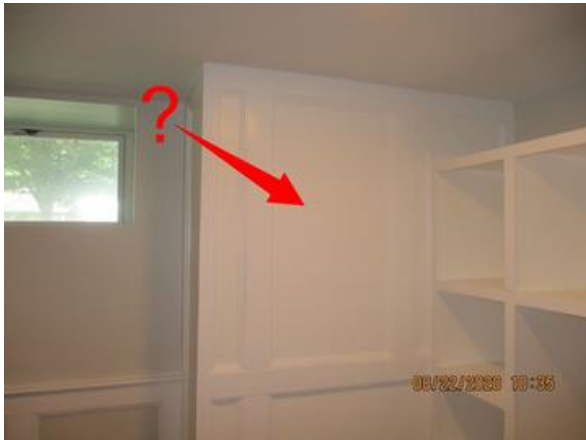
It was observed that the water meter and main shut-off could not be accessed due to a fixed wall panel. It is recommended that the fixed panel be made removable.
